Inspection Report

Property Address:
Sample Report
Victoria British Columbia

Highland Home Inspections

Date: 2017-08-12	Time:	Report ID: 2017-352
Property: Sample Report Victoria British Columbia	Customer: Mr. Joe Somebody	Real Estate Professional:

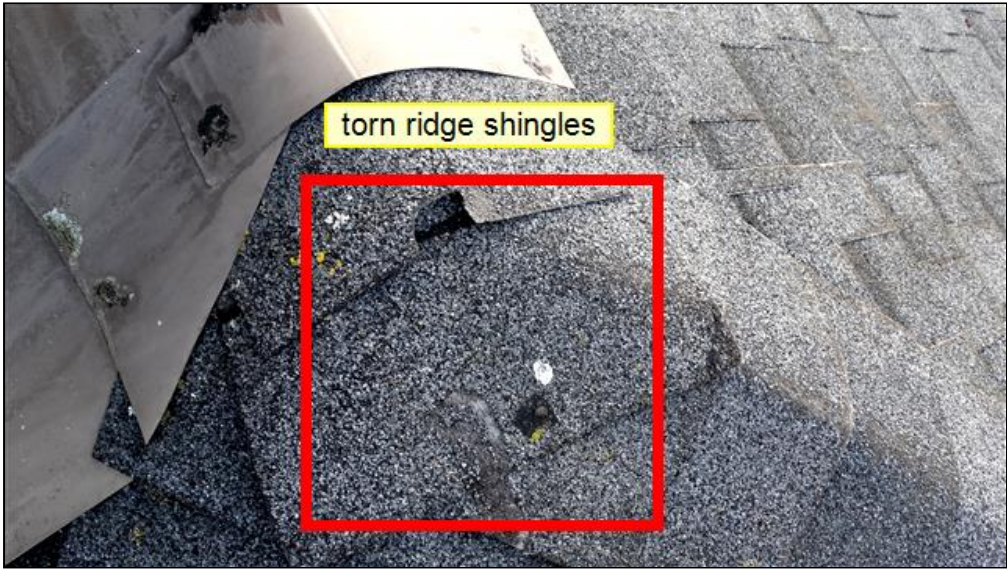
1.0 Item 1(Picture)

A few shingles are torn on the roof and should be replaced to prevent water ingress. Have a qualified roofer perform the work.

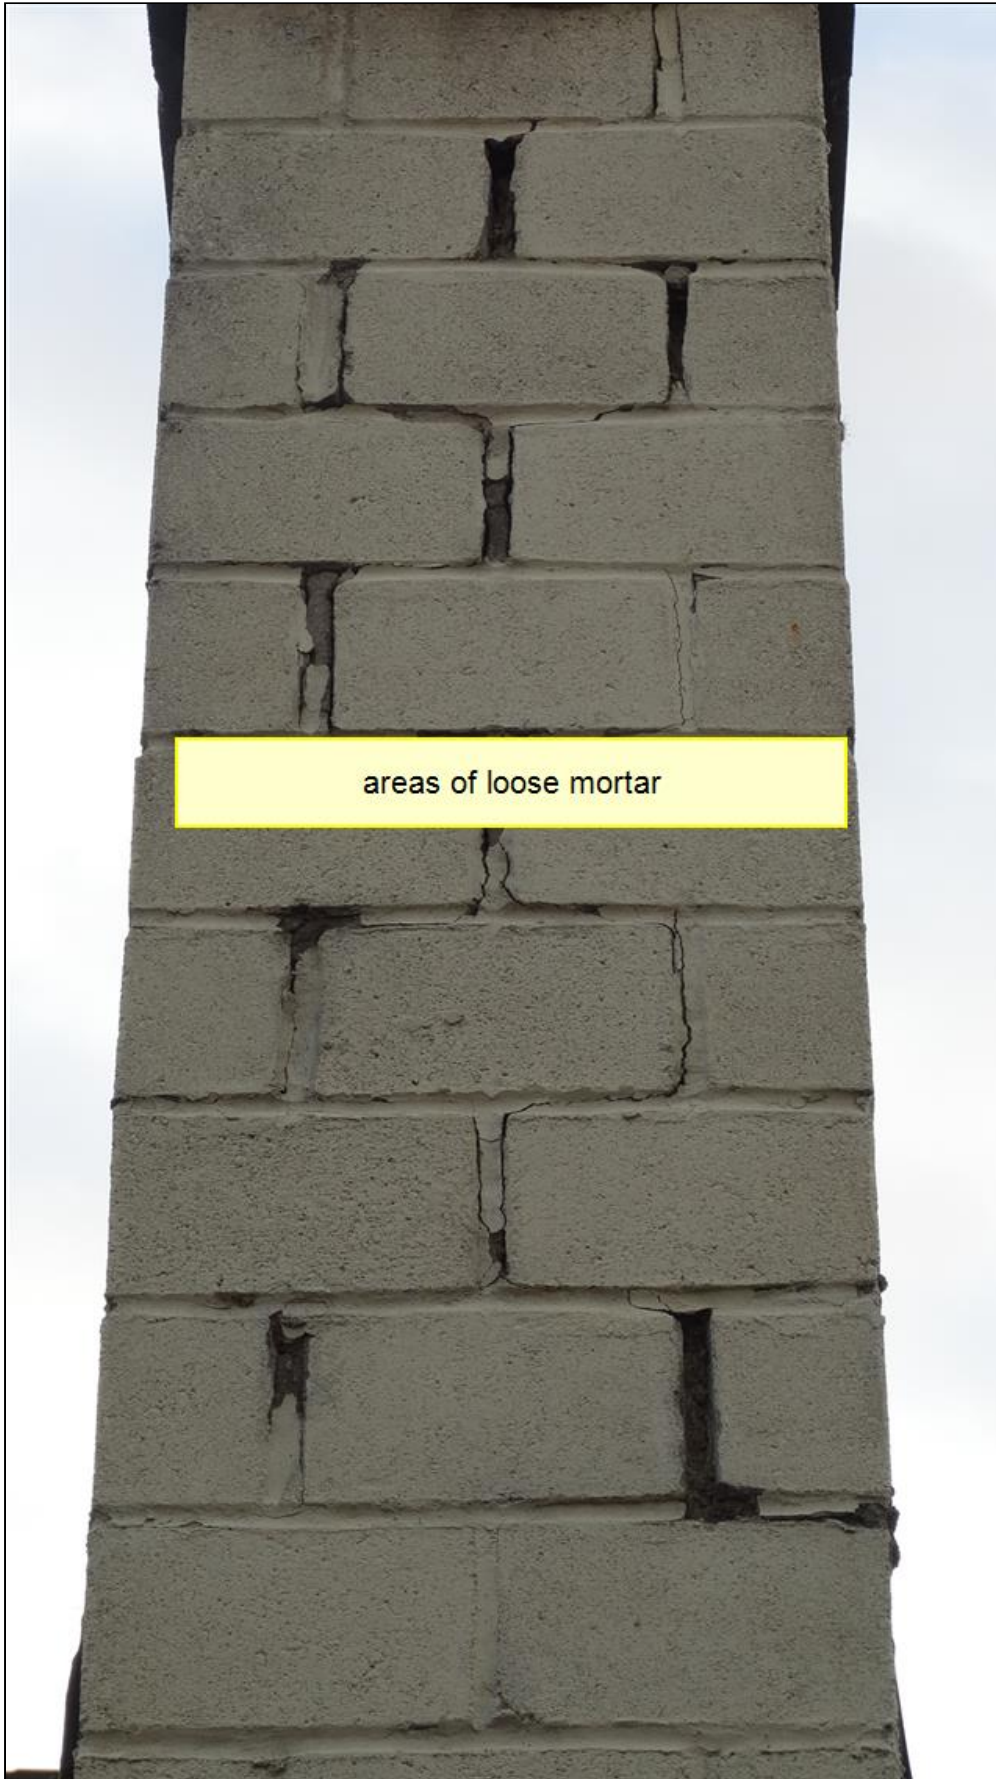
1.2 Item 1(Picture)

(1) The concrete block chimney has some areas of deteriorating mortar and should be re-pointed by a qualified mason to prevent further deterioration.

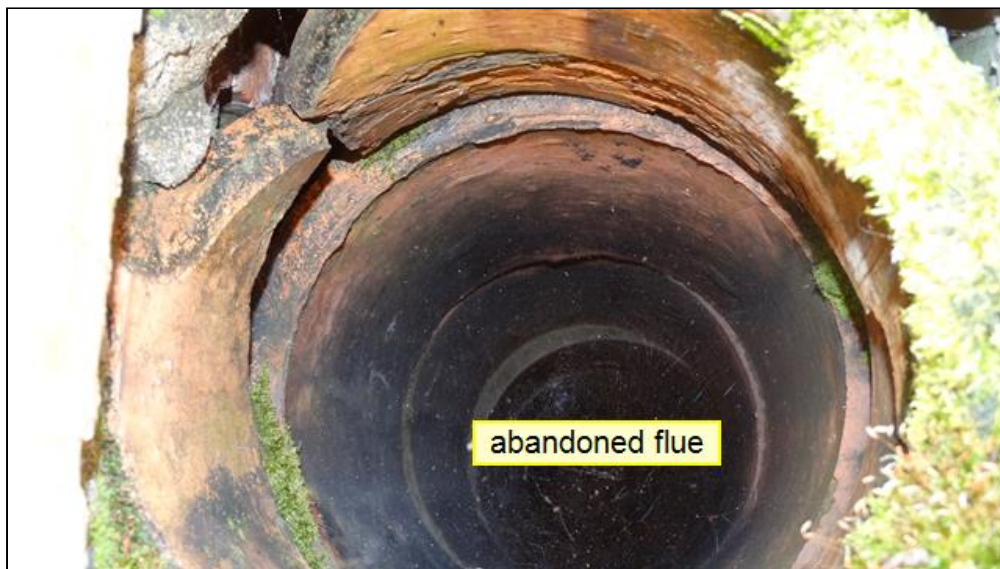
1.2 Item 3(Picture)

(2) One of the chimney flues on the brick chimney is not in use. Some of the liner is deteriorated. Recommend capping off this flue to prevent unwanted water and pests from entering.

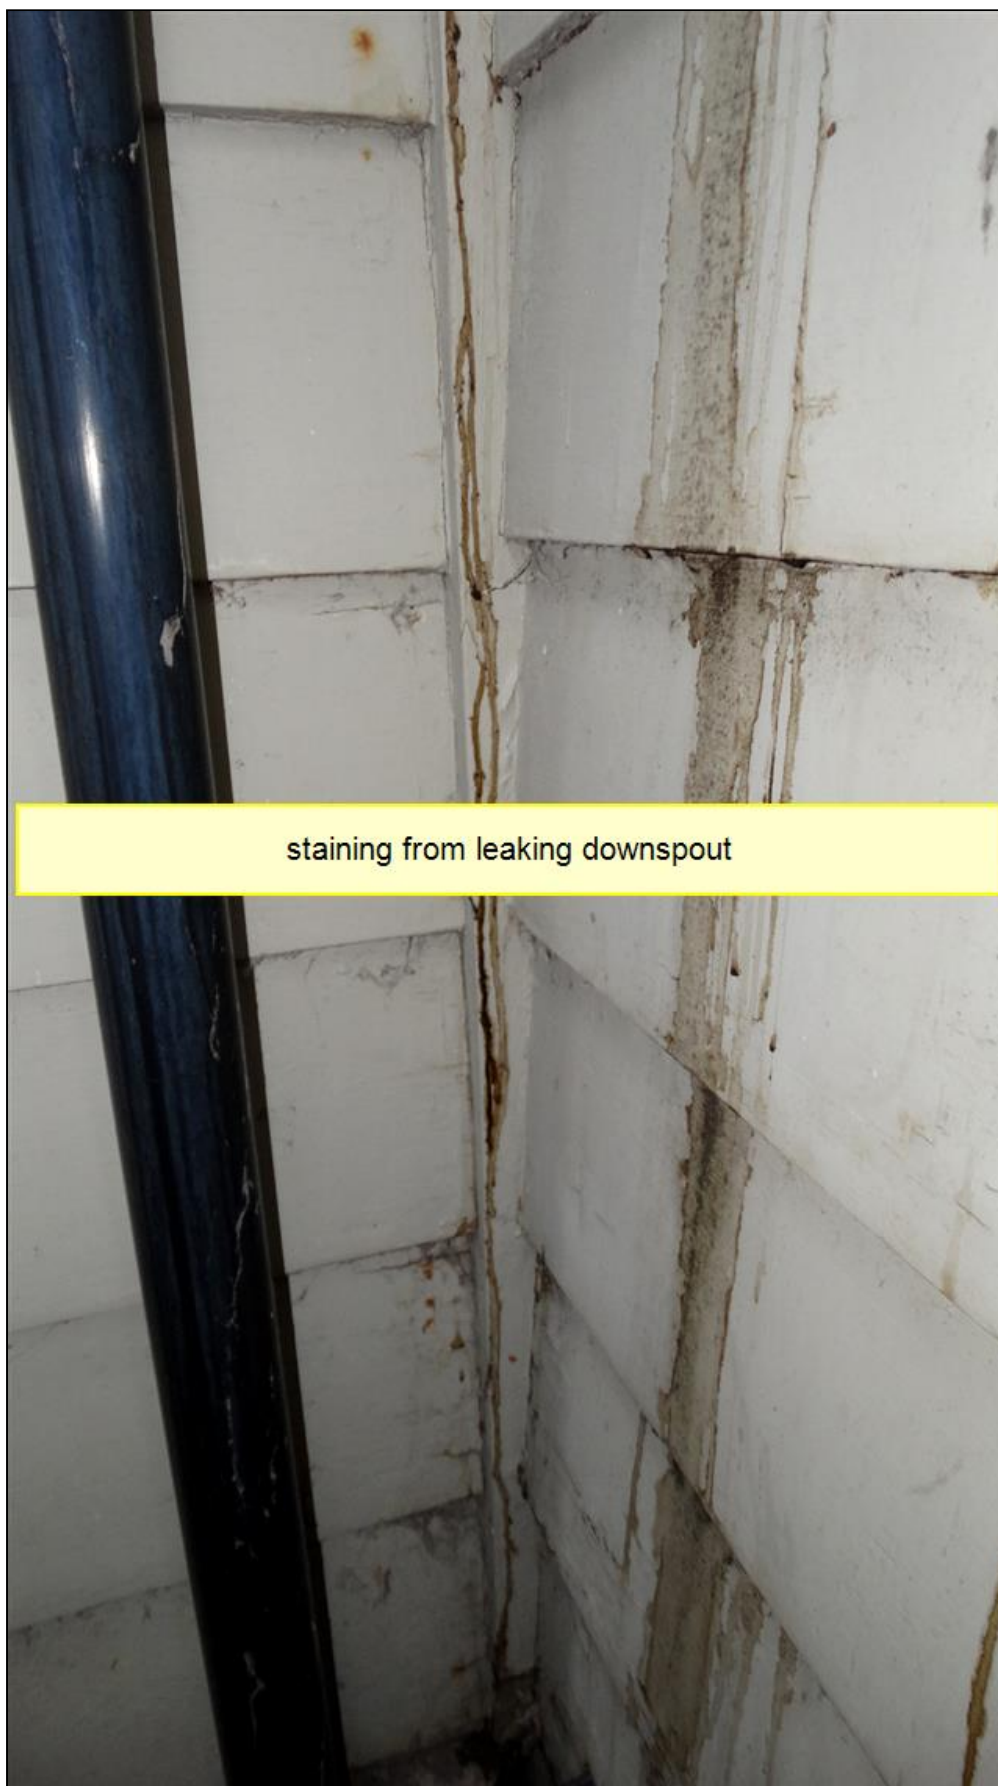
1.3 Item 1(Picture)

Some of the gutters are leaking and should be repaired by a qualified contractor.

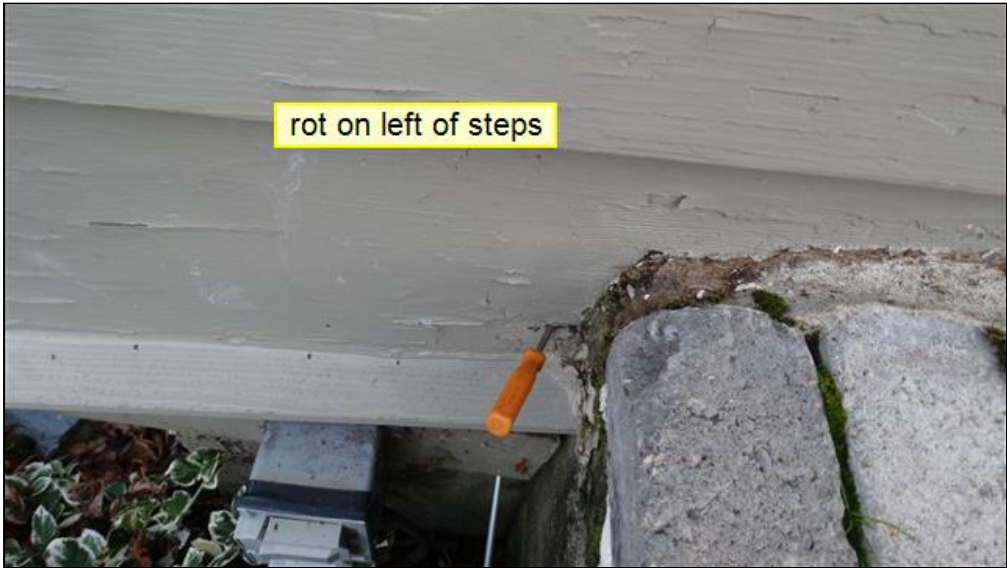
2.0 Item 1(Picture)

Comments: Inspected, Repair or Replace
(1) The cladding on the exterior near the front steps has some rot on either side. A qualified contractor should replace the rotten wood.

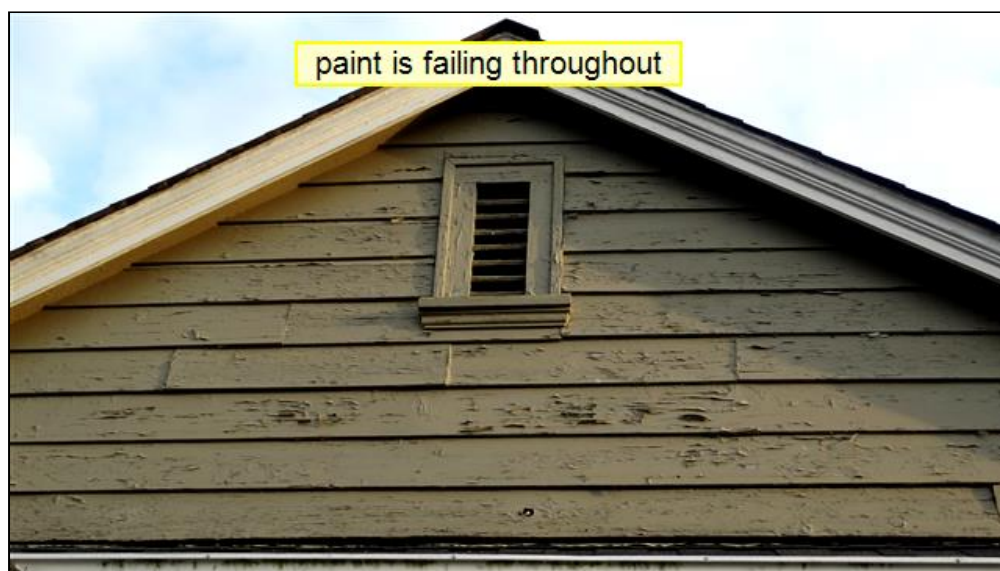
2.0 Item 3(Picture)

(2) The cladding has bare wood in areas and needs prep and paint by a qualified individual.

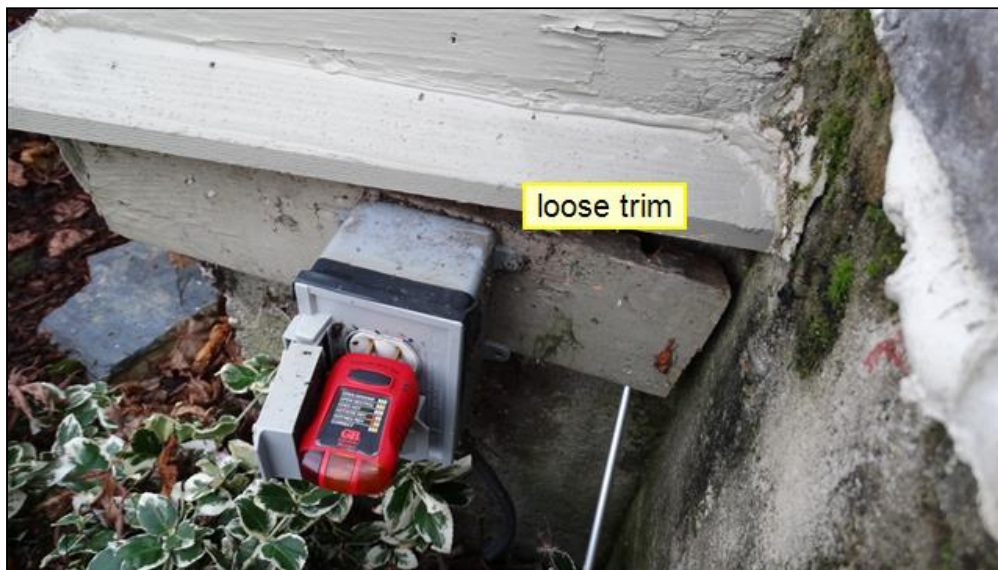
2.0 Item 4(Picture)

(3) The trim board holding a receptacle to the house at the front of the house is loose. Please have a qualified person secure.

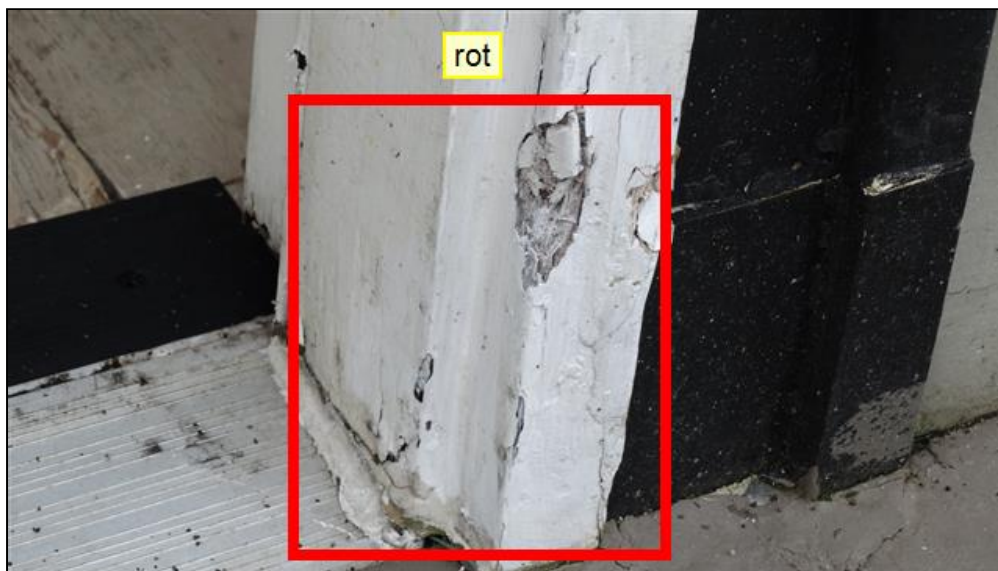
2.1 Item 1(Picture)

The rear entry door jamb has some rot at the bottom edge on both sides. The jamb should be replaced by a qualified contractor.

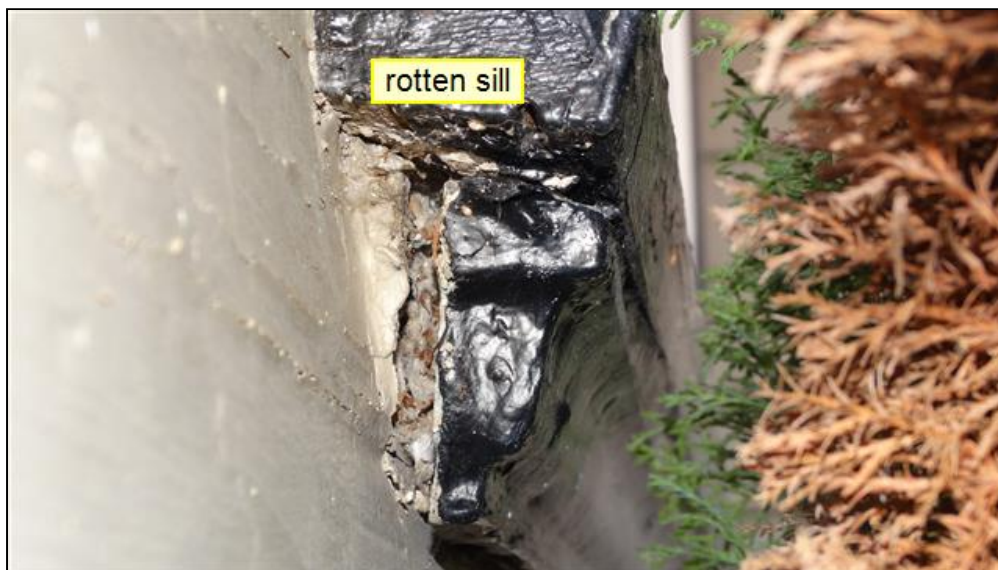
2.2 Item 1(Picture)

The window sill at the front of the house is rotten and needs to be replaced by a qualified contractor.

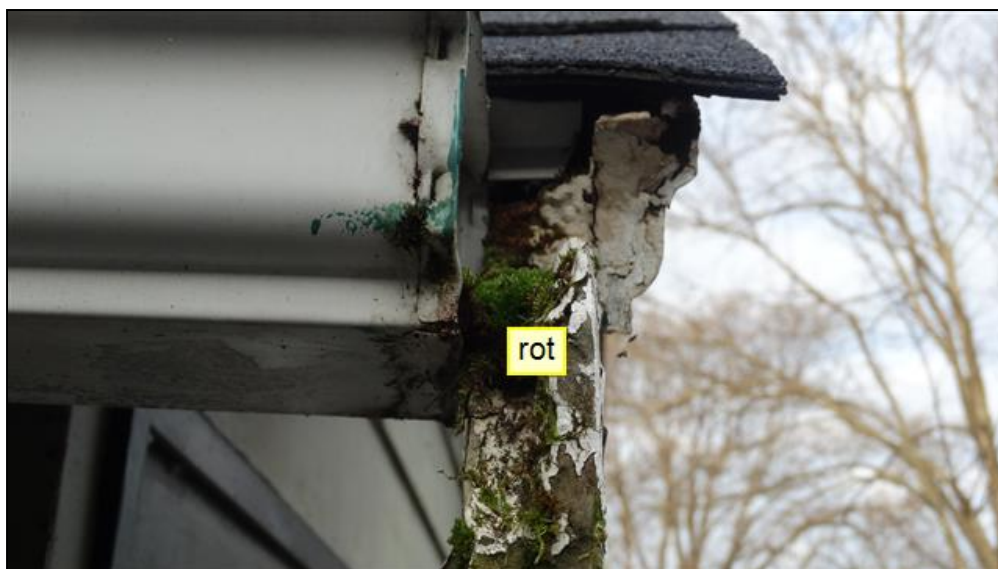
2.5 Item 1(Picture)

The fascia is rotten near the bottom end at the rear of the house. Please have a qualified contractor replace all rotten exterior wood.

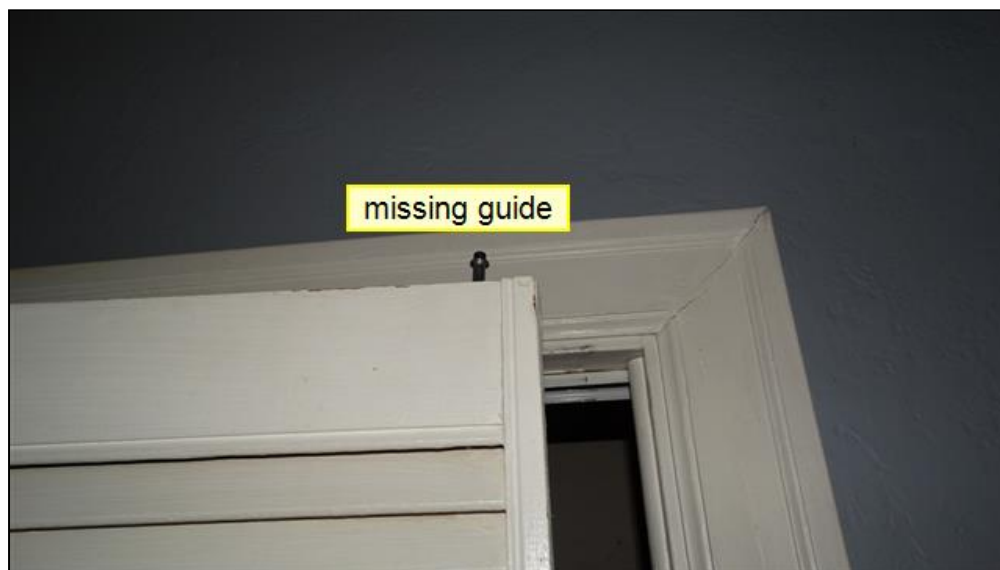
3.5 Item 1(Picture)

The entry bifold door is missing its guide. Please have a qualified individual repair.

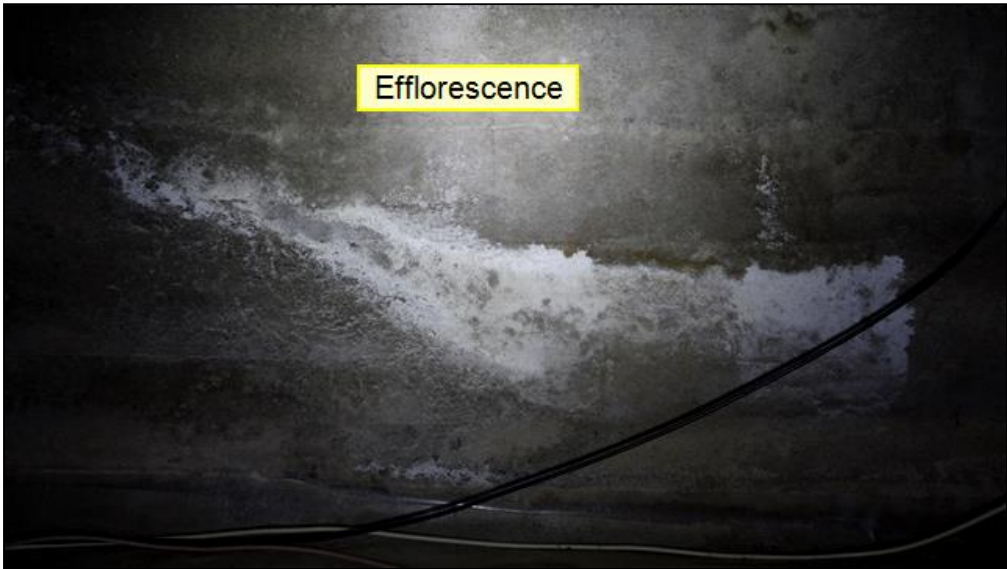
4.0 Item 1(Picture)

(1) White efflorescence (powder substance) on the foundation wall indicates moisture is in contact with the foundation. This does not necessarily indicate that intrusion will occur. I recommend checking the gutters and the downspout drain lines for proper operation. It should alert you to the possibility that future steps may be needed to divert water away from the structure.

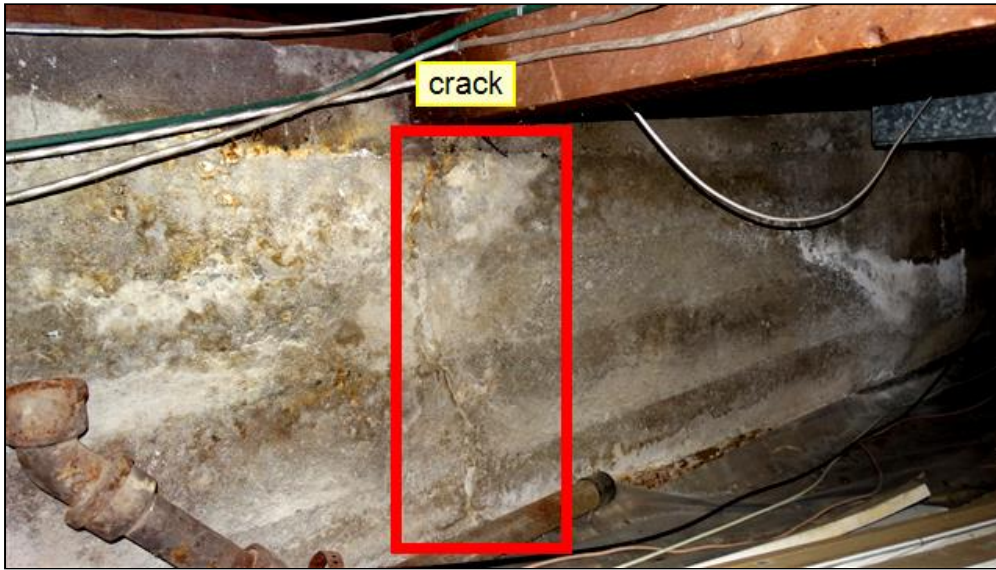
4.0 Item 2(Picture)

(2) A crack in the foundation was noted below a structural beam in the crawlspace. Re-support may be required if the crack starts to grow in size. Recommend monitoring over time and repair if necessary.

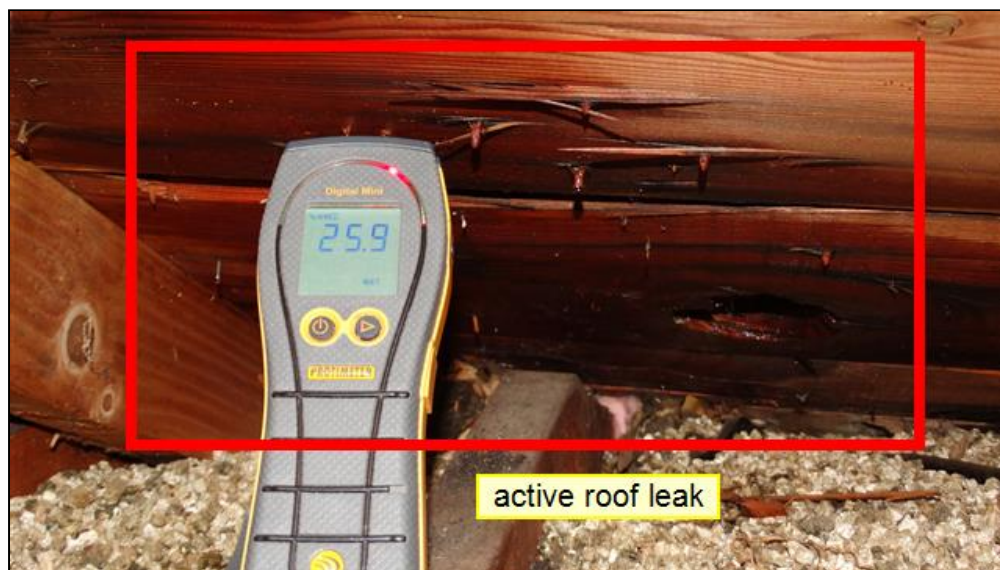
4.5 Item 1(Picture)

A few active leaks were found in the attic. Please have a qualified roofer repair these areas.

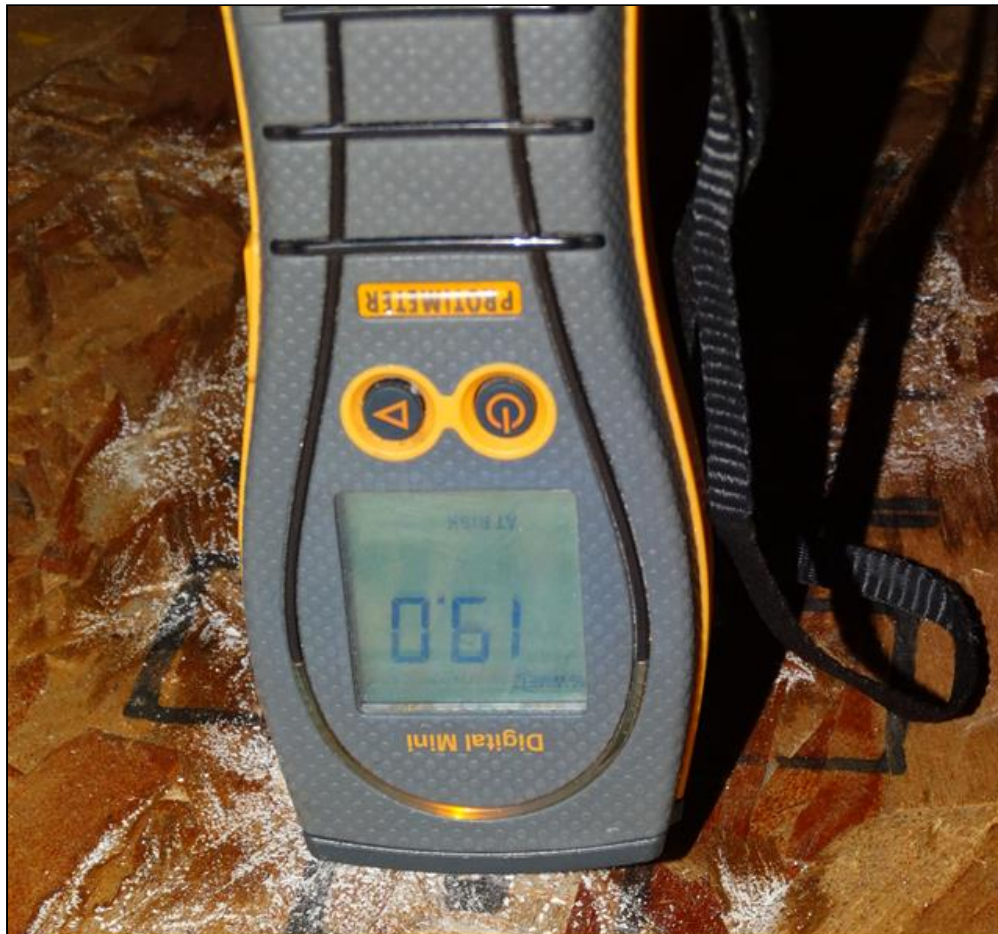
evidence of active leak below wet nail

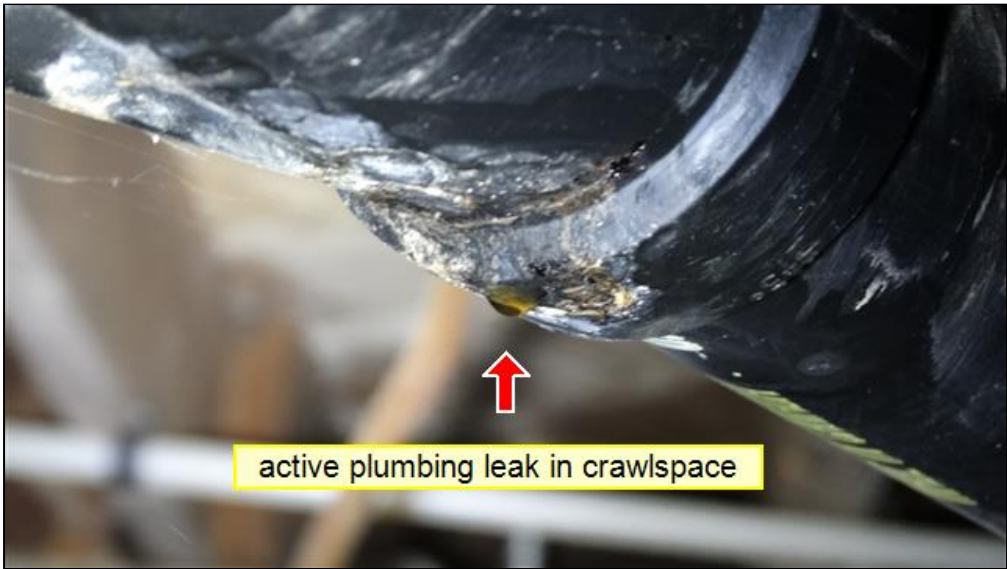
Comments: Inspected
There is a small leak on the ABS waste plumbing in the crawlspace. Please have a qualified plumber repair.

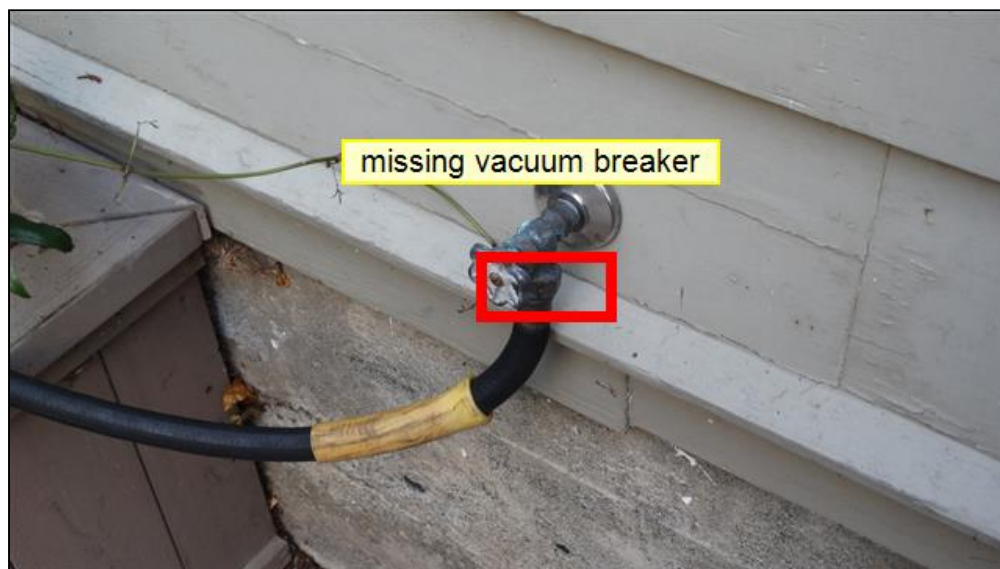
5.1 Item 1(Picture)

(1) The hose bibb at the rear of the home is missing a vacuum breaker. One is required when attached to a garden hose to prevent back-siphonage and a potential cross-connection. Please have a qualified individual make the repairs.

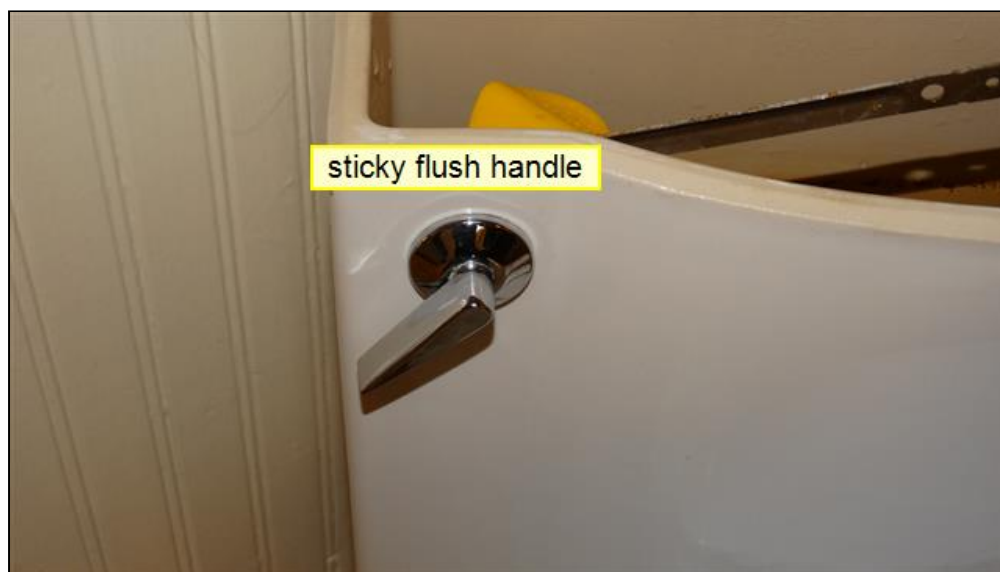
5.1 Item 2(Picture)

(2) The control knob for the toilet in the main bathroom sticks when operated. Please have qualified plumber repair or replace.

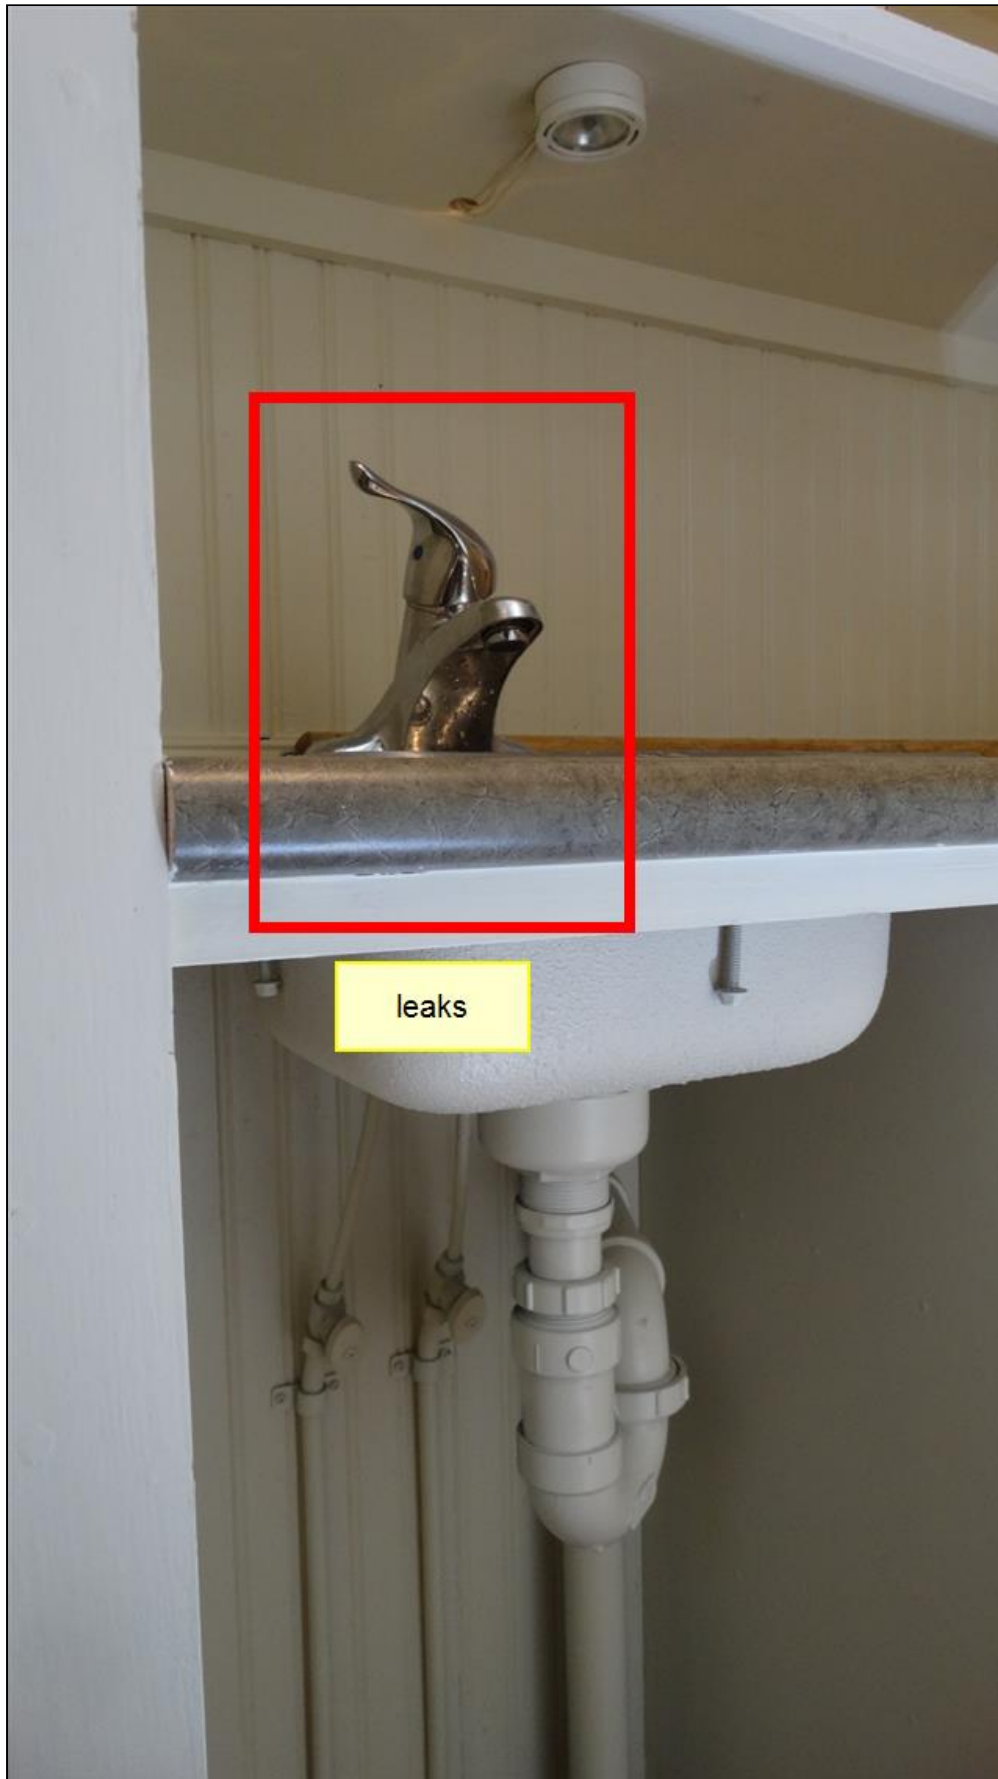
5.1 Item 3(Picture)

(3) The faucet for the small sink in the hallway leaks when in use. Please have a qualified plumber repair the faucet or replace.

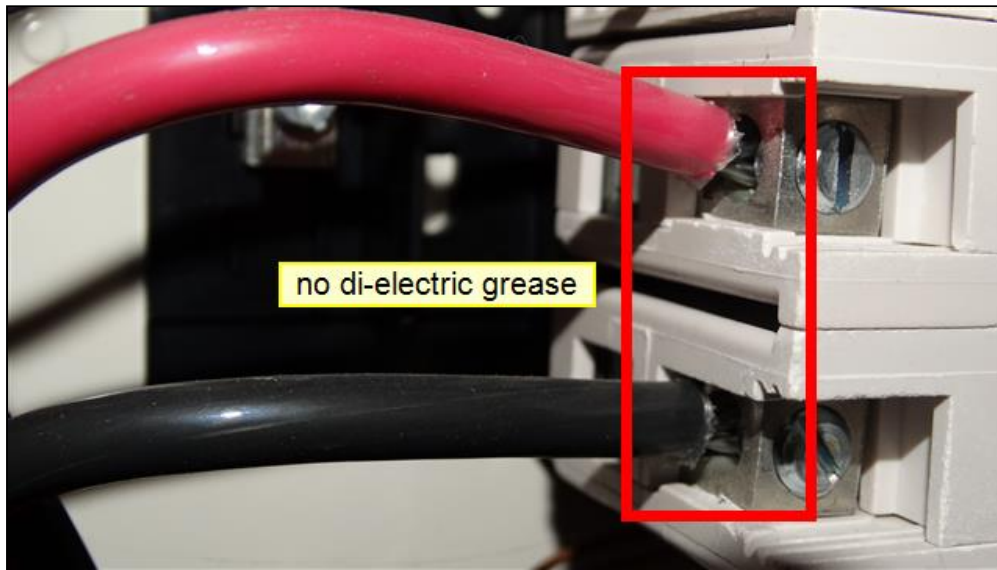
6.1 Item 1(Picture)

The stranded aluminum branch wiring in the main electrical panel is not covered in di-electric grease. It is required when wiring with stranded aluminum. Please have a qualified electrician repair.

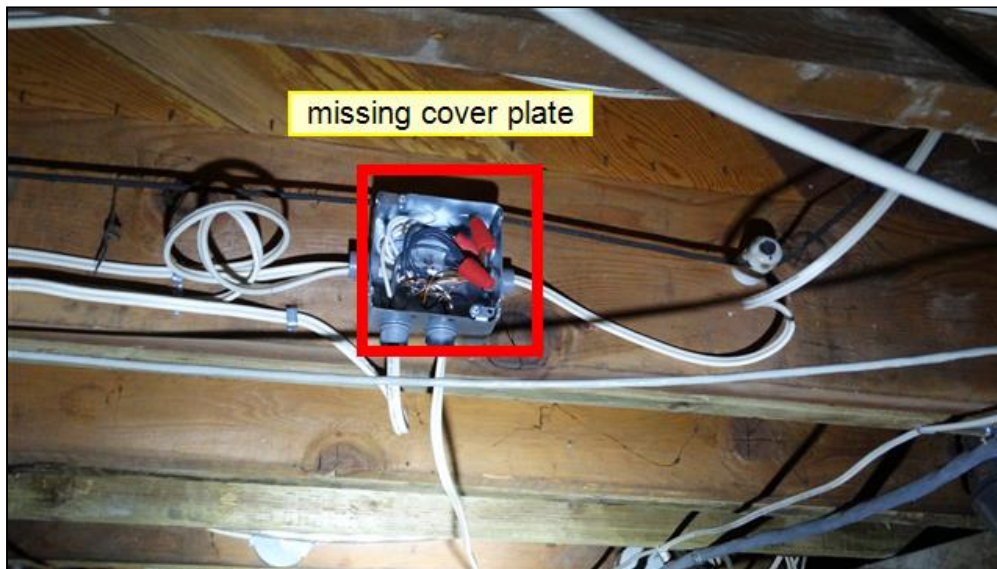
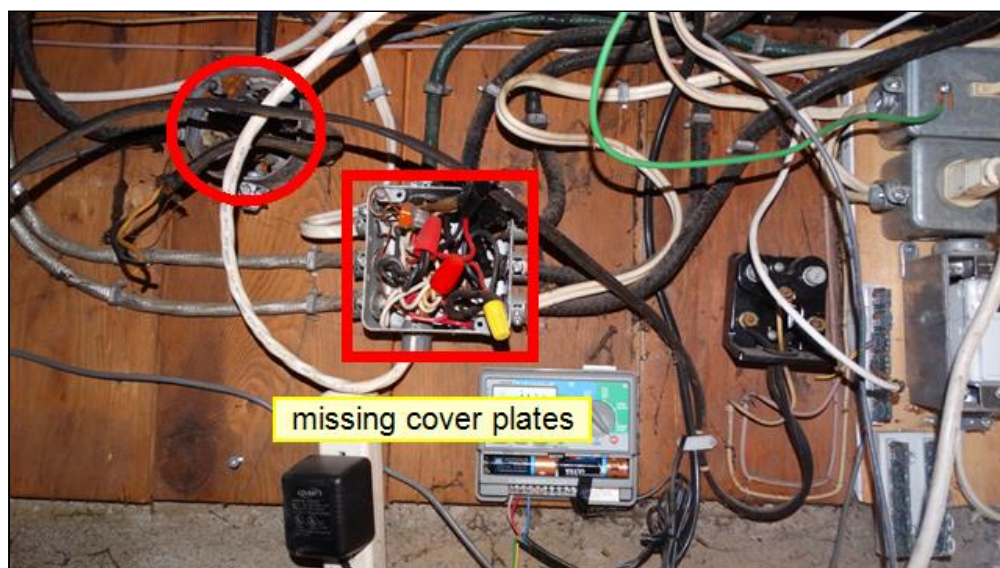
(1) Many junction boxes in the attic and crawlspace are missing their cover plates. They are a safety hazard if left without them. Please have a qualified electrician install the cover plates.

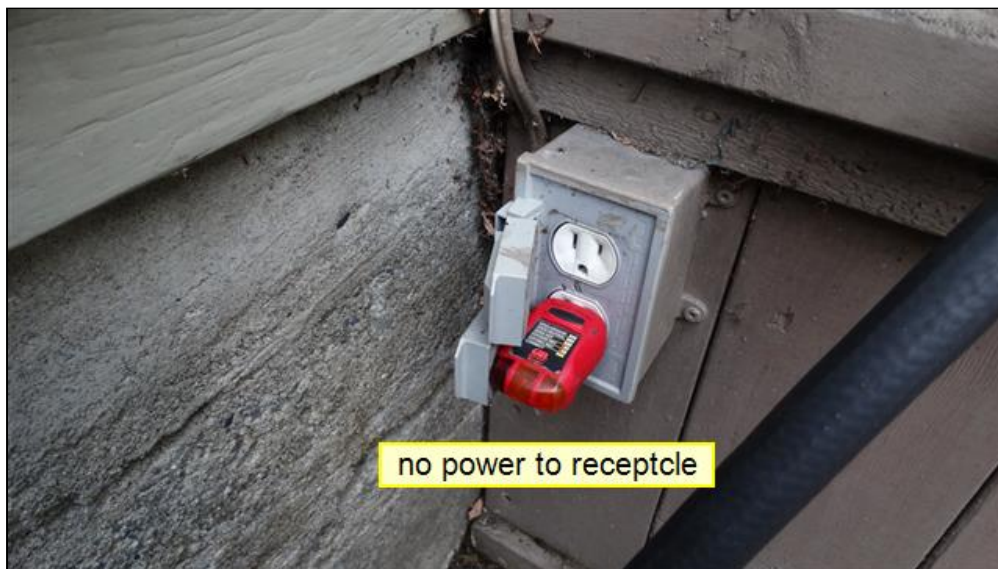
6.4 Item 1(Picture)

The exterior electrical receptacle at the side of the house had no power when tested. An up-stream GFCI may have been tripped. Please have a qualified electrician repair or replace.

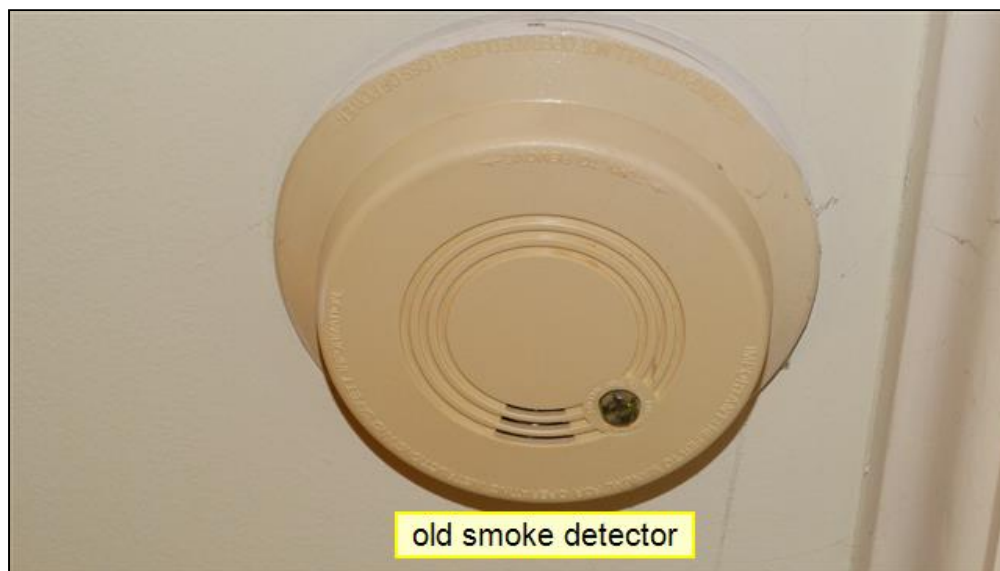
6.7 Item 1(Picture)

Smoke detectors over 10 years of age should be replaced by a qualified individual. Please replace this smoke detector.

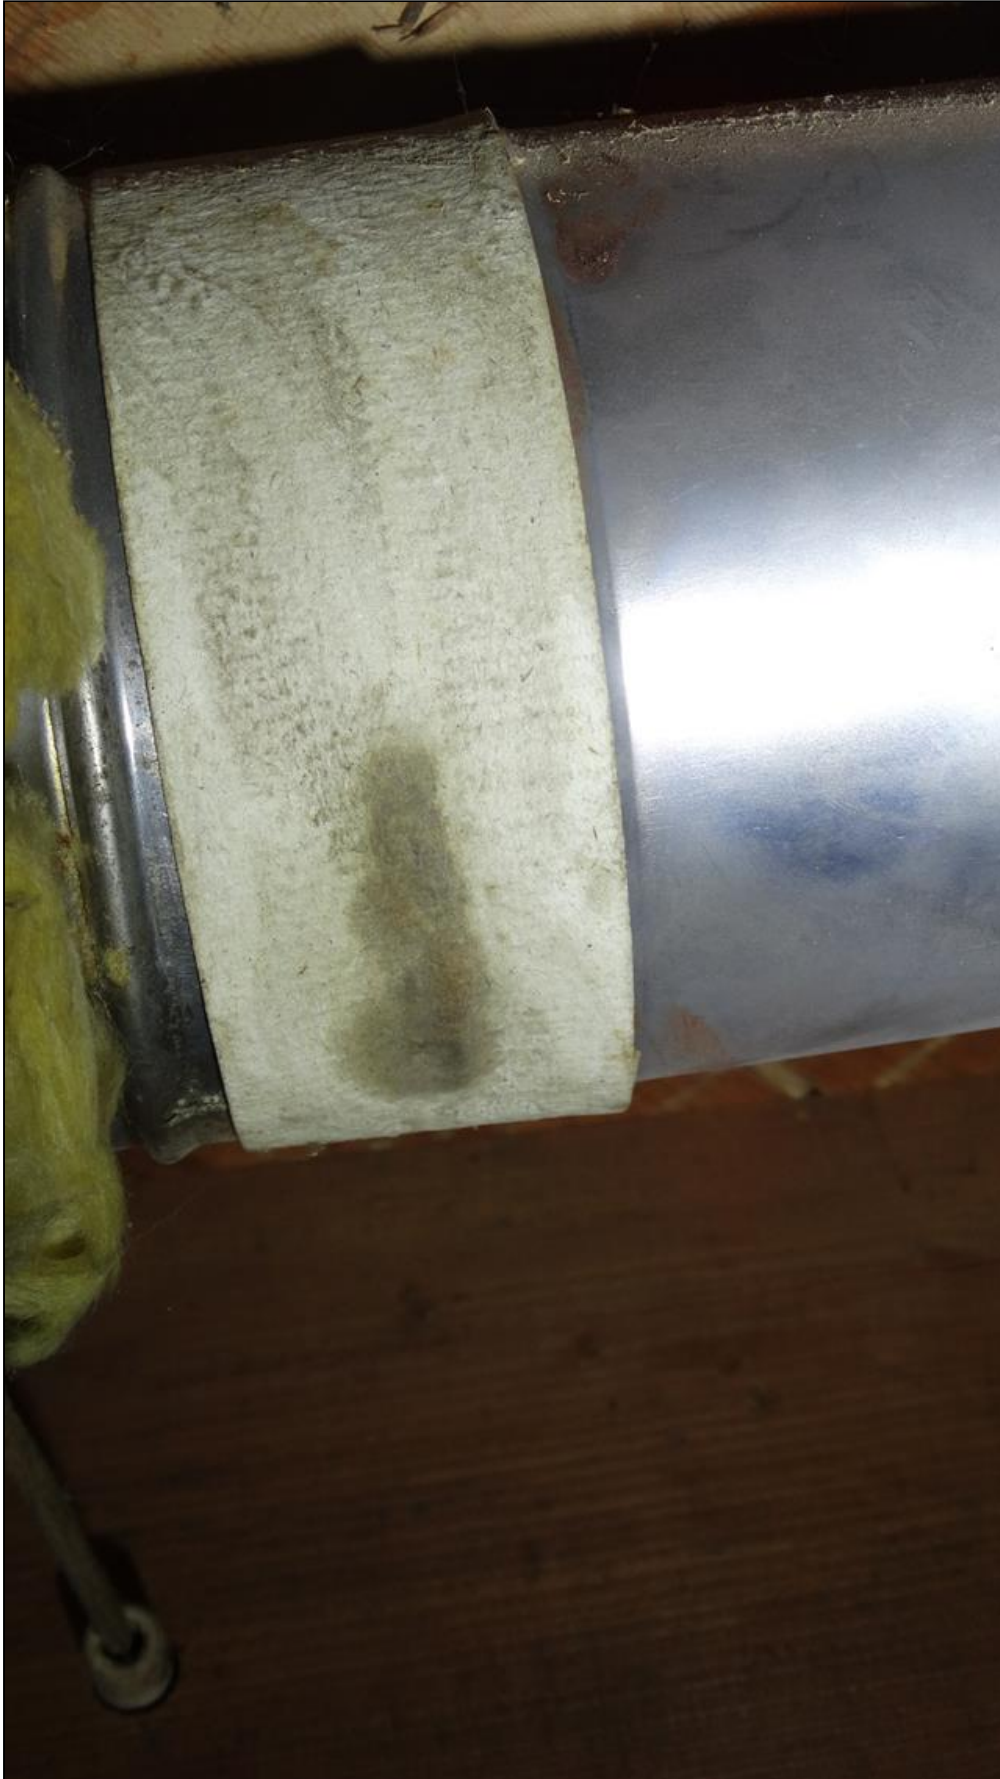
7.3 Item 1(Picture)

(1) The ductwork in the crawlspace has what looks like asbestos tape on it. Recommend having a qualified individual tape over the asbestos tape with foil faced tape.

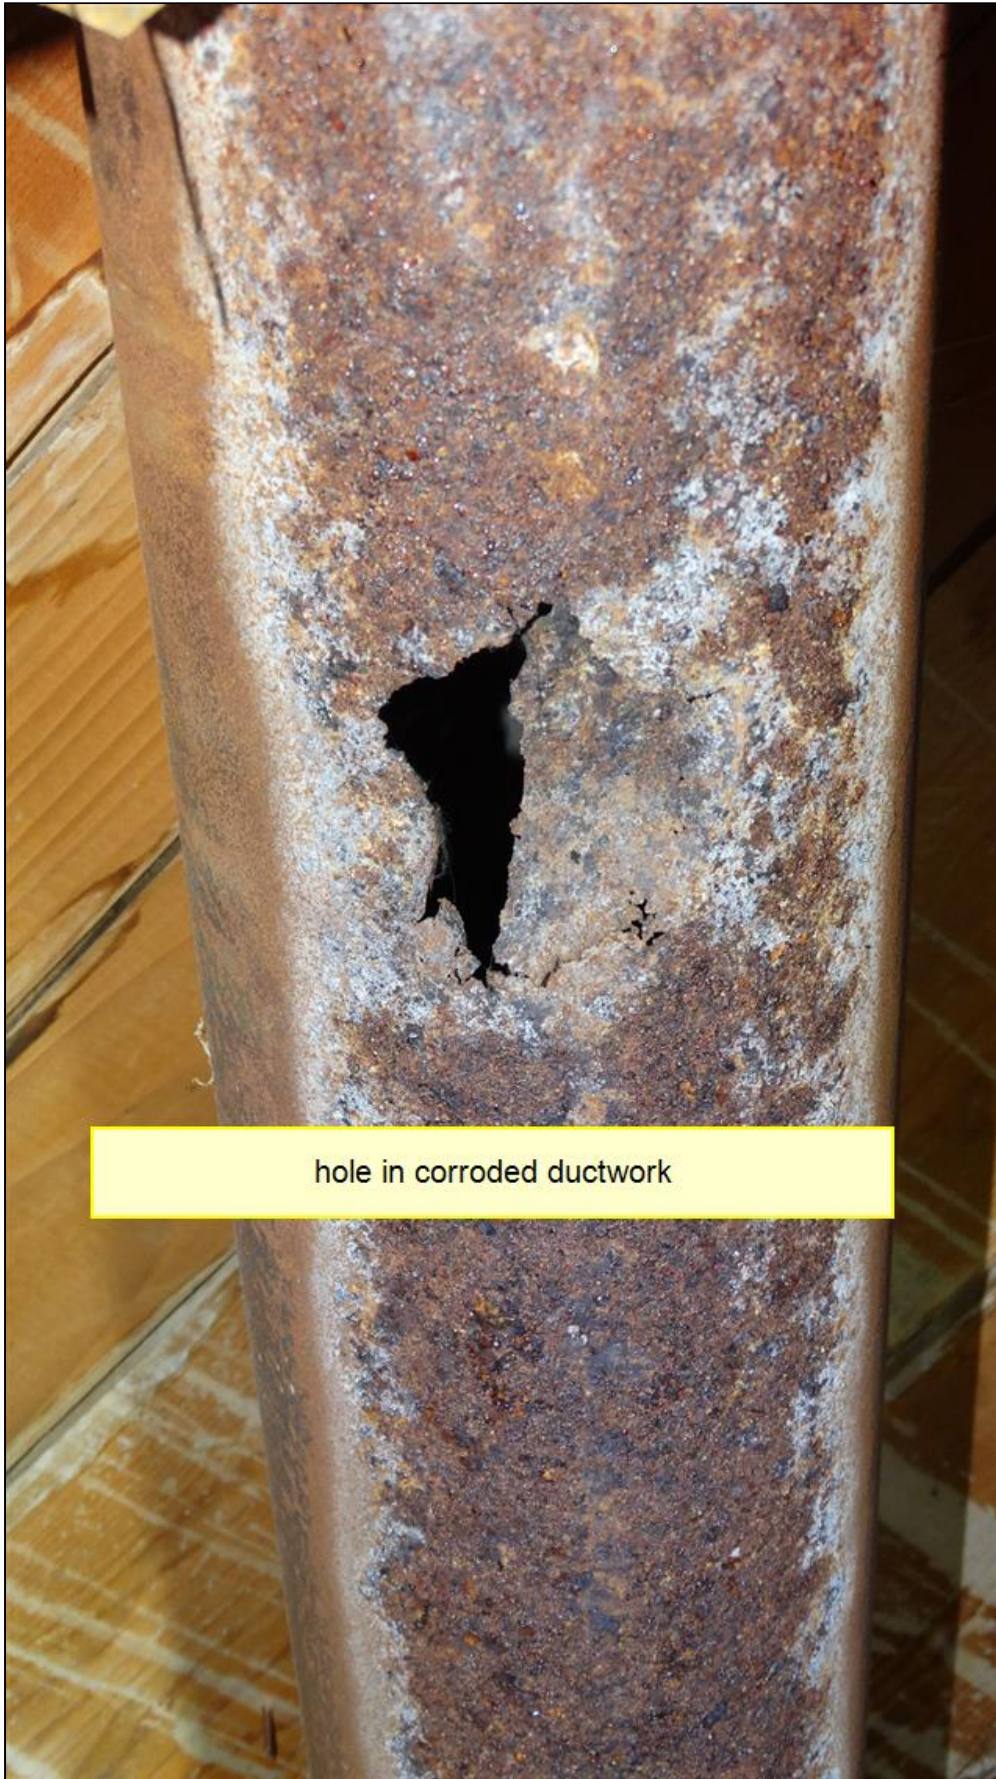
(2) Some of the ductwork in the crawlspace is very rusty and in need of replacement. Please have a qualified HVAC specialist replace the corroded ductwork.

hole in corroded ductwork

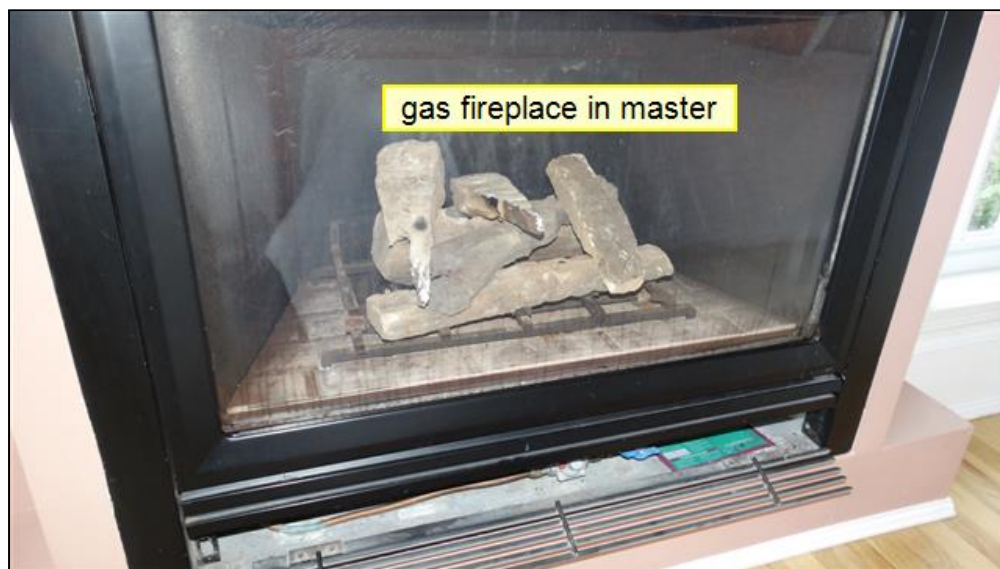
7.8 Item 1(Picture)

The gas fireplace was shut off and not tested. It does have a corroded gas line in the access panel. Recommend it be serviced before operation.
