Inspection Report

Property Address:
Sample Report
Victoria British Columbia

Highland Home Inspections

Date: 2017-08-12	Time:	Report ID: 2017-352
Property: Sample Report Victoria British Columbia	Customer: Mr. Joe Somebody	Real Estate Professional:

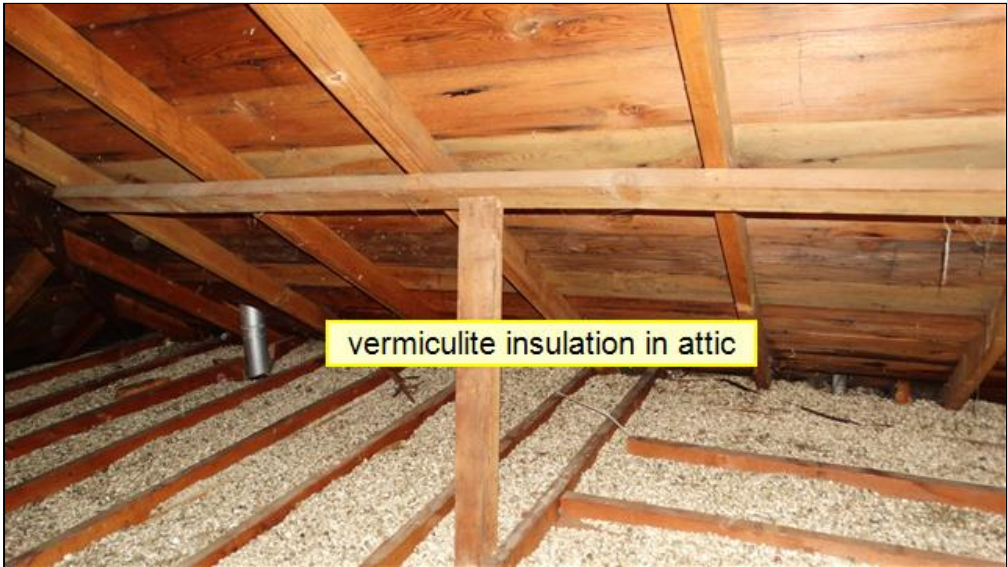
8.0 Item 1(Picture)

(1) It appears that Vermiculite insulation was used in the attic. Some Vermiculite insulation is known to contain asbestos. Its strongly recommend that Vermiculite insulation is left undisturbed. It is also recommended that you do not store boxes or other items in your attic, do not allow children to play in an attic, and do not attempt to remove the insulation yourself. Hire a professional contractor if you plan to remodel or conduct renovations that would disturb the Vermiculite in your attic or walls to make sure the material is safely handled and/or removed.

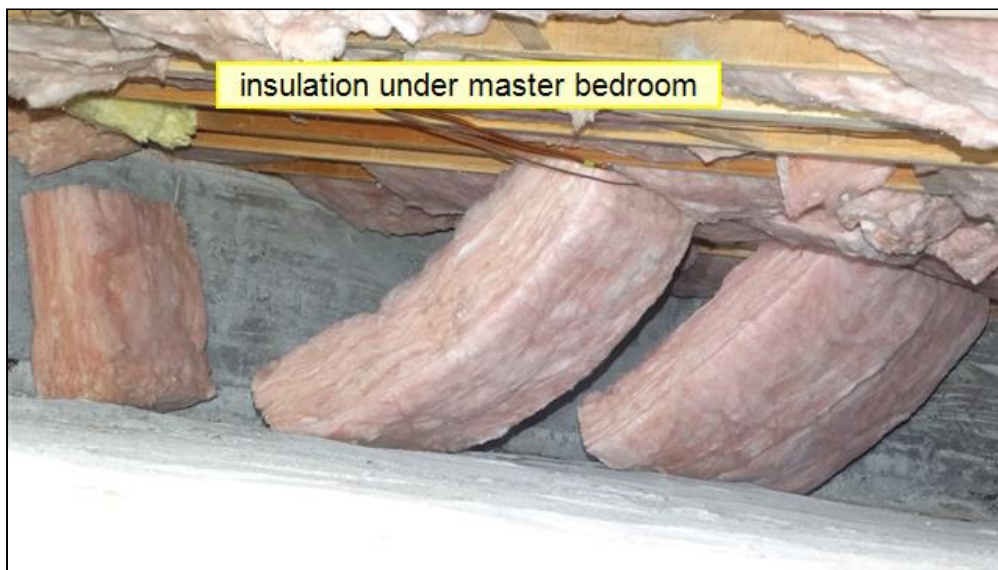
8.1 Item 1(Picture)

(1) Some insulation has fallen down under the master bedroom. Please replace for comfort.

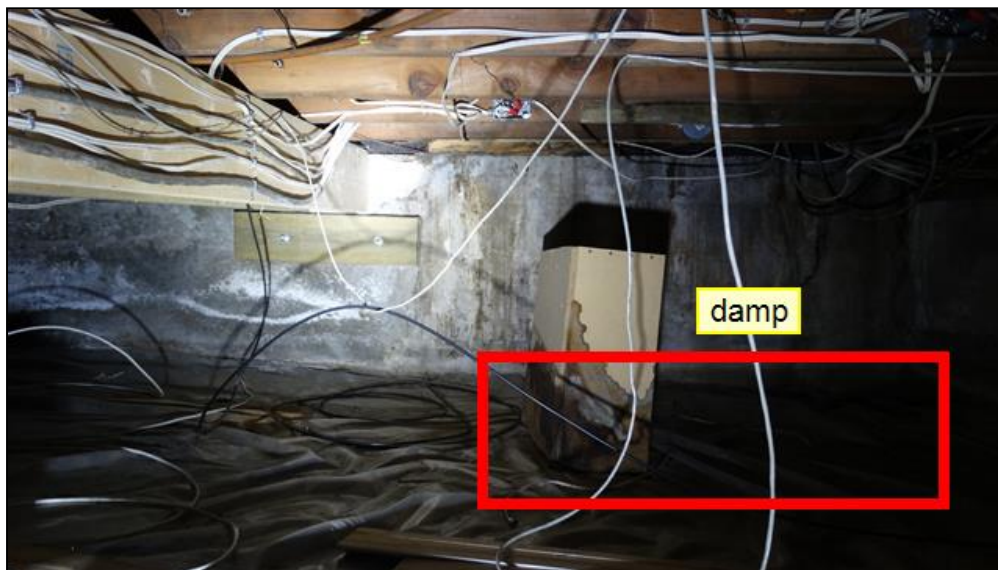
8.2 Item 1(Picture)

Some areas of the crawlspace showed moisture under the vapour barrier. Extra effort may be needed to divert water away from the structure. This is for your information.

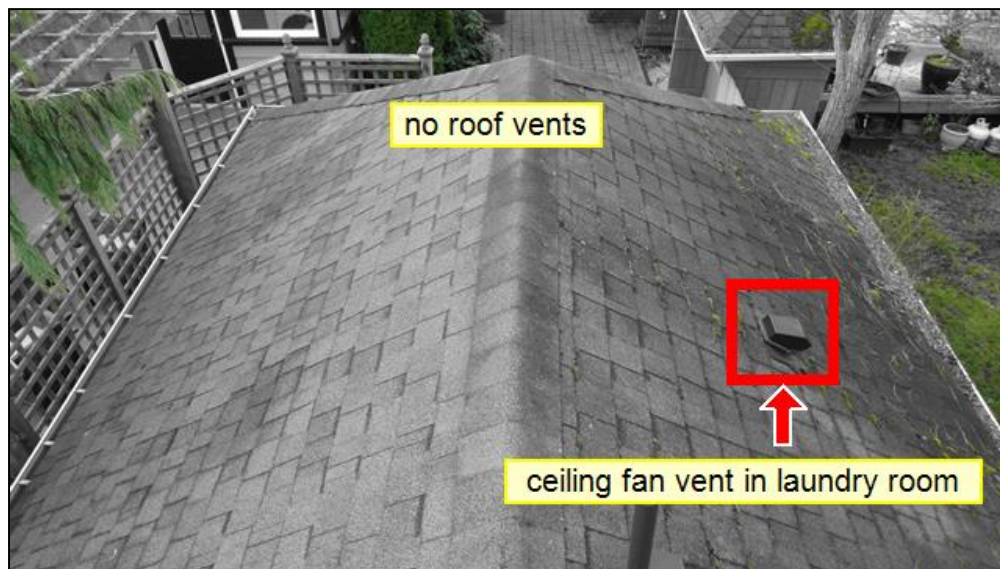
9.2 Item 1(Picture)

The roof over the older lower part of the roof does not have any roof ventilation. Recommend installing roof vents to promote life of the structure.

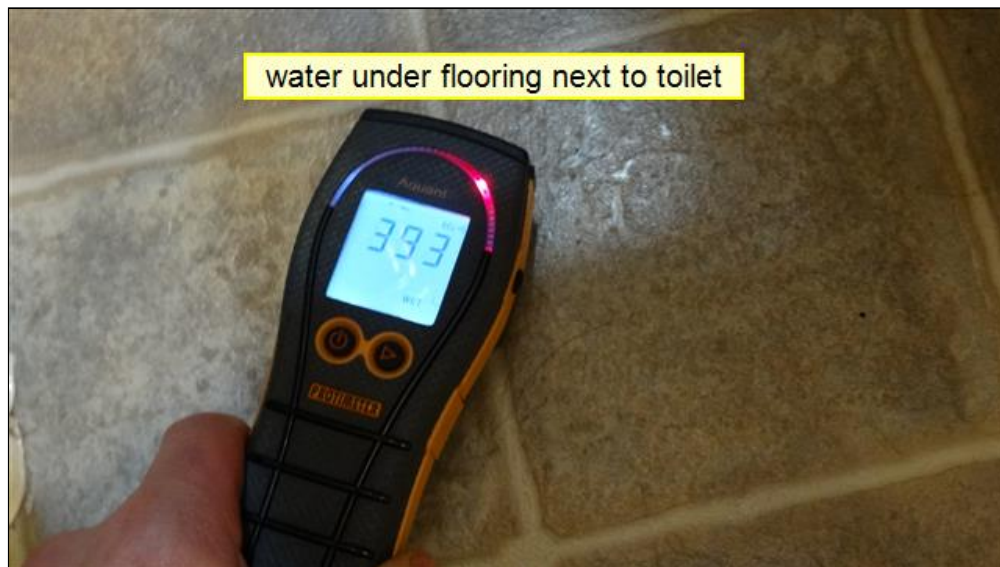
9.17 Item 1(Picture)

The toilet is loose at the floor in the bathroom. Repairs may involve re-setting the toilet on a new wax seal. I recommend a qualified licensed plumber make the repairs. The thermal imaging camera and moisture meter confirmed water under the flooring in the bathroom from the leaking toilet.

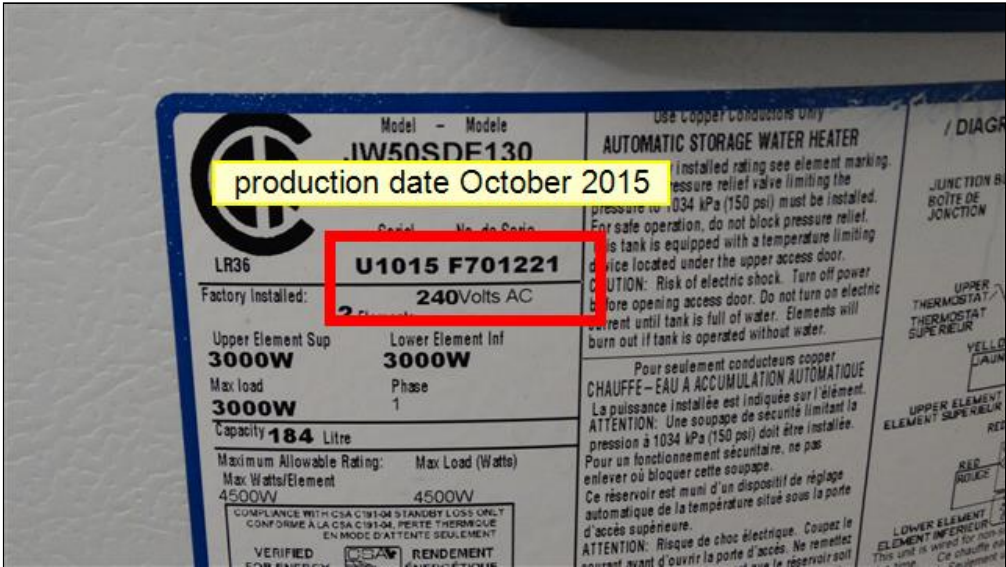
9.18 Item 1(Picture)

In areas determined to have high earthquake risk, it is important that a water heater be fastened in place with two straps to avoid damage. Strapping should be at a point within the upper one-third and lower one-third of the tank's vertical dimension. At the lower point, the strapping should maintain a minimum distance of 4 inches above the controls. Water heater supports and piping supports should be designed to resist seismic loads. Failure of water heater supports has been shown to be a threat to health and safety. In addition to strapping, a thermal expansion tank should be installed.

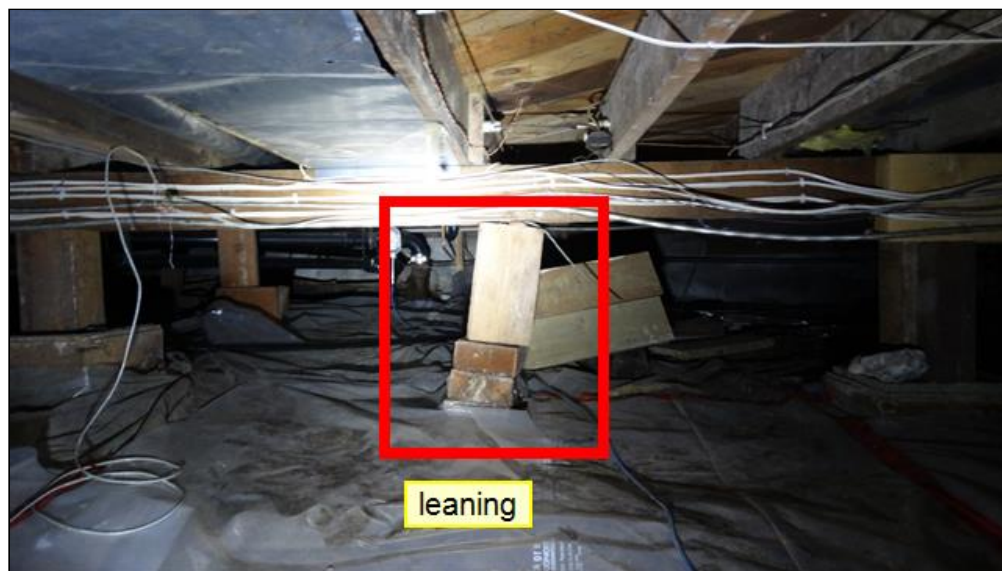
Item 11 - Item 1(Picture)

- 11 A support post for a beam in the crawlspace has moved and is out of plumb. Please have a qualified contractor make the repairs.

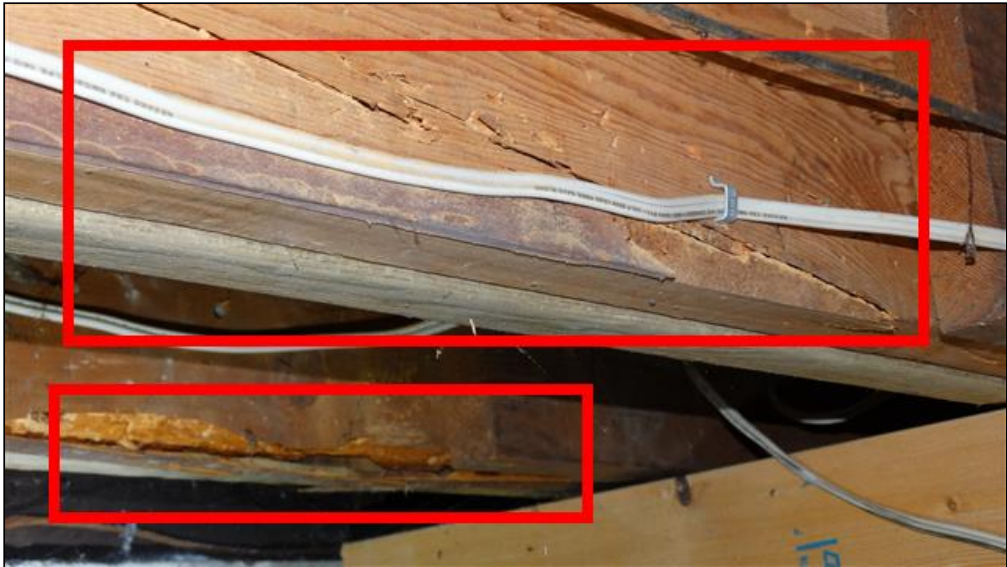
Item 12 - Item 1(Picture)

- 12 (1) There is evidence of previous insect activity in the crawlspace. Some floor joists have been structurally compromised and previously repaired. Recommend having a pest control specialist visit the house and confirm inactivity of the wood destroying organisms.

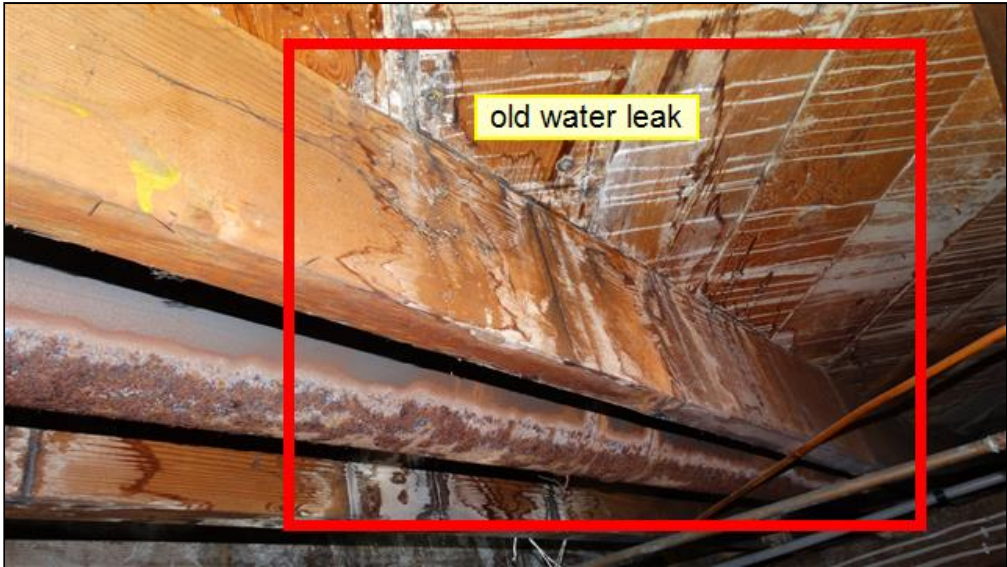
Item 13 - Item 1(Picture)

- 13
- (2) There is evidence of a previous water leak in the area of the gas water heater. Dry at time of inspection. This is for your information.

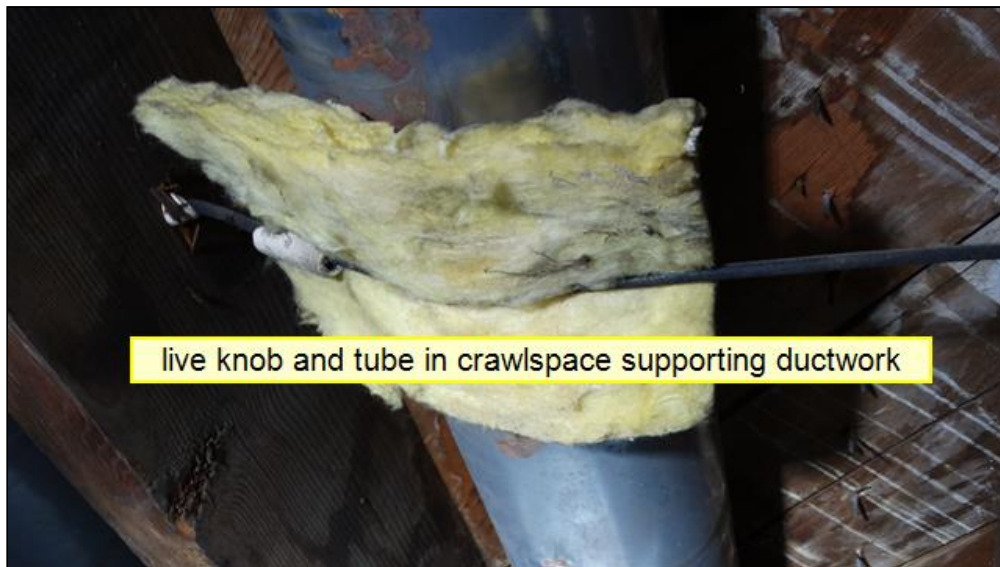
Item 19 - Item 1(Picture)

- 19 (3) This property has "knob and tube" wiring which was commonly installed prior to 1950. It is ungrounded, and considered unsafe by today's standards. Over time, the wire's insulation becomes brittle and falls apart, resulting in exposed conductors and a risk of shock and/or fire. This wiring is also easily damaged by covering it with insulation (a common practice), and incorrectly tapping new wiring into it. Some energized knob and tube wiring was found during the inspection. It is not within the scope of this inspection to determine what percentage of this property's wiring is of the knob and tube type or to determine what percentage of the knob and tube wiring is energized vs. abandoned. A qualified electrician should evaluate this wiring and make repairs or replace wiring as necessary. I recommend you verify acceptability with your insurance company and/or lender prior to closing.

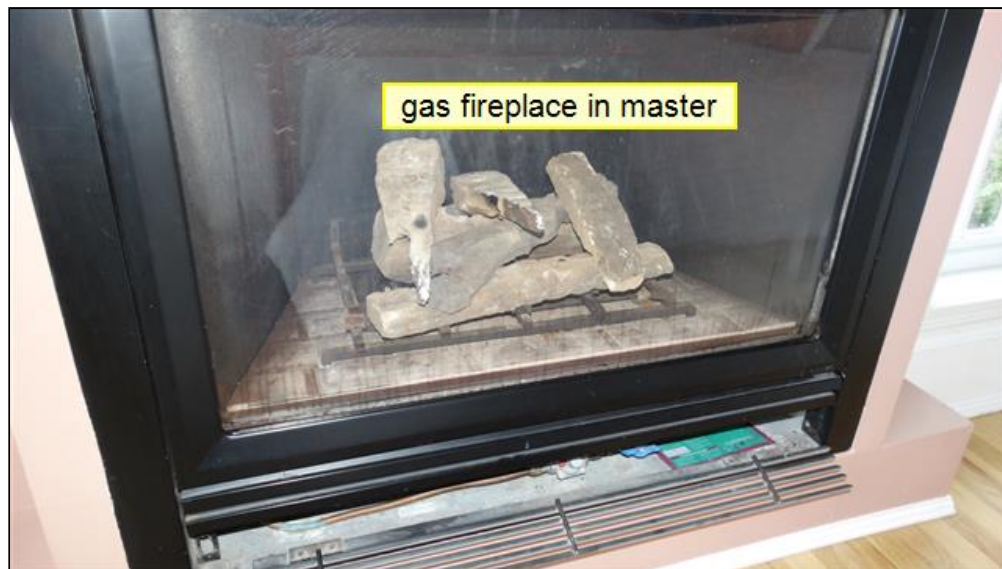
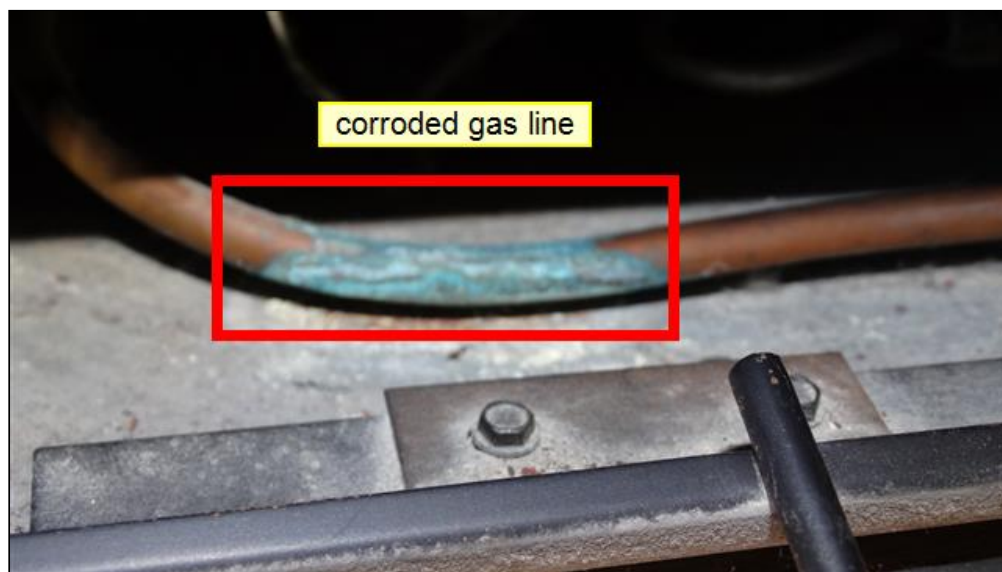
- 25 The gas fireplace was shut off and not tested. It does have a corroded gas line in the access panel. Recommend it be serviced before operation.

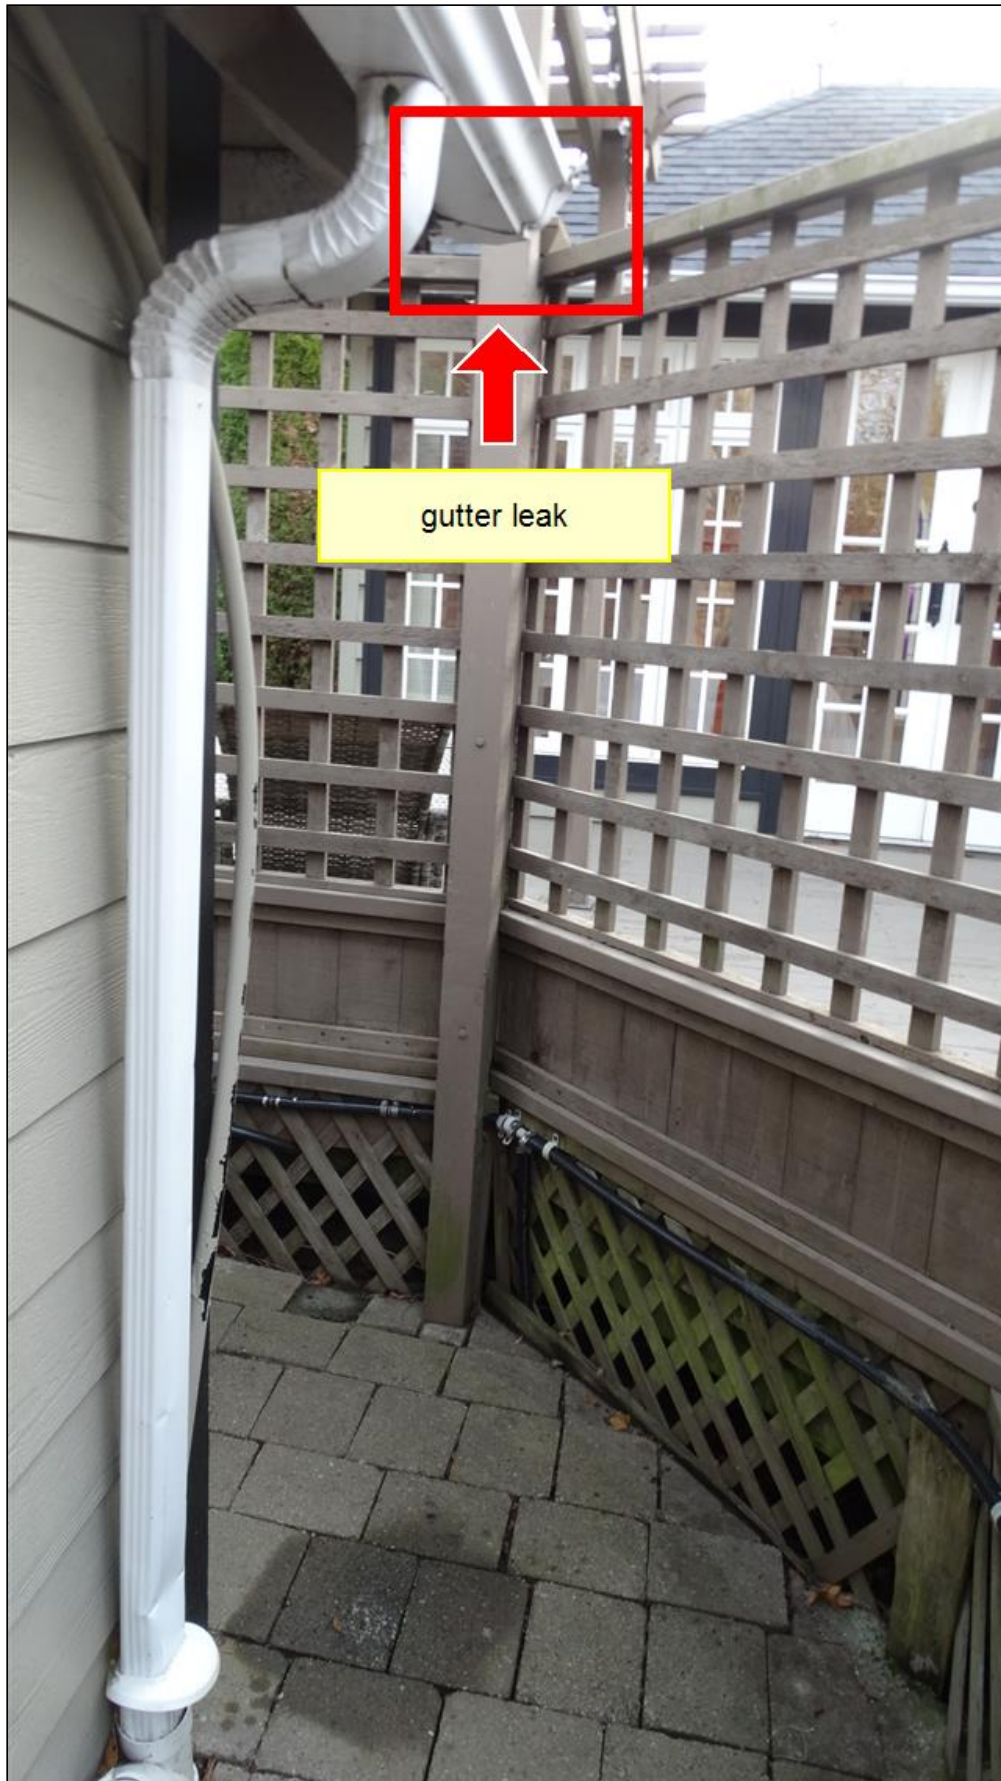
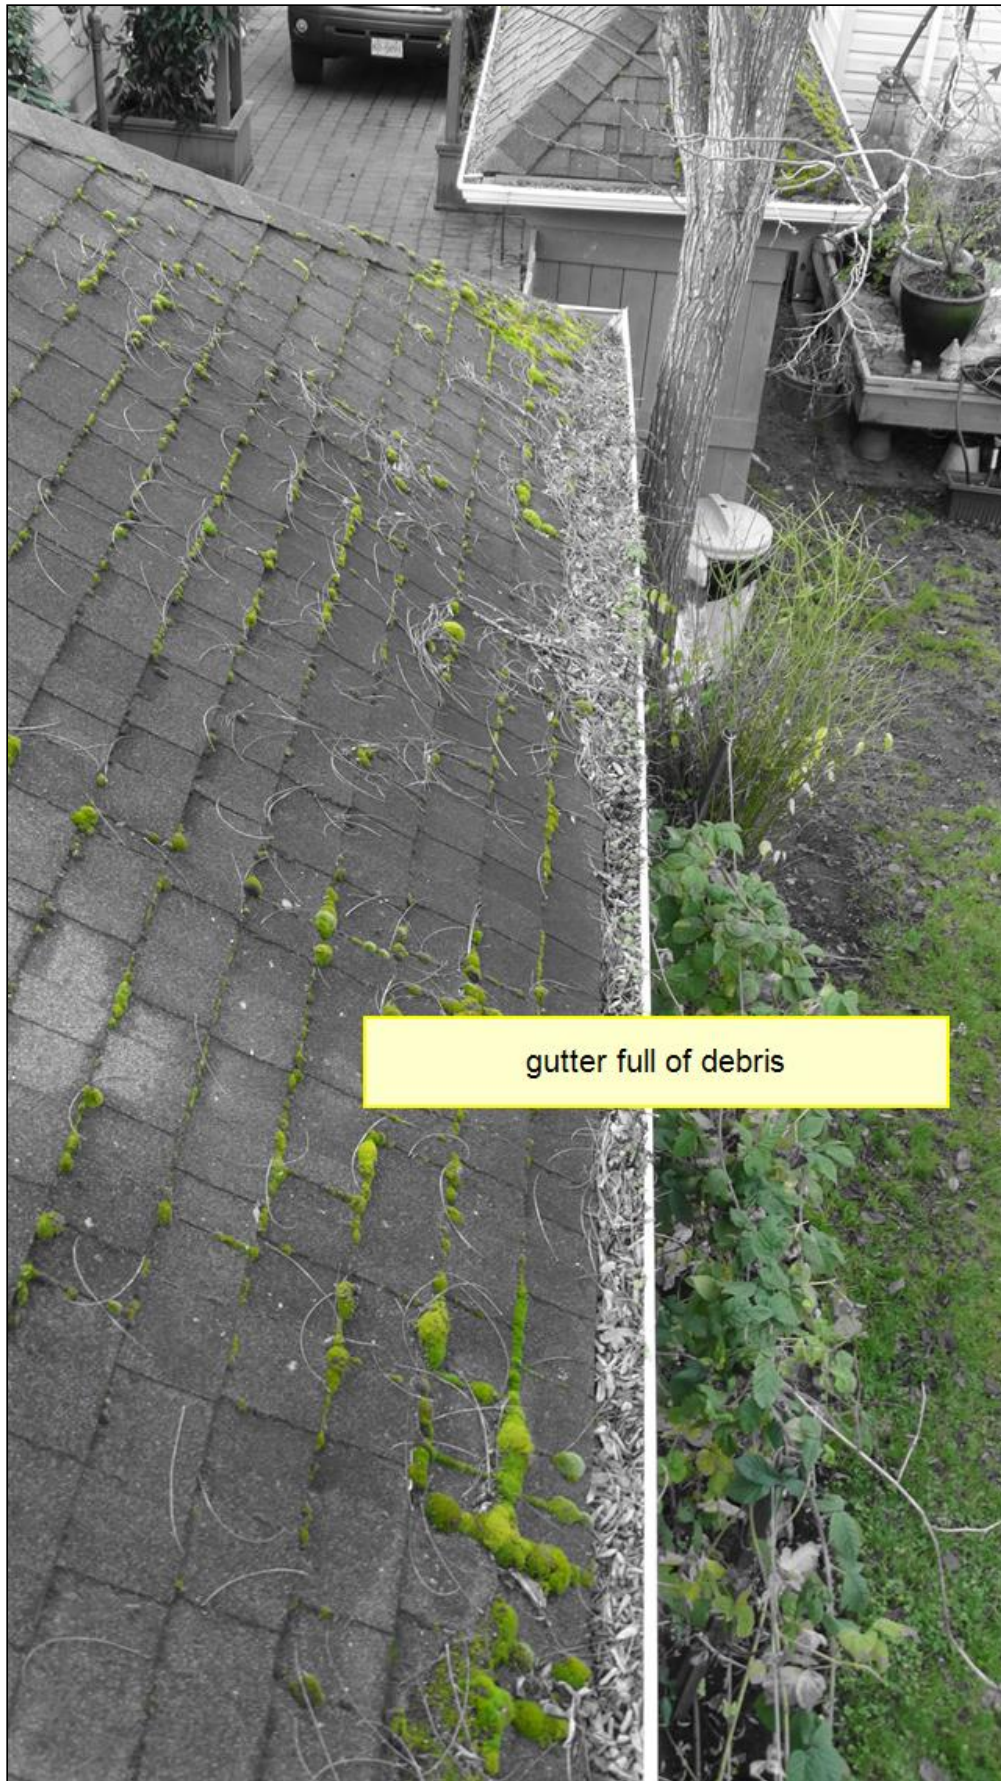
- 31 The gutter is leaking and needs some gutter seal at the front corner of the suite.
- The gutter on the left side of the suite (facing suite) is full of debris and needs to be cleaned.
