Inspection Report

Property Address:
10-1414 Oceanview Pl
Saanich British Columbia

Date: 2019-08-12	Time:	Report ID: 2019-187
Property: 10-1414 Oceanview Pl Saanich British Columbia	Customer: Mr. Steven Hart	Real Estate Professional:

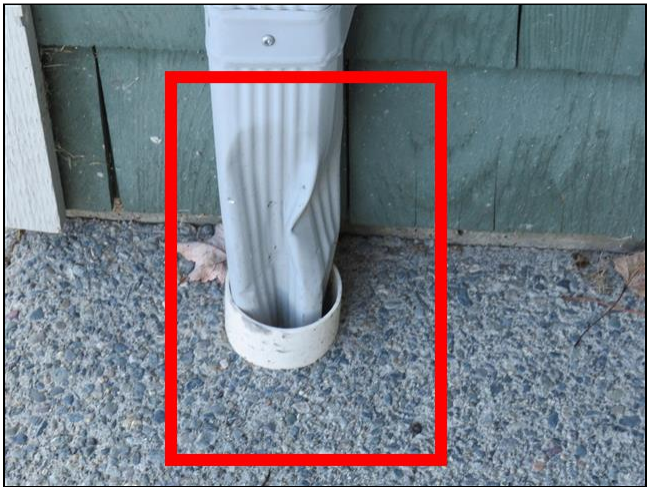
1.3 Item 1(Picture)

The downspout near the garage is dented. This is considered cosmetic.

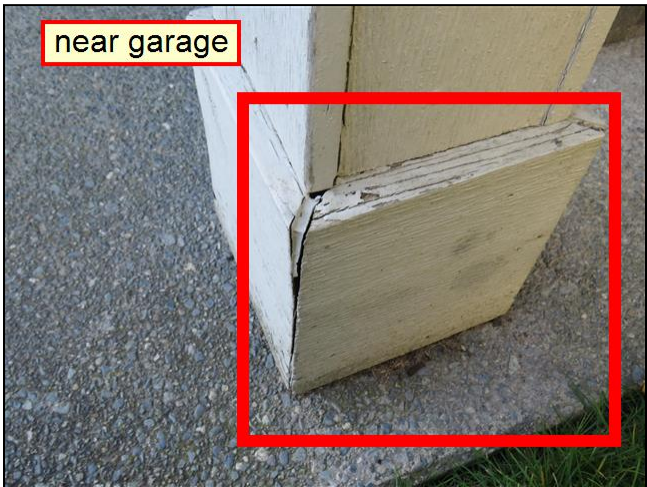
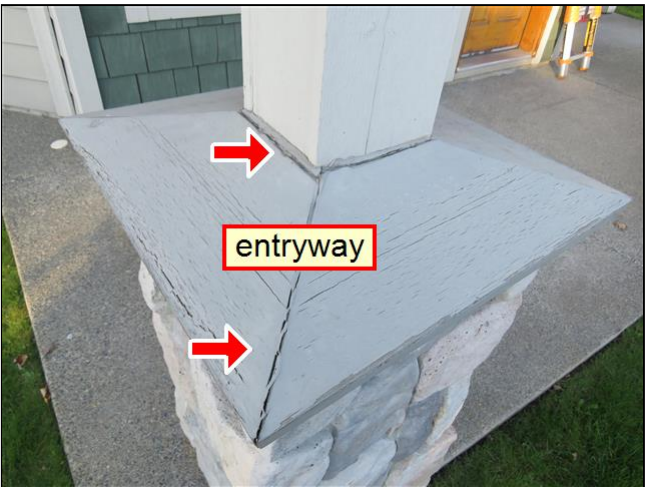
2.0 Item 1(Picture)

Some exterior wood trim boards are starting to show evidence of rot. Caulking and paint on the exterior should be freshened up to maintain lifespan and prevent water ingress.

Some exterior wood trim boards are starting to show evidence of rot. Caulking and paint on the exterior should be freshened up to maintain lifespan and prevent water ingress.

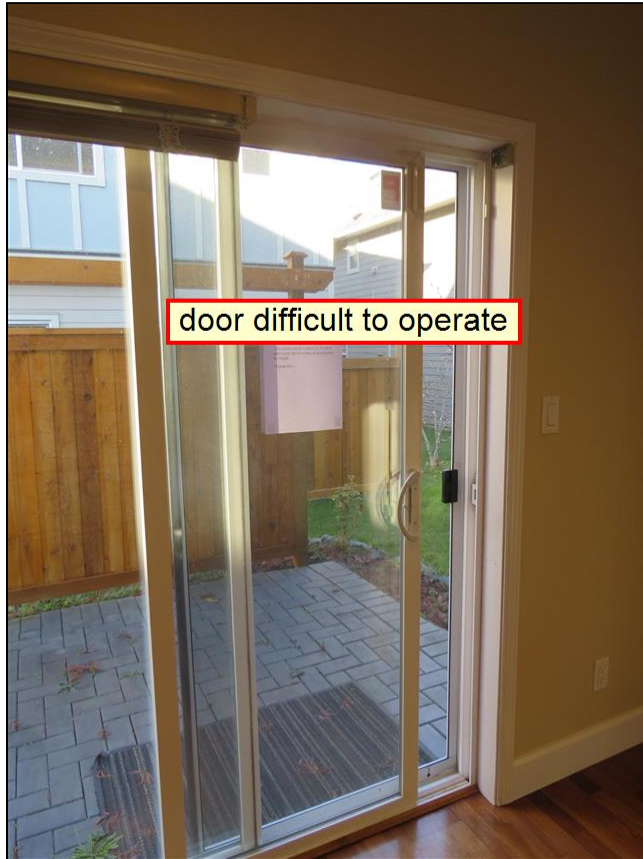
2.1 Item 1(Picture)

The sliding glass door at the rear of the townhouse is very difficult to operate. Please follow through with the strata to have the unit repaired.

The sliding glass door at the rear of the townhouse is very difficult to operate. Please follow through with the strata to have the unit repaired.

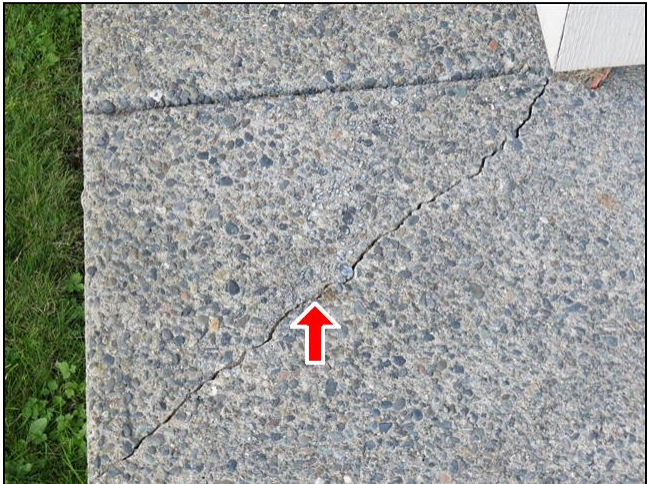
2.6 Item 1(Picture)

A crack was noted in the walkway at the front left of the townhouse. This appears cosmetic from typical settlement.

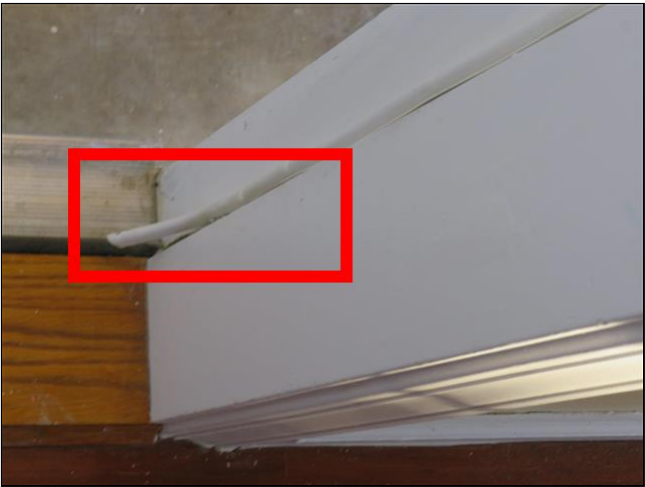
3.4 Item 1(Picture)

The occupant door from inside garage to inside the home does not auto close. This means that should a fire occur in garage, the occupant door does not afford protection until fireman arrive. The hinges should be replaced or the spring tension in the hinges needs to be adjusted in the near term. Please replace the damaged weatherstripping as well to limit heat loss in winter.

The occupant door from inside garage to inside the home does not auto close. This means that should a fire occur in garage, the occupant door does not afford protection until fireman arrive. The hinges should be replaced or the spring tension in the hinges needs to be adjusted in the near term. Please replace the damaged weatherstripping as well to limit heat loss in winter.

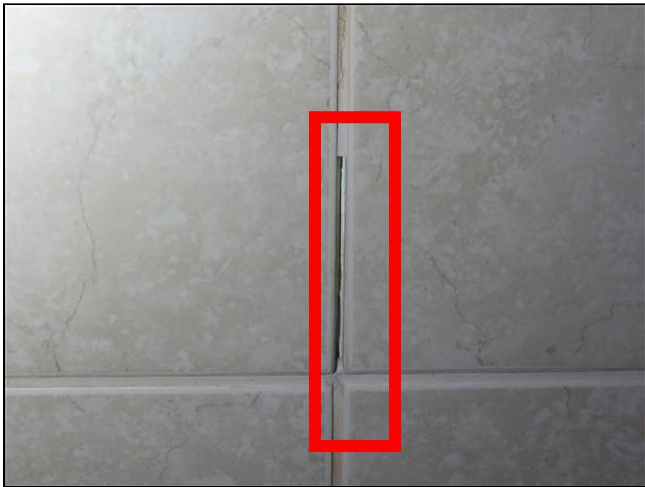
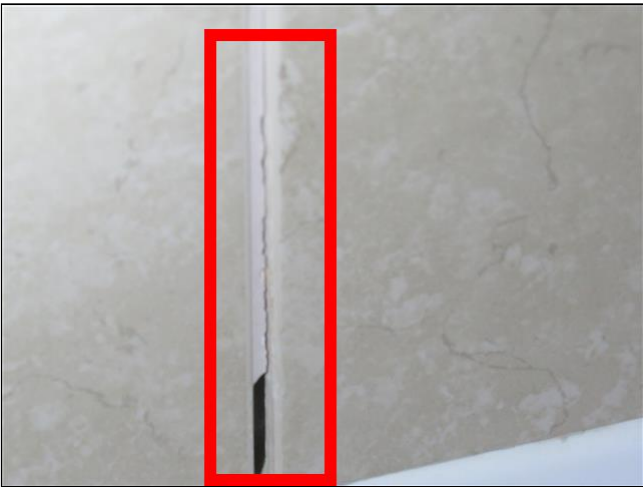
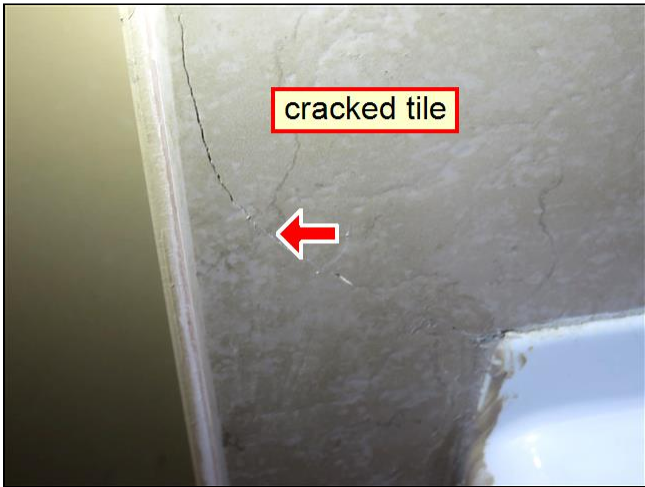
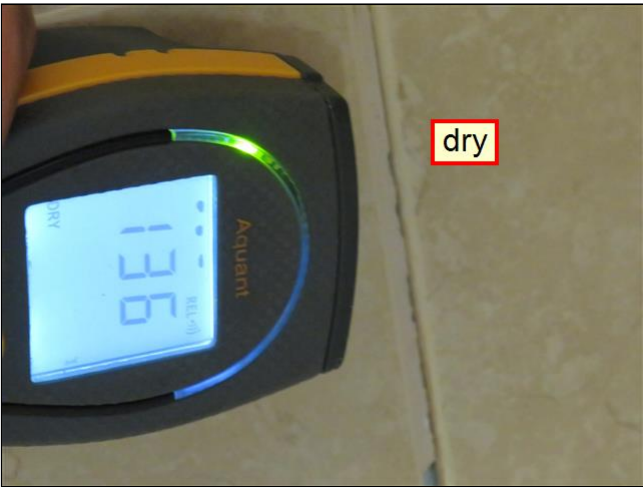
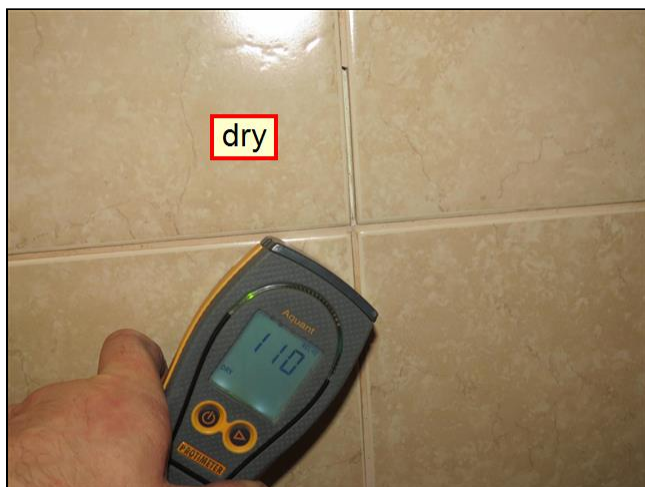
4.1 Item 1(Picture)

The grout at the tile surround at the main bath is deteriorated and needs repair or replacement. The wall board and framing may need repair (not visible). I recommend repair or replace using a qualified contractor prior to use. The moisture meter and thermal imaging camera were used and no elevated moisture levels were observed.

The grout at the tile surround at the main bath is deteriorated and needs repair or replacement. The wall board and framing may need repair (not visible). I recommend repair or replace using a qualified contractor prior to use. The moisture meter and thermal imaging camera were used and no elevated moisture levels were observed.

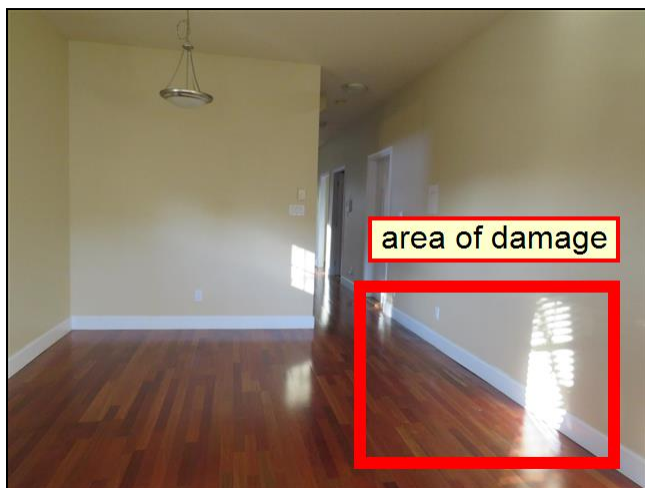
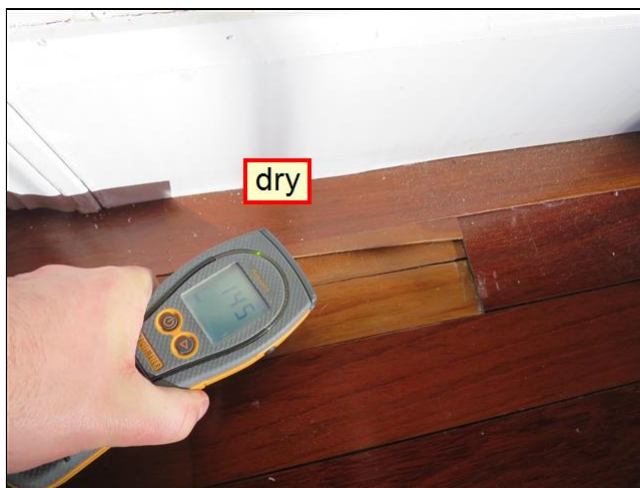
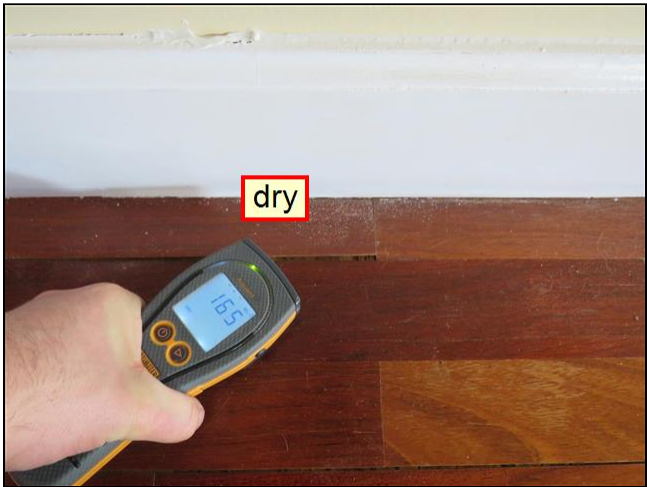
4.2 Item 1(Picture)

(1) The flooring on the main level near the garage wall is water damaged. The moisture meter and thermal imaging camera did not detect any active leaks. Recommend the flooring be replaced as needed.

(1) The flooring on the main level near the garage wall is water damaged. The moisture meter and thermal imaging camera did not detect any active leaks. Recommend the flooring be replaced as needed.

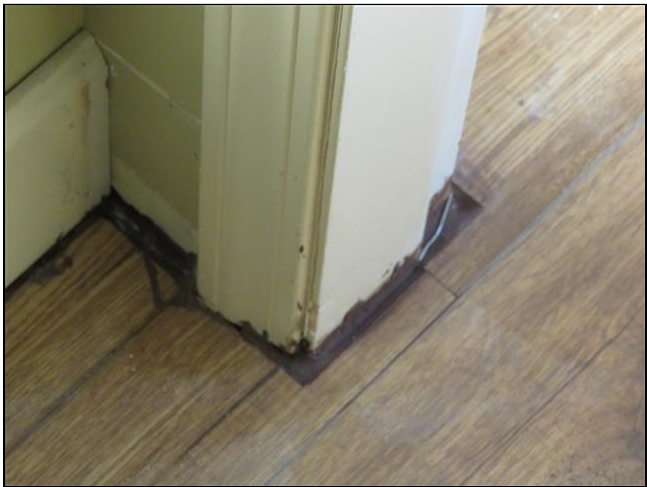
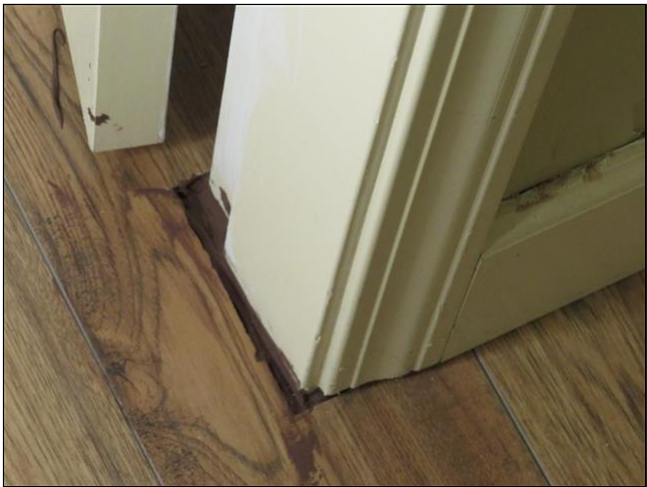
4.2 Item 5(Picture)

(2) The door jambs are nit undercut for the laminate flooring on the upper level. This is considered cosmetic.

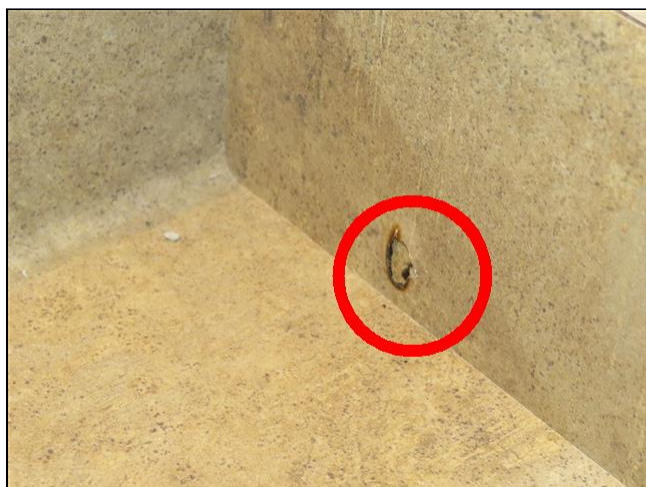
4.4 Item 1(Picture)

A small blemish was noted on the laminate countertop in the hall bath. This is considered cosmetic.

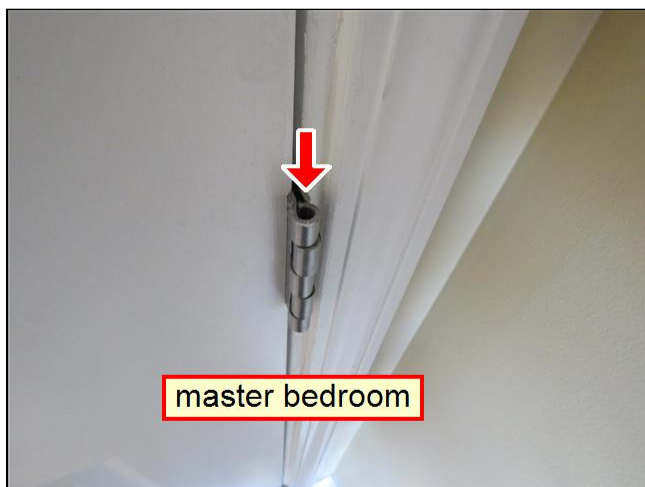
4.5 Item 1(Picture)

At least one hinge pin is missing. Please provide.

At least one hinge pin is missing. Please provide.

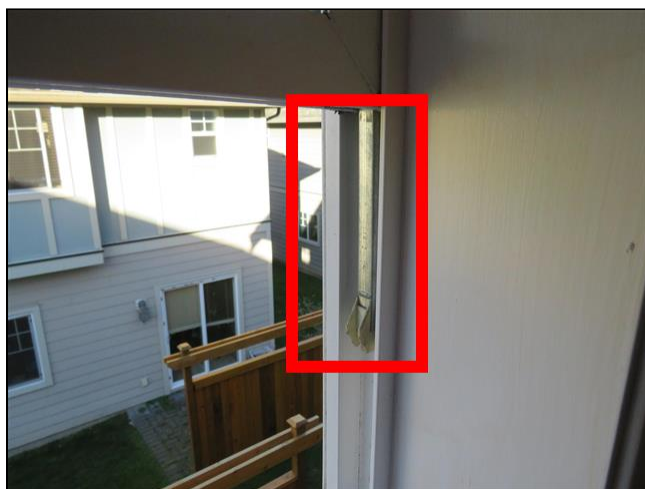
4.6 Item 1(Picture)

The ensuite window does not function as intended and needs repairs. Have a qualified contractor investigate further and repair/replace.

The ensuite window does not function as intended and needs repairs. Have a qualified contractor investigate further and repair/replace.

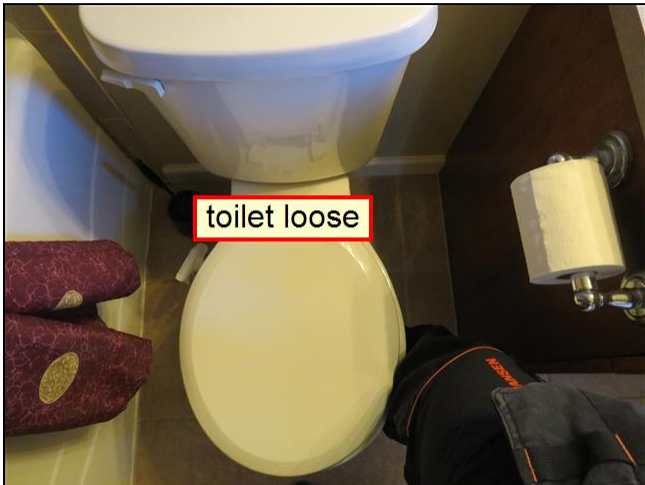
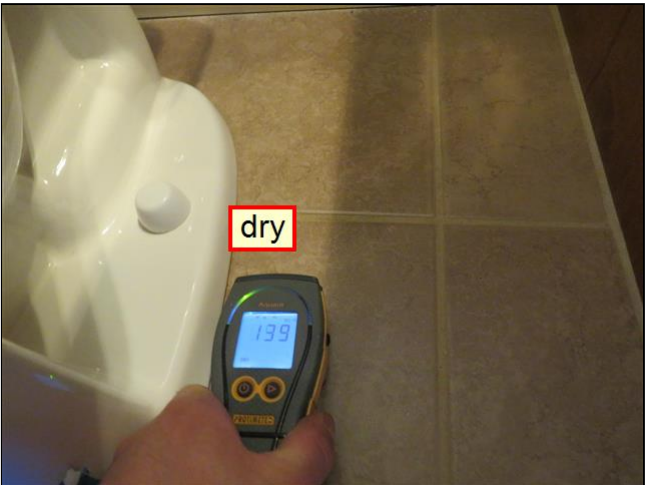
6.0 Item 1(Picture)

(1) The toilet is loose at floor at the ensuite. Repairs may involve re-setting the toilet on a new wax seal. The moisture meter did not detect any elevated moisture in the subfloor near the toilet. I recommend a plumber repair or correct in the near term.

(1) The toilet is loose at floor at the ensuite. Repairs may involve re-setting the toilet on a new wax seal. The moisture meter did not detect any elevated moisture in the subfloor near the toilet. I recommend a plumber repair or correct in the near term.

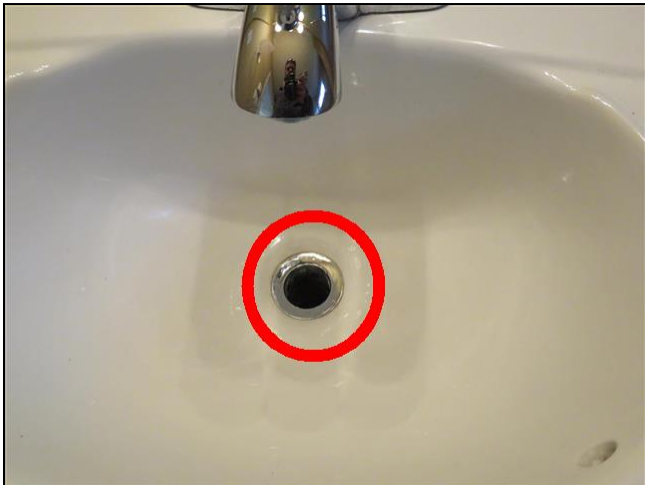
6.0 Item 3(Picture)

(2) The stop-valve is missing at the hall bath sink on the upper level. This is a cosmetic issue and doesn't effect the function. Repair as needed.

(2) The stop-valve is missing at the hall bath sink on the upper level. This is a cosmetic issue and doesn't effect the function. Repair as needed.

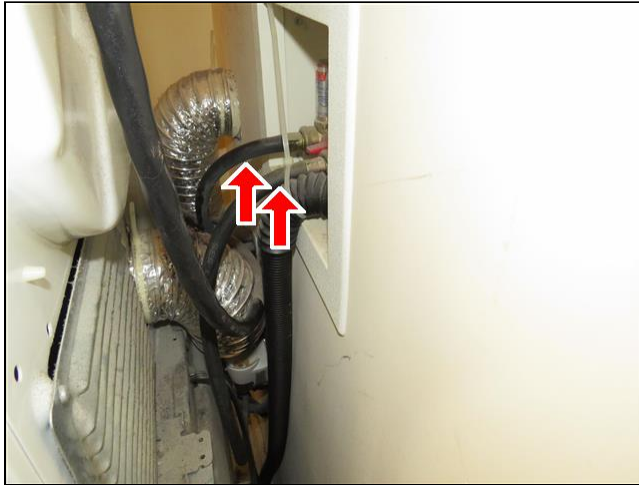
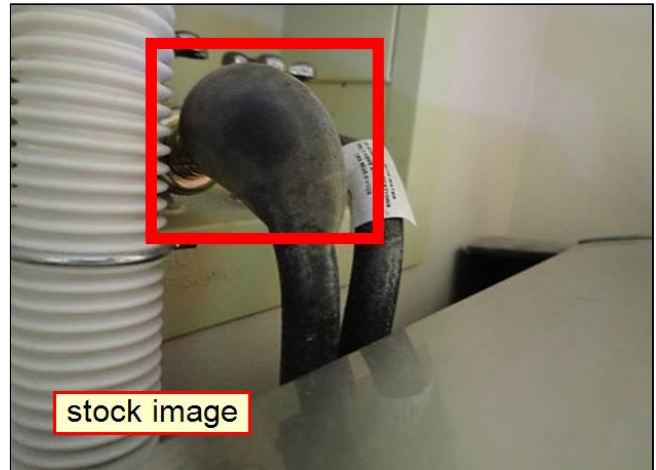
6.1 Item 1(Picture)

(1) The washing machine supply hoses are rubber and typically have a 5-yr lifespan. Premature rupture of the hoses can result in flooding. Recommend replacing the supply lines in the near term with braided stainless steel hoses that are less prone to bursting.

(1) The washing machine supply hoses are rubber and typically have a 5-yr lifespan. Premature rupture of the hoses can result in flooding. Recommend replacing the supply lines in the near term with braided stainless steel hoses that are less prone to bursting.

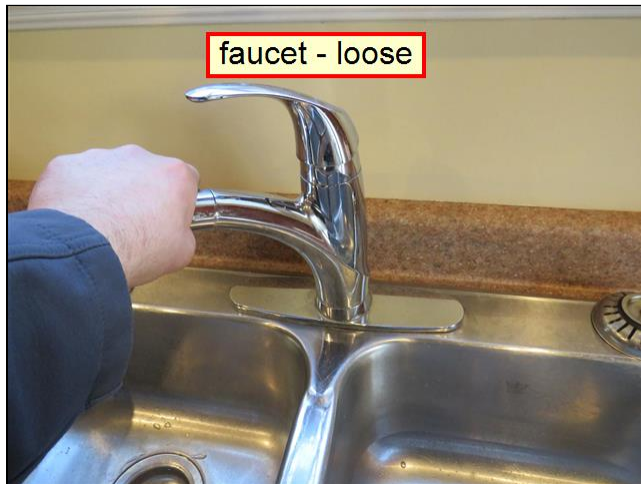
6.1 Item 3(Picture)

(2) The faucet at the kitchen sink is loose. Please secure to prevent further damage.

(2) The faucet at the kitchen sink is loose. Please secure to prevent further damage.

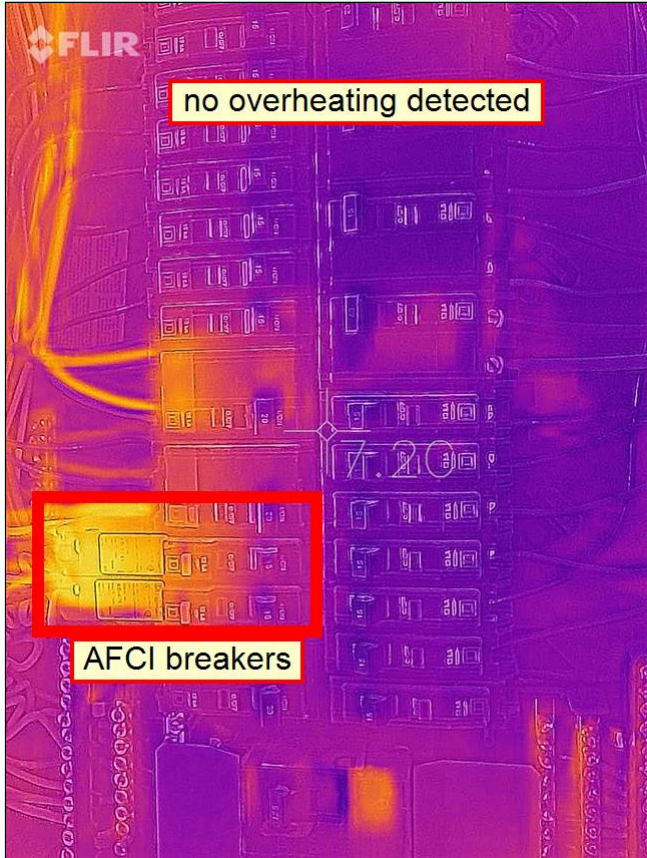
7.6 Item 1(Picture)

The main panel box is located in the garage. This is for your information.

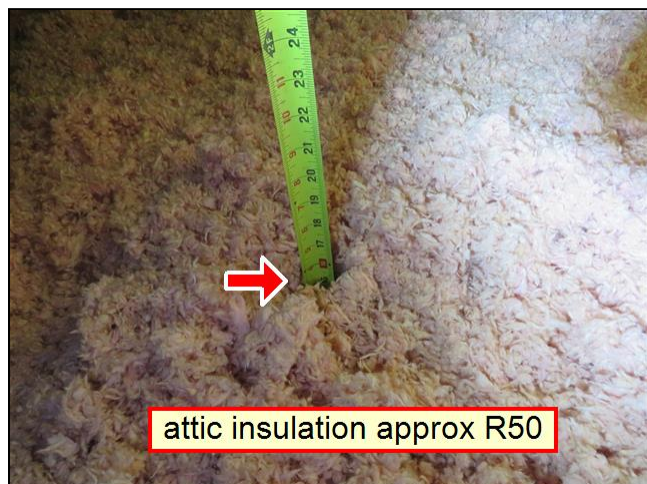
9.0 Item 1(Picture)

The attic insulation is about 16 inches thick or approx R-50 value. This is greater than what is required for the geographical location (R-40). This is for your information.

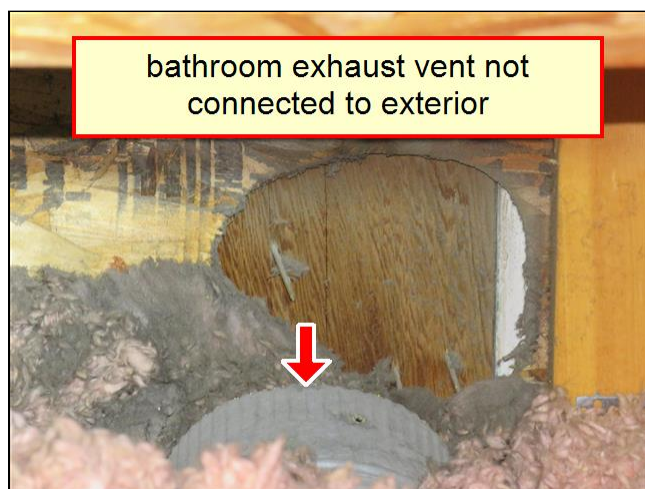
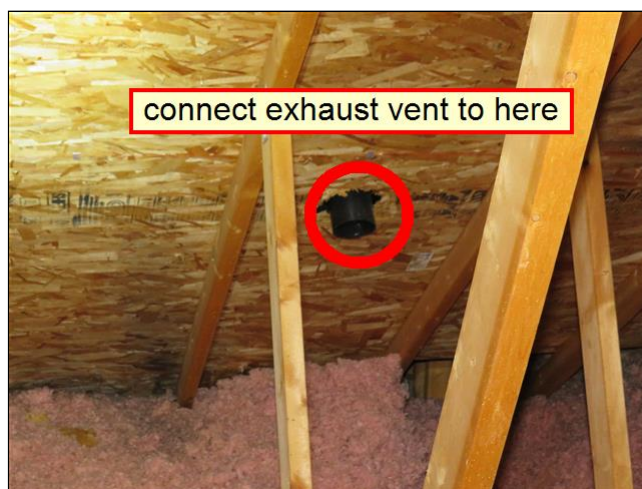
9.4 Item 1(Picture)

(1) The upstairs main bathroom exhaust vent is not vented to the exterior. Warm moist air can condense on the underside of the cool roof sheathing and lead to rot, mold, health issues, and deterioration. Please provide insulated flex duct to the roof vent (min 5" diameter) immediately by a qualified professional.

(1) The upstairs main bathroom exhaust vent is not vented to the exterior. Warm moist air can condense on the underside of the cool roof sheathing and lead to rot, mold, health issues, and deterioration. Please provide insulated flex duct to the roof vent (min 5" diameter) immediately by a qualified professional.

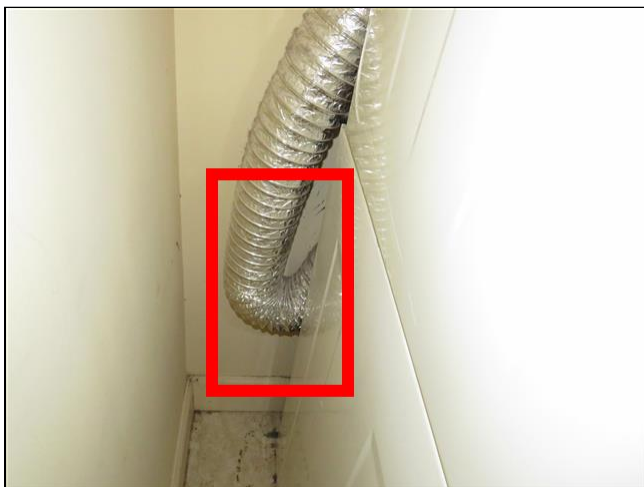
9.4 Item 3(Picture)

(2) The dryer vent piping can trap lint at sags. Recommend the vent be shortened.

(2) The dryer vent piping can trap lint at sags. Recommend the vent be shortened.
