Inspection Report

Property Address:
Sample Report
Victoria British Columbia

Highland Home Inspections

Date: 2017-08-12	Time:	Report ID: 2017-352
Property: Sample Report Victoria British Columbia	Customer: Mr. Joe Somebody	Real Estate Professional:

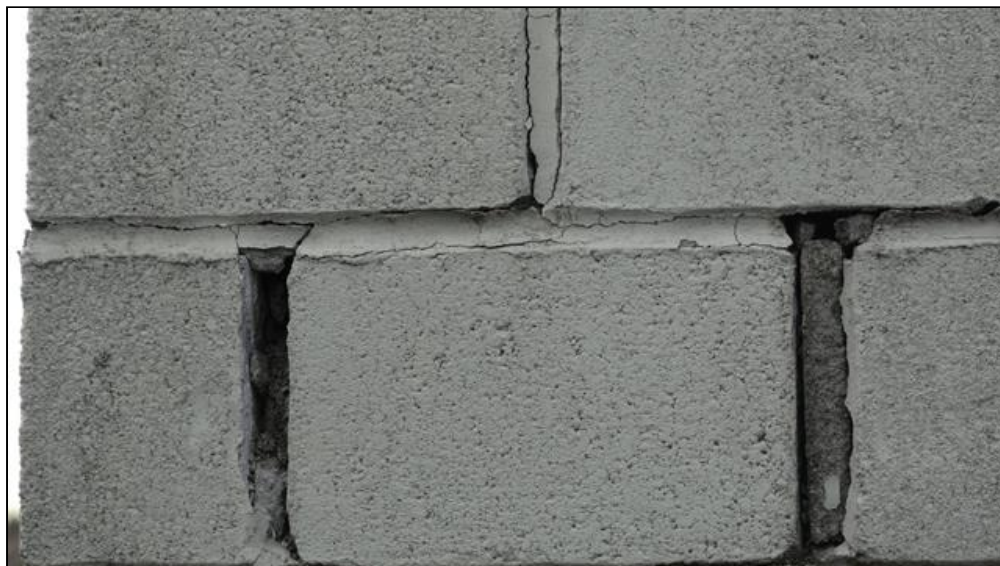
1.2 Item 2(Picture)

(1) The concrete block chimney has some areas of deteriorating mortar and should be re-pointed by a qualified mason to prevent further deterioration.

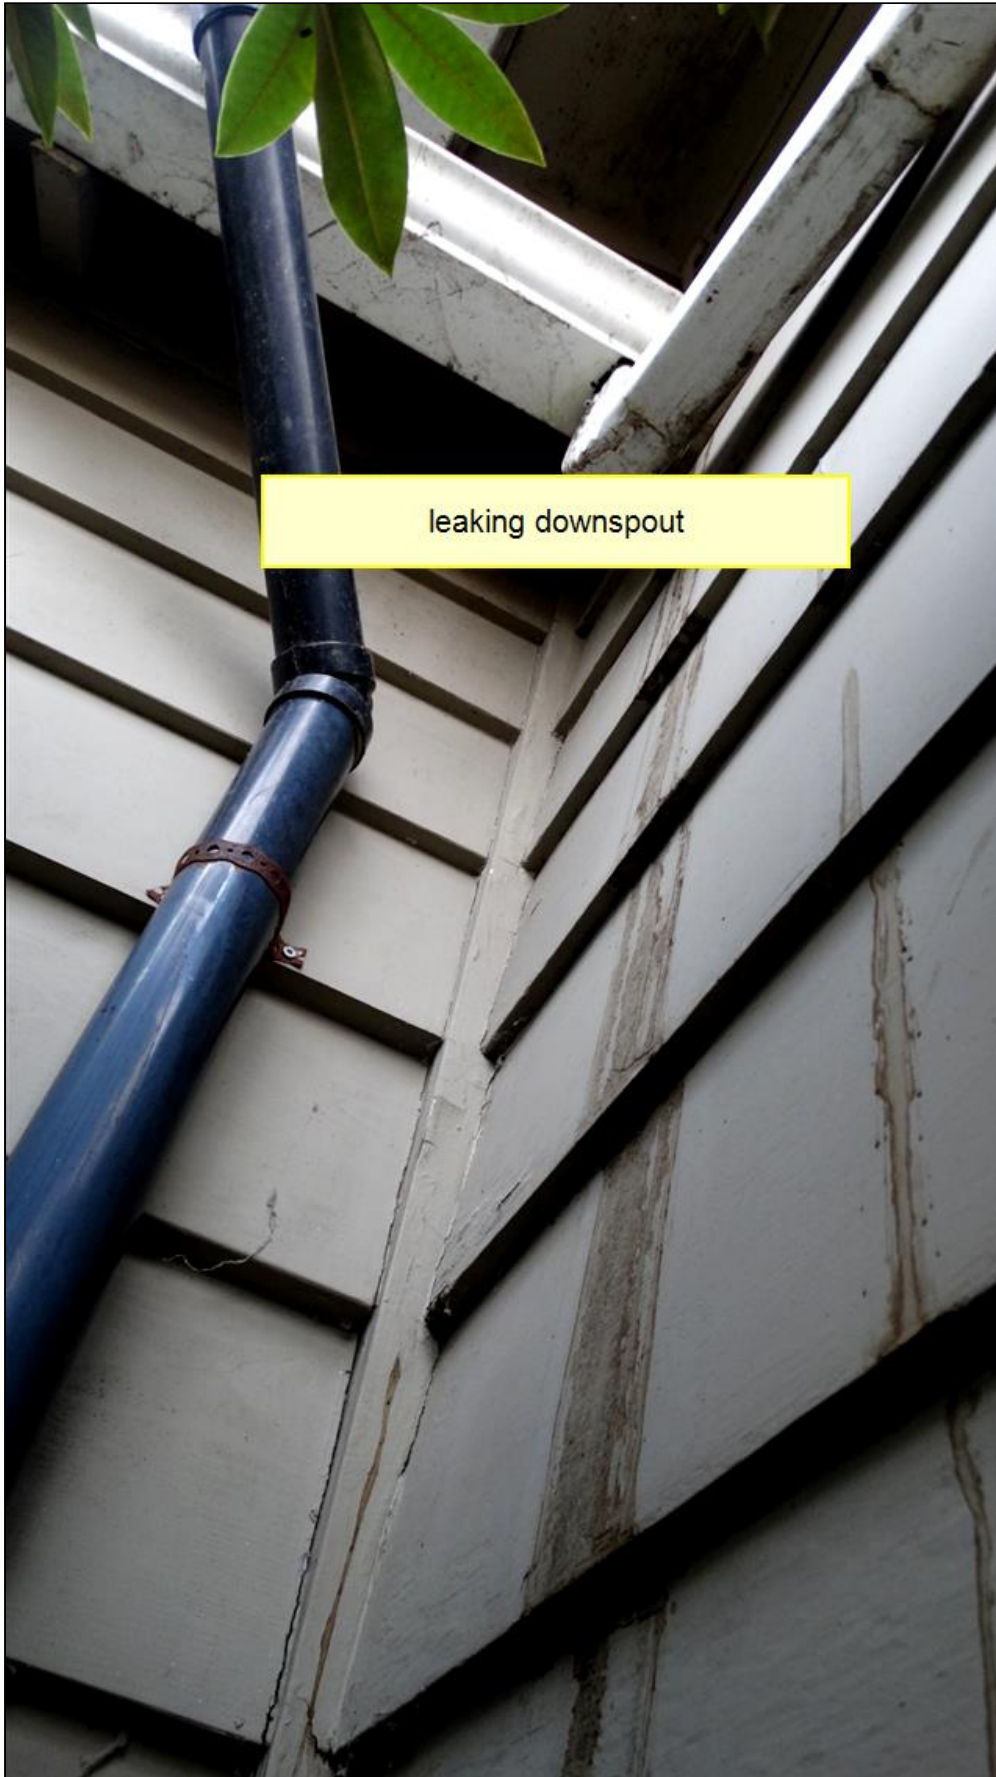
1.3 Item 2(Picture)

Some of the gutters are leaking and should be repaired by a qualified contractor.

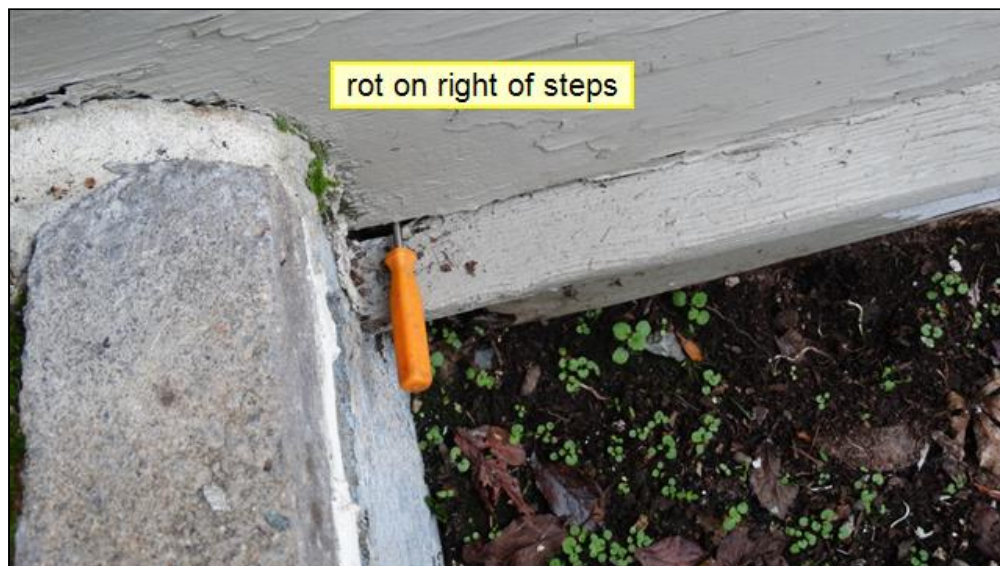
2.0 Item 2(Picture)

Comments: Inspected, Repair or Replace
(1) The cladding on the exterior near the front steps has some rot on either side. A qualified contractor should replace the rotten wood.

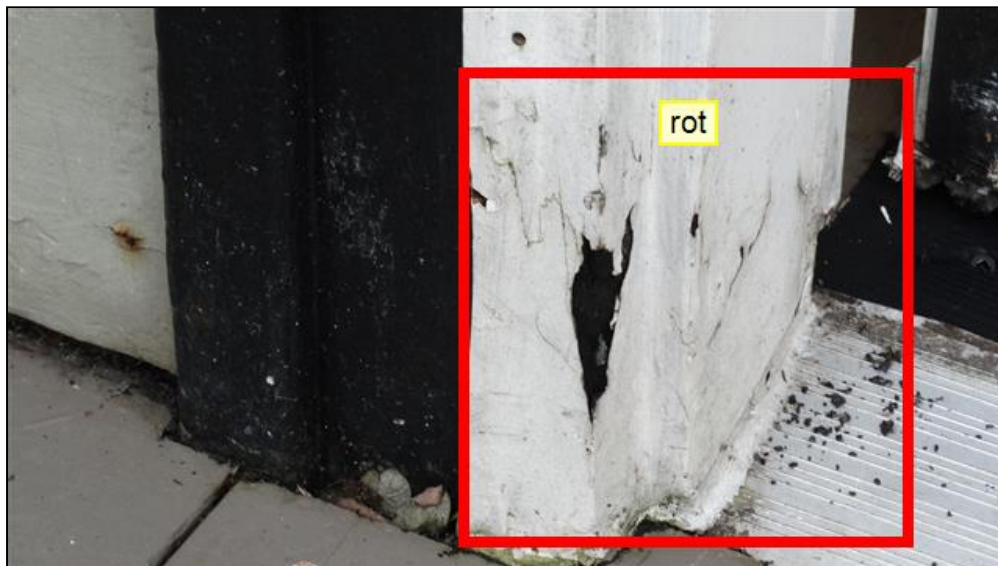
2.1 Item 2(Picture)

The rear entry door jamb has some rot at the bottom edge on both sides. The jamb should be replaced by a qualified contractor.

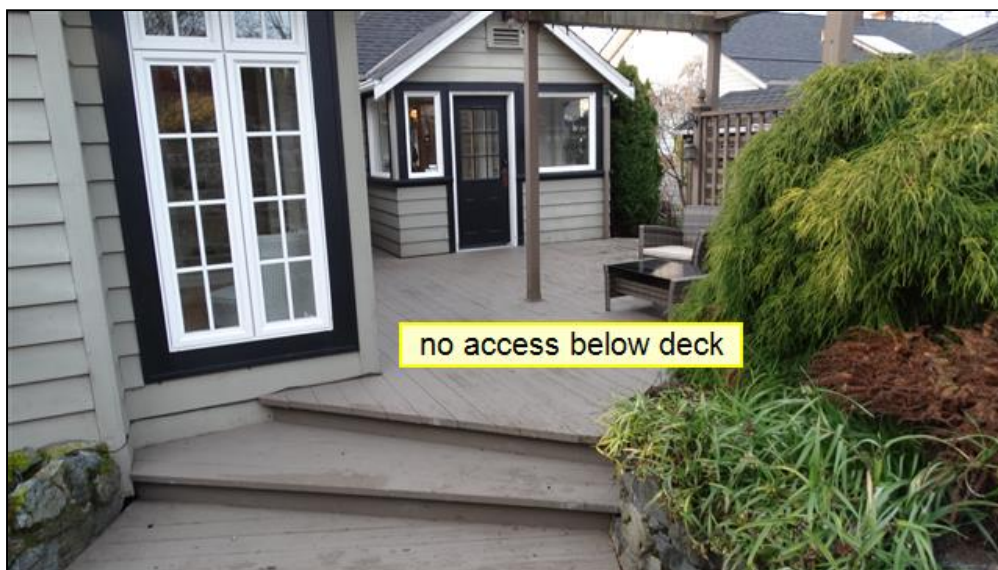
2.3 Item 1(Picture)

There is to access to inspect under the deck at the rear of the house. As such, it was inspected from below.

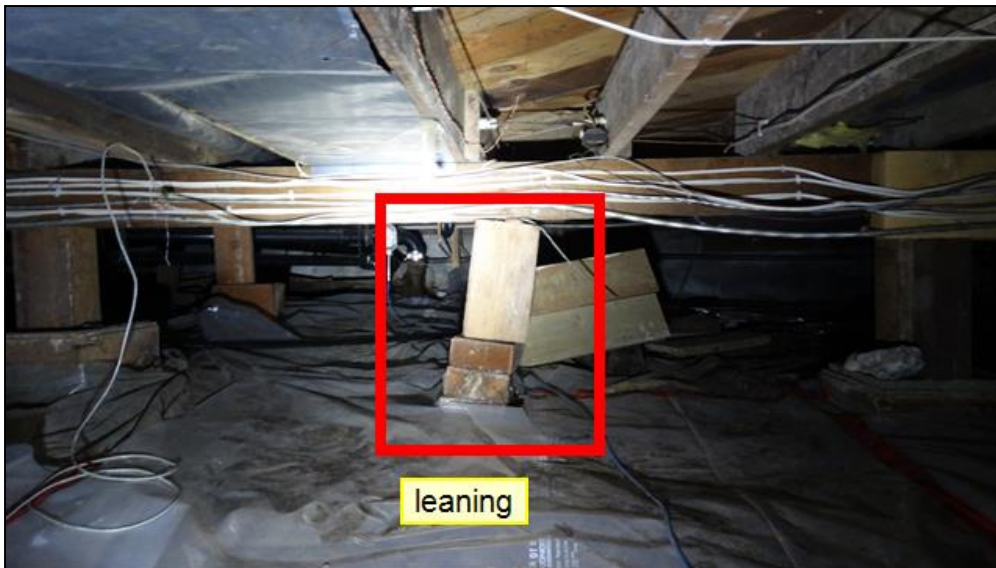
4.2 Item 1(Picture)

A support post for a beam in the crawlspace has moved and is out of plumb. Please have a qualified contractor make the repairs.

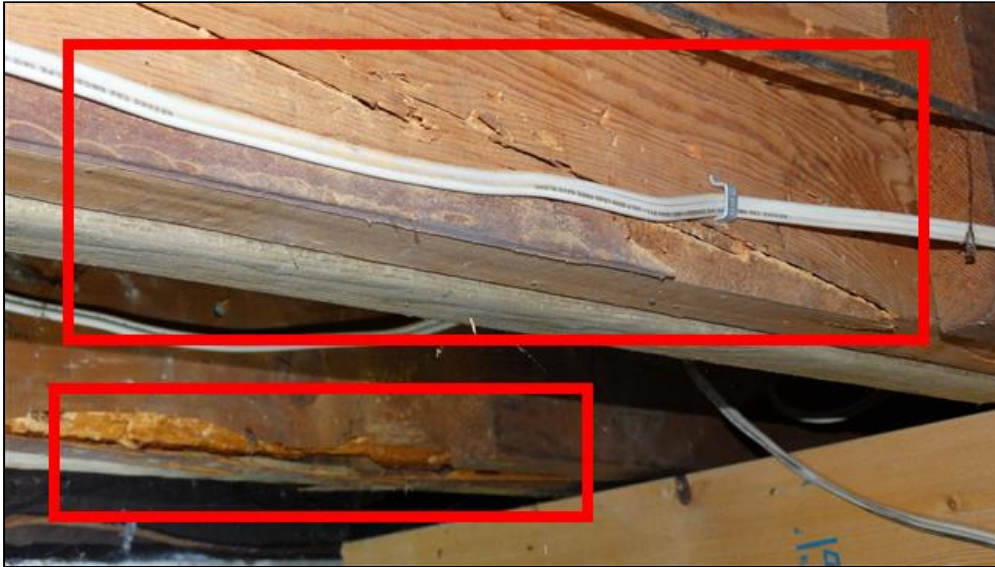
4.3 Item 1(Picture)

(1) There is evidence of previous insect activity in the crawlspace. Some floor joists have been structurally compromised and previously repaired. Recommend having a pest control specialist visit the house and confirm inactivity of the wood destroying organisms.

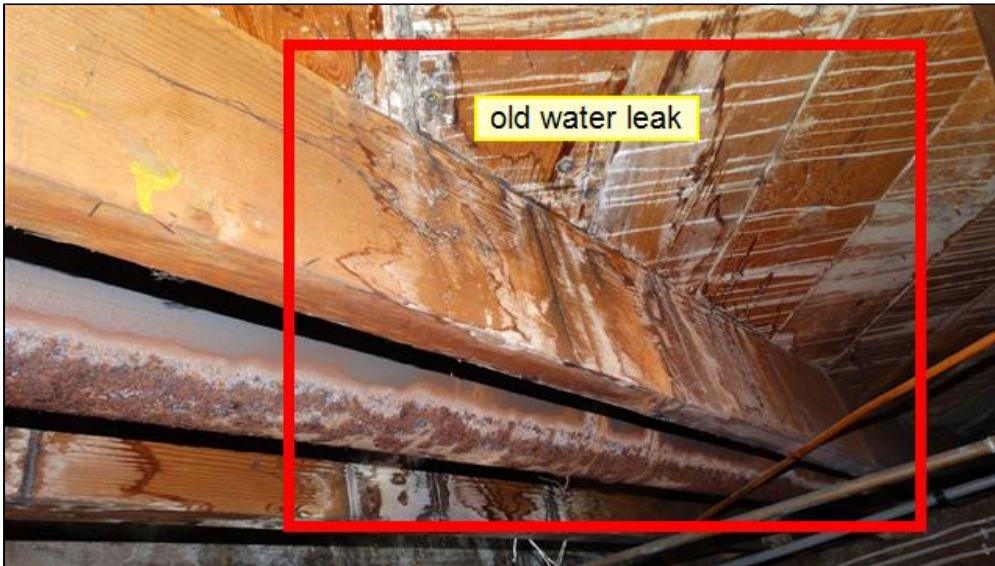
4.3 Item 2(Picture)

(2) There is evidence of a previous water leak in the area of the gas water heater. Dry at time of inspection. This is for your information.

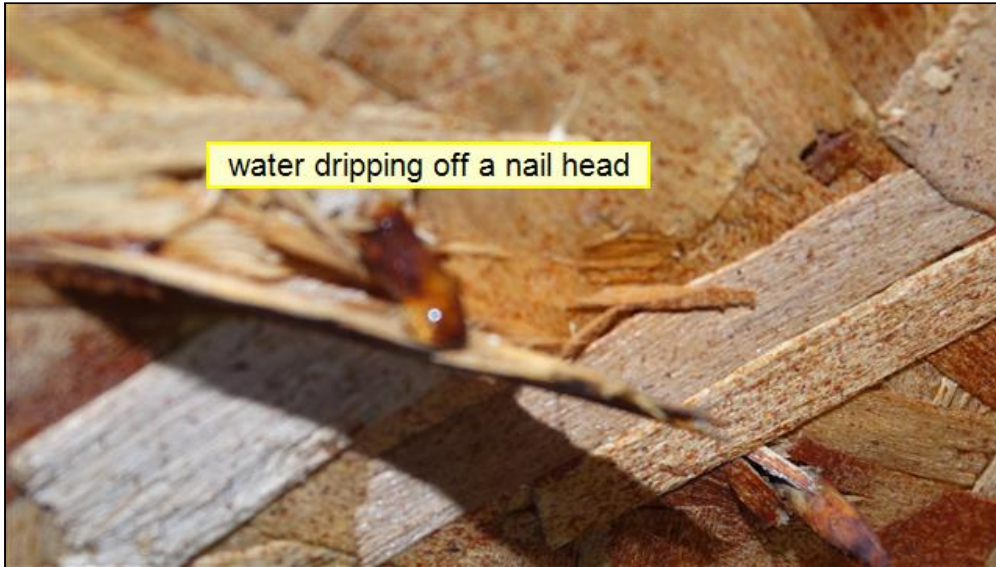
4.5 Item 2(Picture)

A few active leaks were found in the attic. Please have a qualified roofer repair these areas.

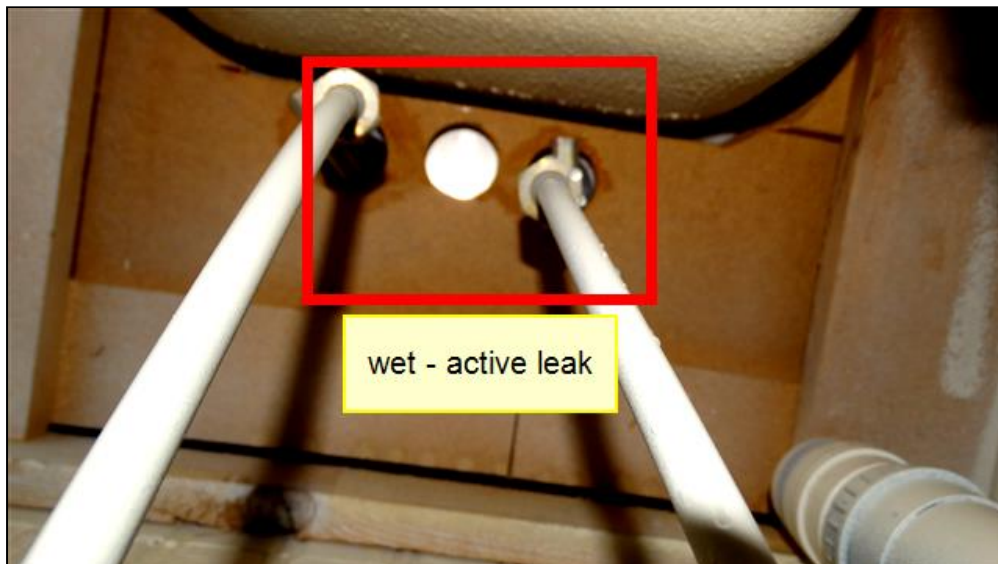
5.1 Item 4(Picture)

(3) The faucet for the small sink in the hallway leaks when in use. Please have a qualified plumber repair the faucet or replace.

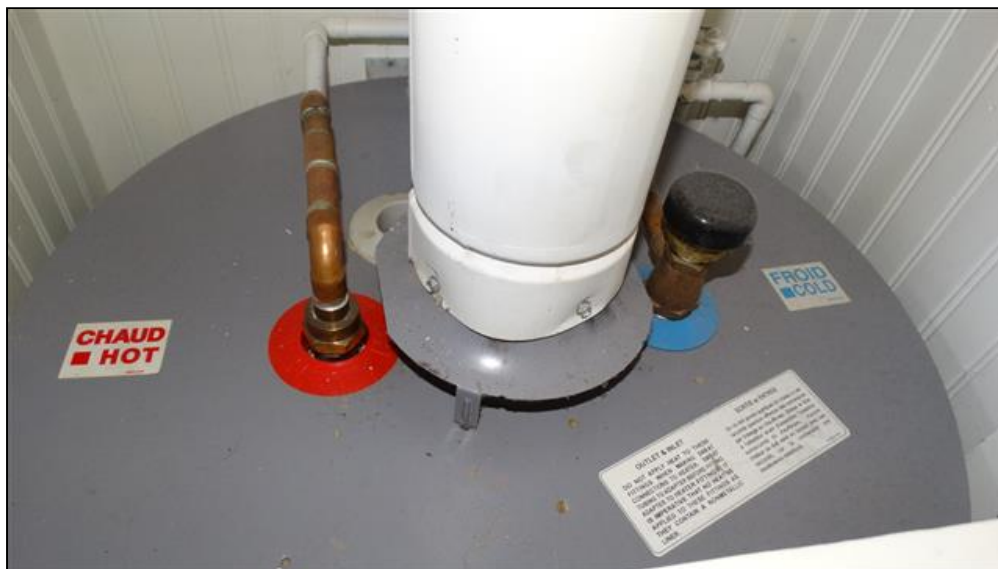
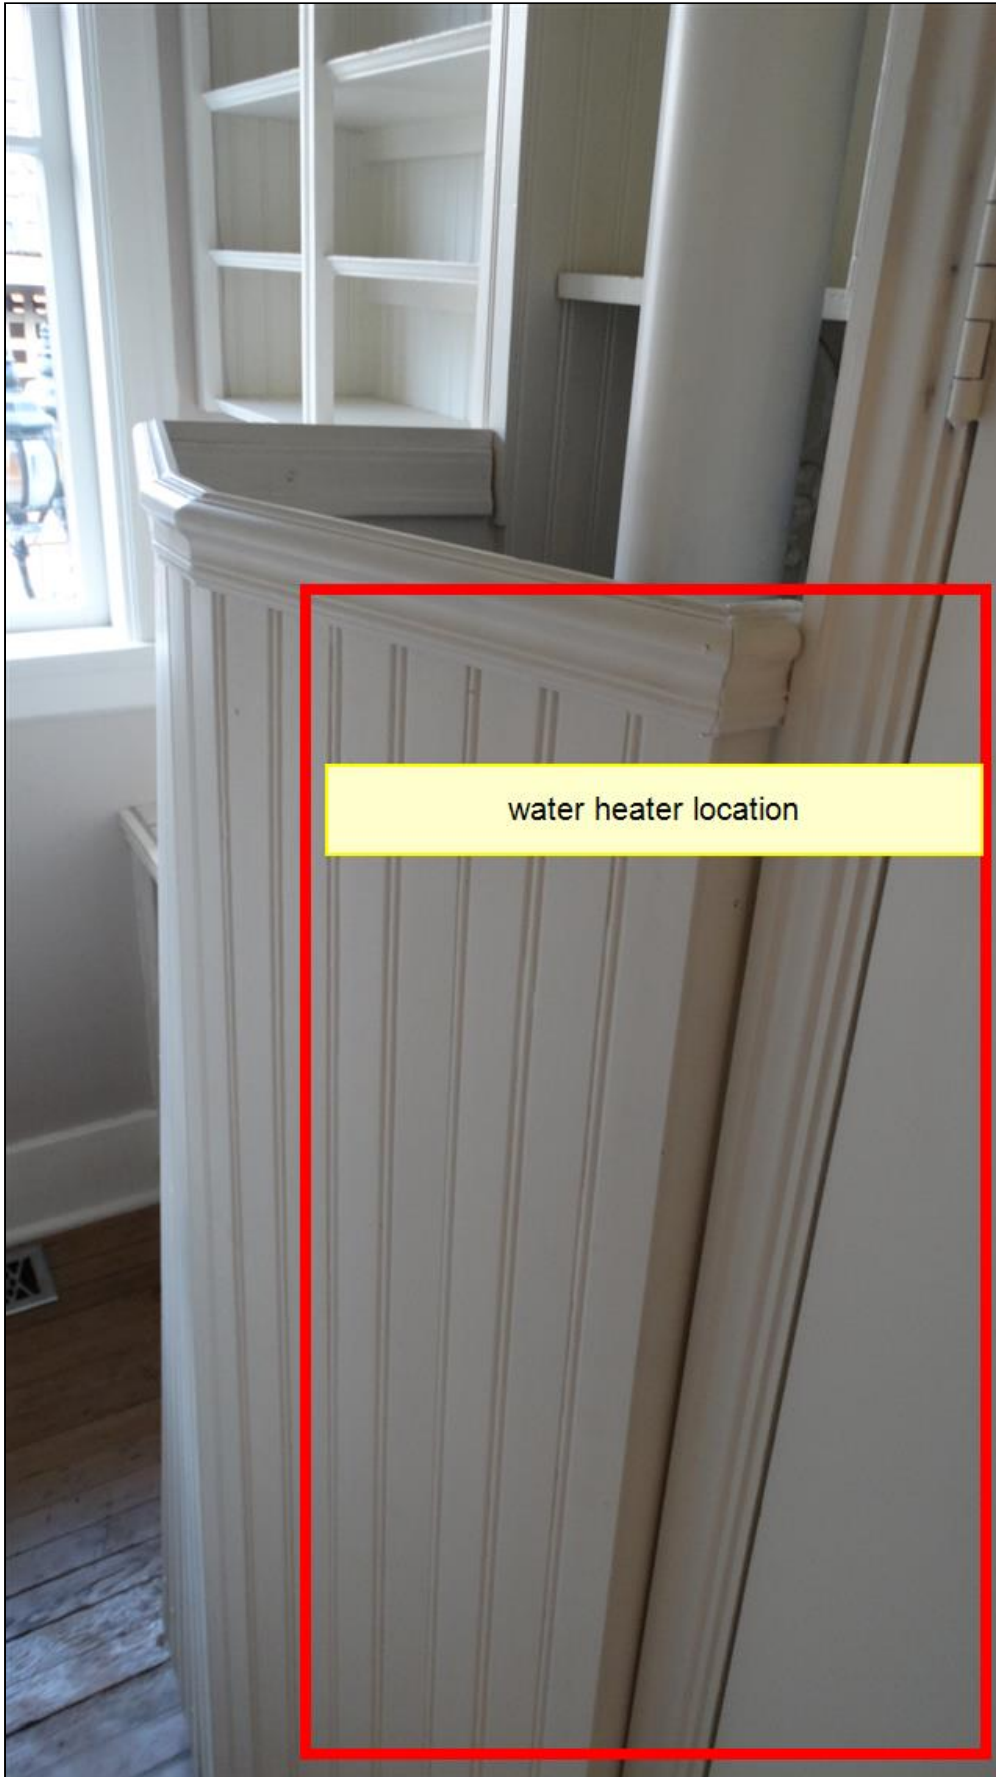
I could not access the gas water heater as it is behind a custom cabinet that is screwed shut. Please allow access to the water heater. The date and make are unknown.

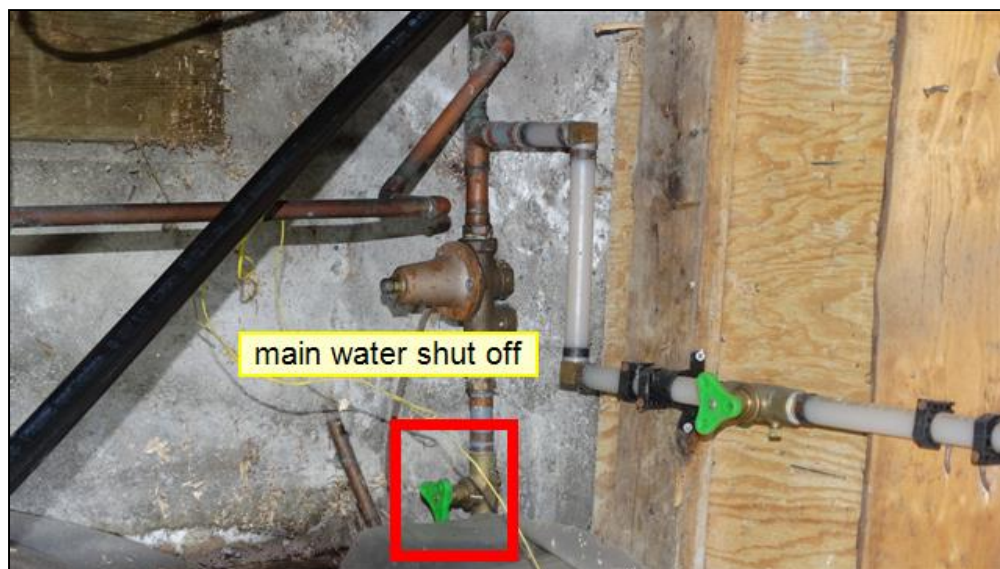
5.3 Item 1(Picture)

The main water shut off is located in the crawlspace. This is for your information.

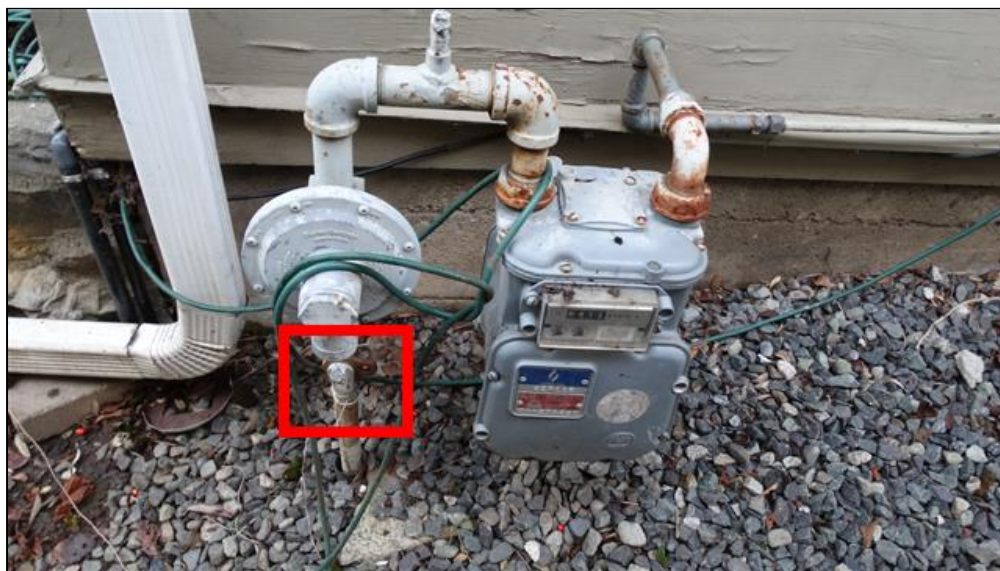
5.5 Item 1(Picture)

The main fuel shut off is at gas meter outside. This is for your information.

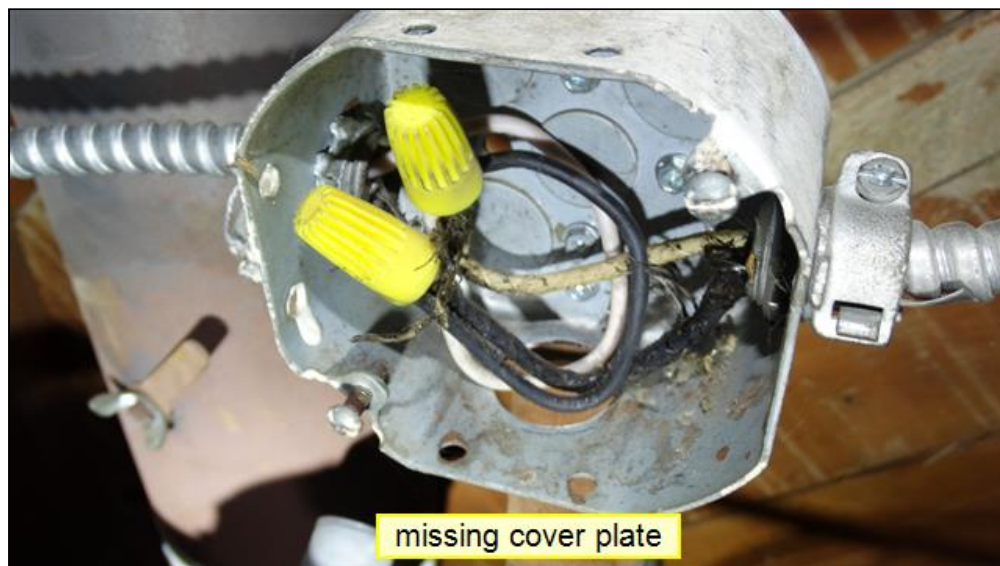
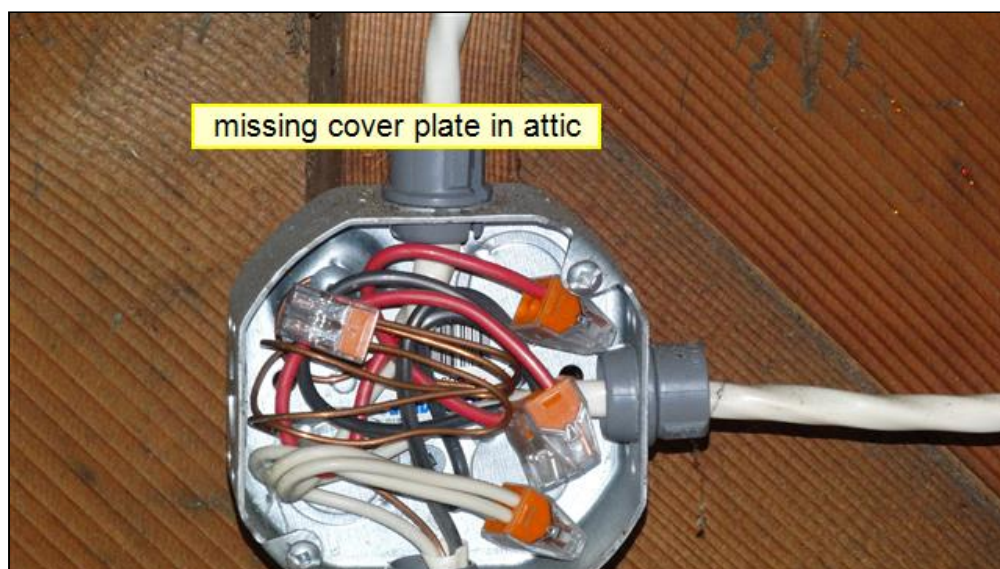
(1) Many junction boxes in the attic and crawlspace are missing their cover plates. They are a safety hazard if left without them. Please have a qualified electrician install the cover plates.

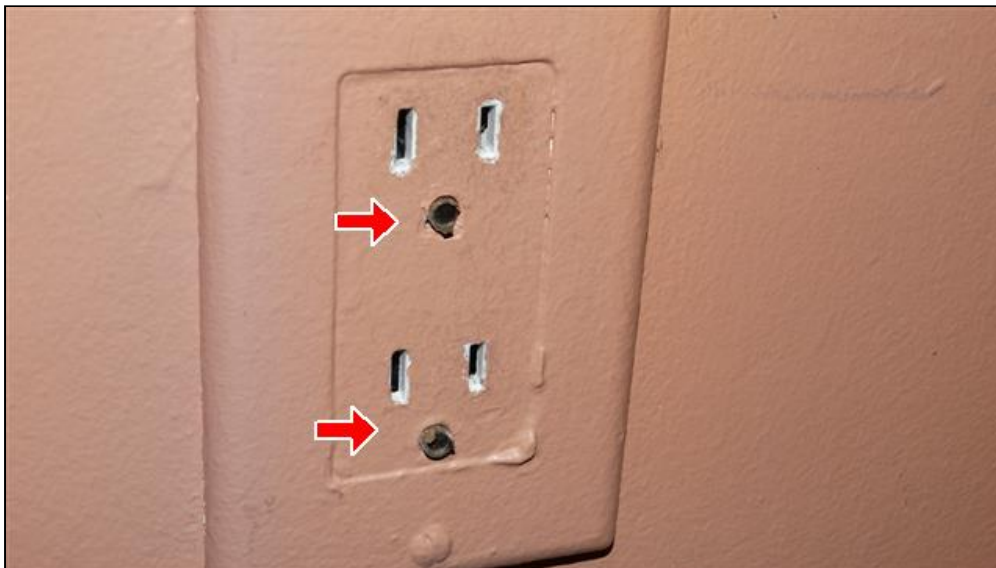
6.3 Item 5(Picture)

(2) The receptacle outside the master bedroom has ground prongs broken off inside of it. Please have a qualified electrician replace the receptacle.

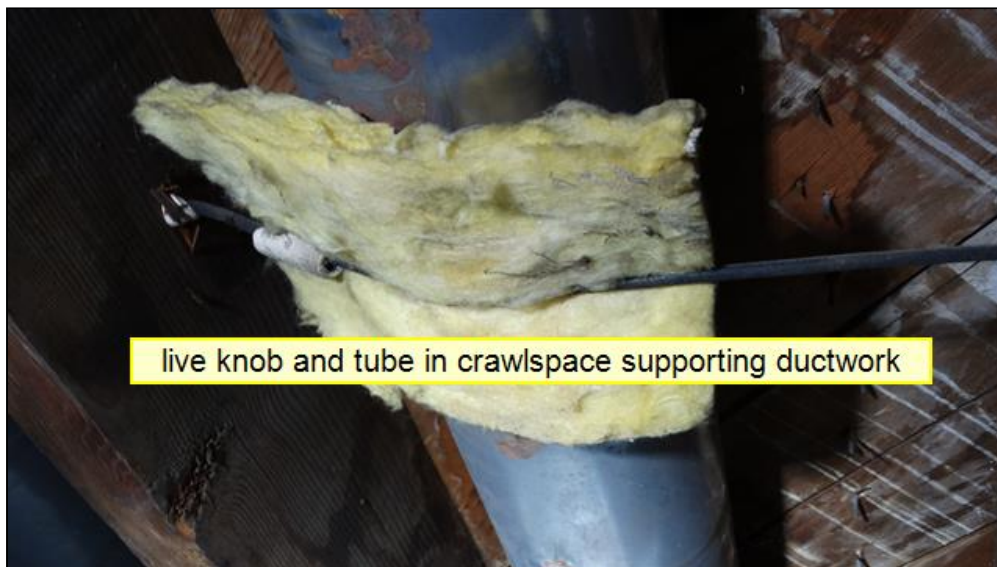
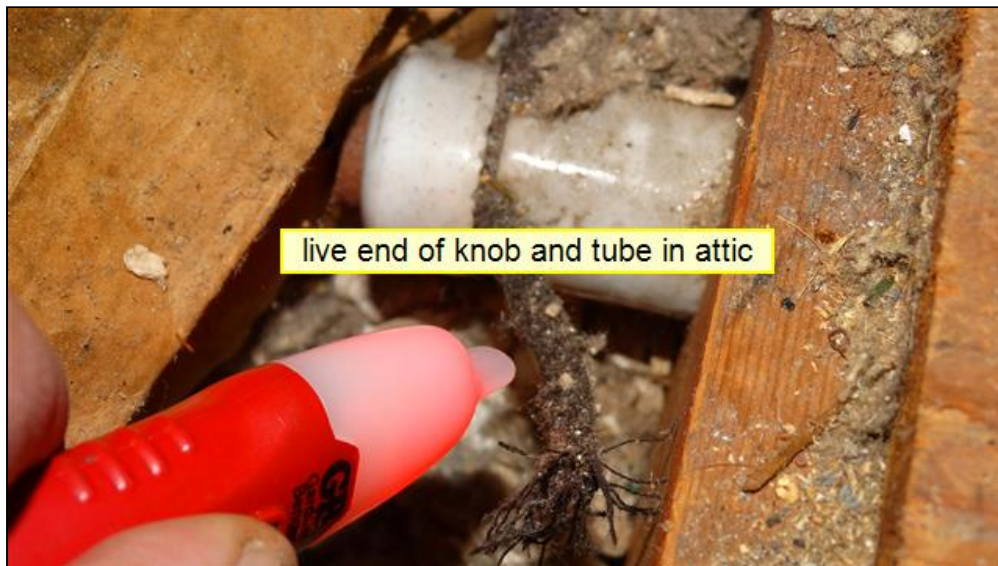
(3) This property has “knob and tube” wiring which was commonly installed prior to 1950. It is ungrounded, and considered unsafe by today’s standards. Over time, the wire’s insulation becomes brittle and falls apart, resulting in exposed conductors and a risk of shock and/or fire. This wiring is also easily damaged by covering it with insulation (a common practice), and incorrectly tapping new wiring into it. Some energized knob and tube wiring was found during the inspection. It is not within the scope of this inspection to determine what percentage of this property’s wiring is of the knob and tube type or to determine what percentage of the knob and tube wiring is energized vs. abandoned. A qualified electrician should evaluate this wiring and make repairs or replace wiring as necessary. I recommend you verify acceptability with your insurance company and/or lender prior to closing.

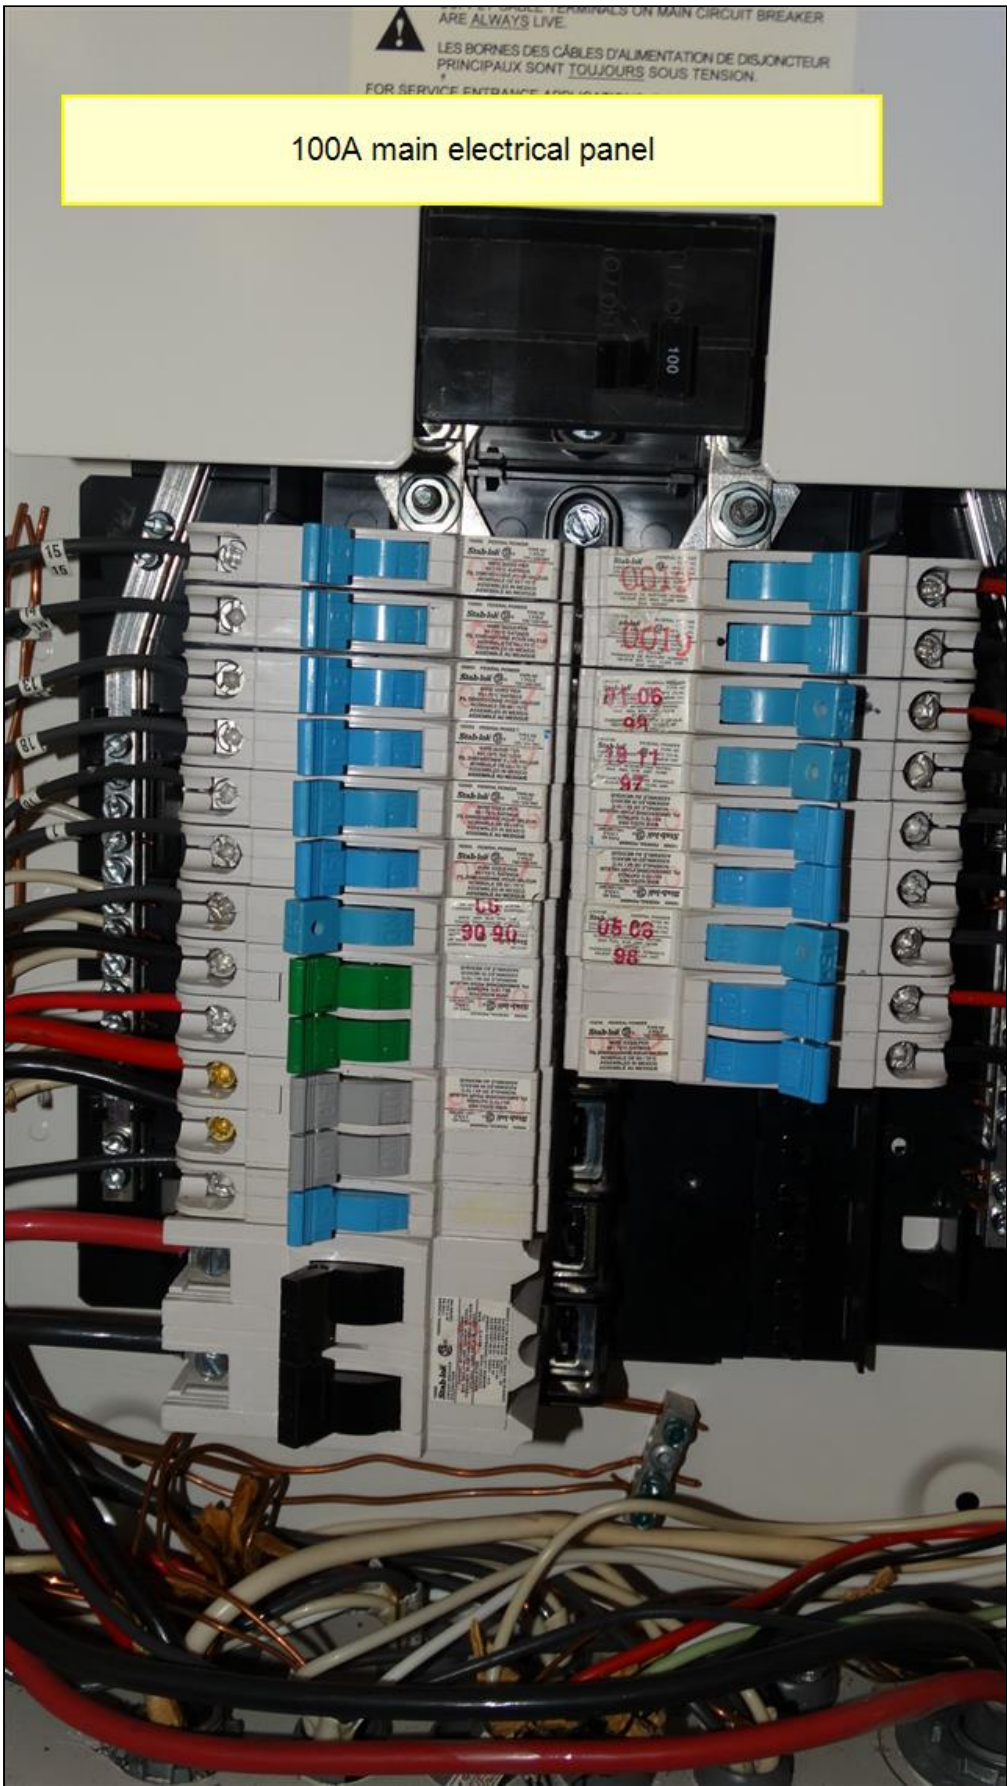
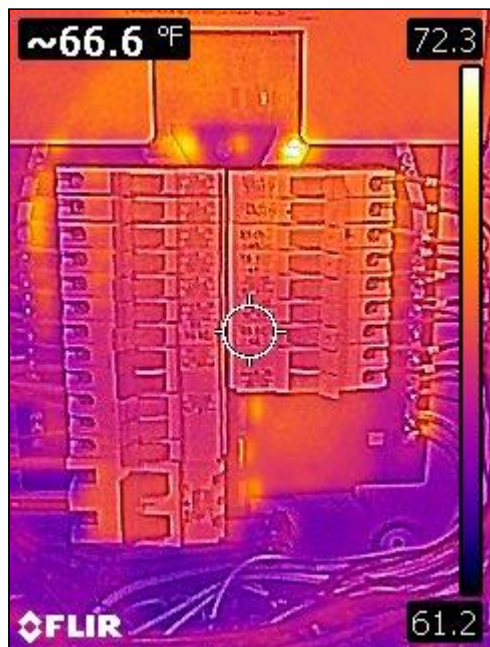
The main electrical panel is located behind the entry door. This is for your information.

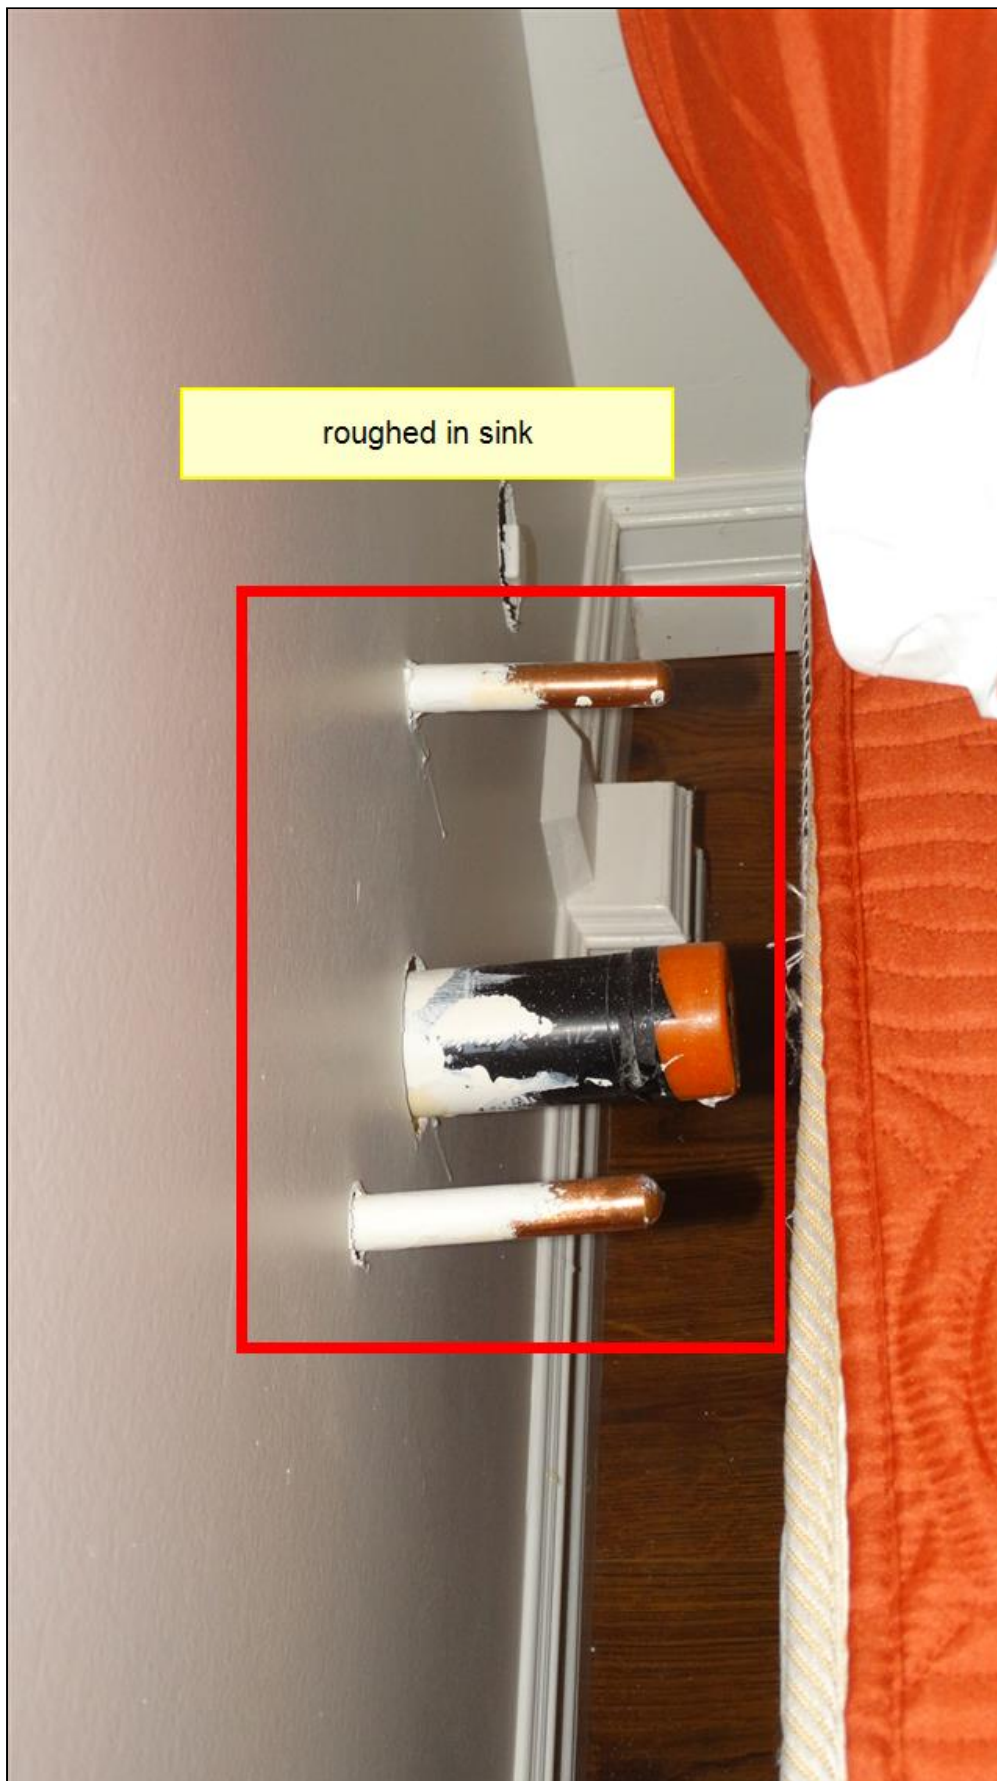
9.4 Item 1(Picture)

(1) There is a roughed in sink in the suite bedroom. This is for your information.

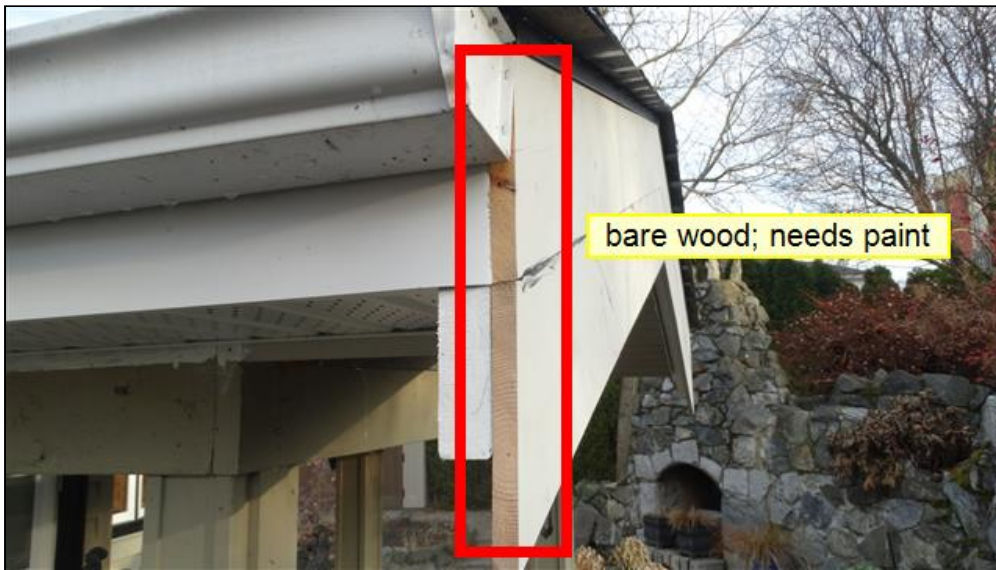
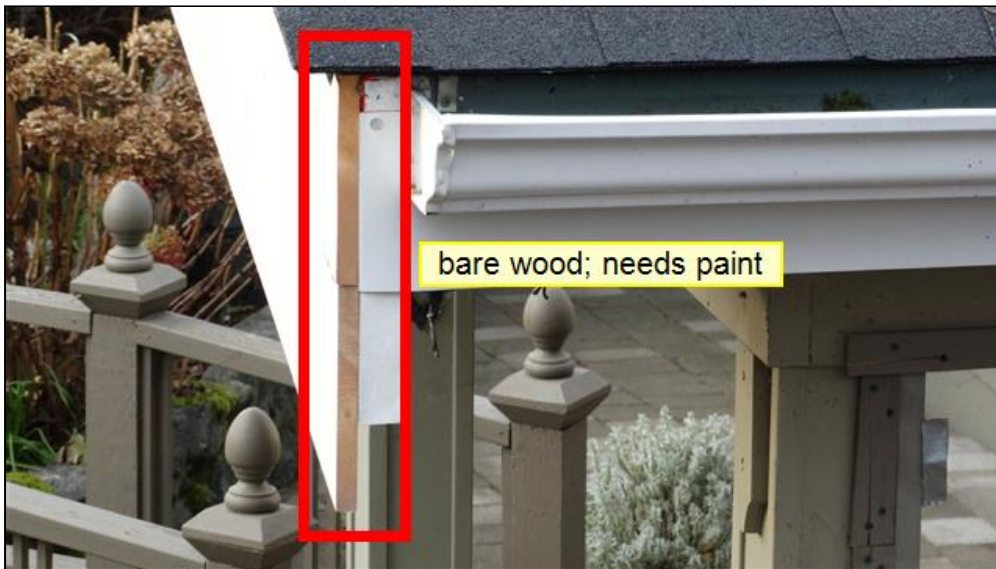
(2) The exposed eave needs primer and paint at the exterior in areas.

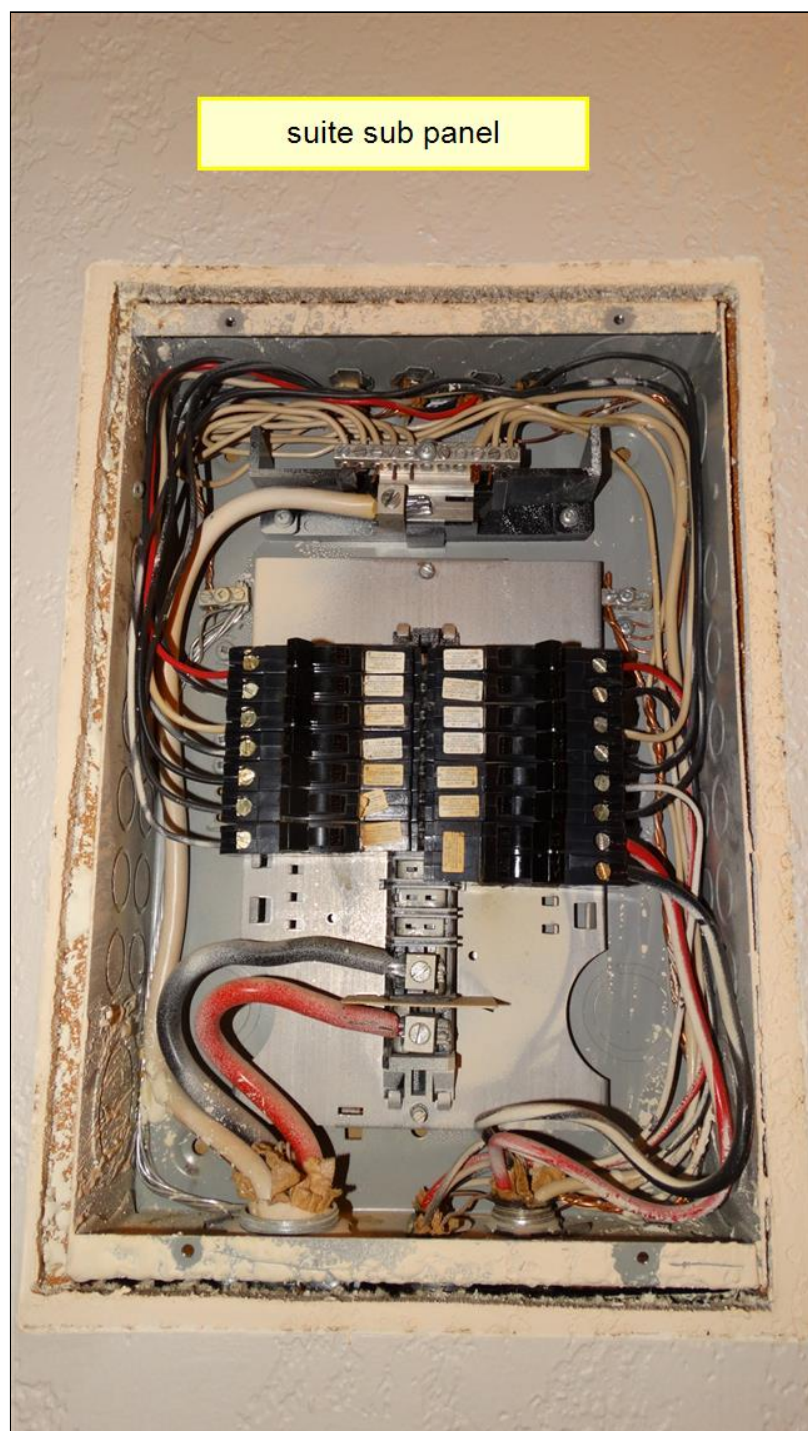
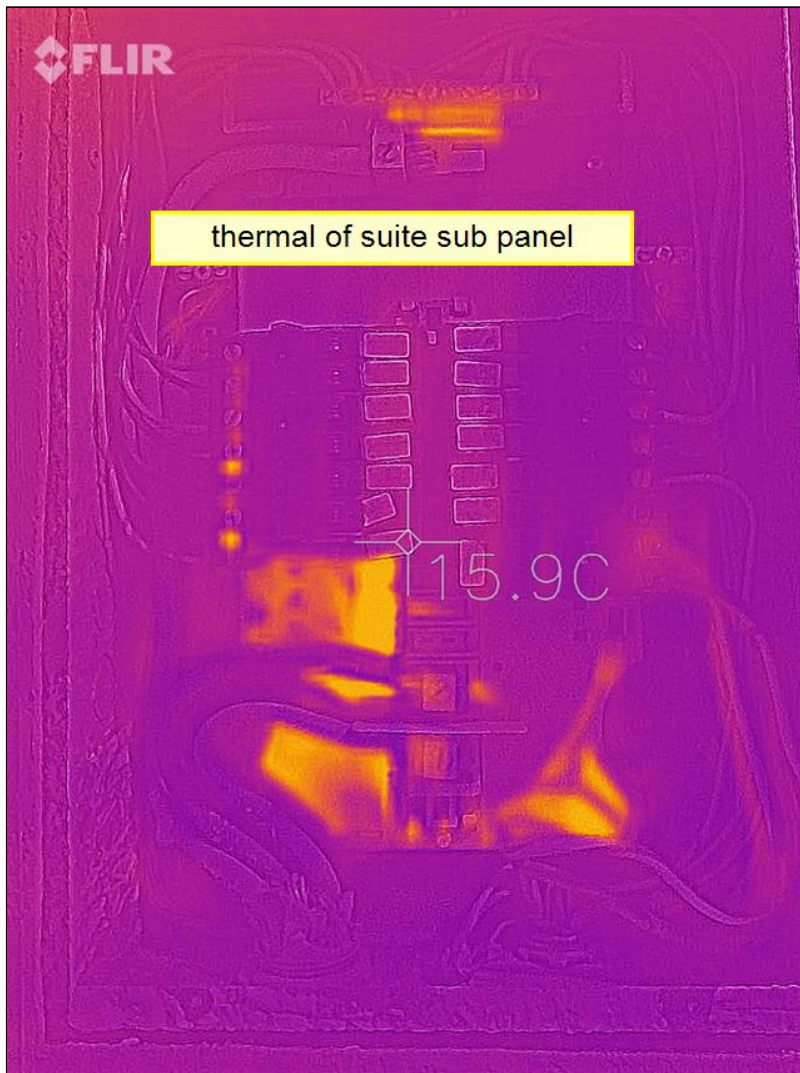
The main electrical panel for the suite is located in the entry hallway.

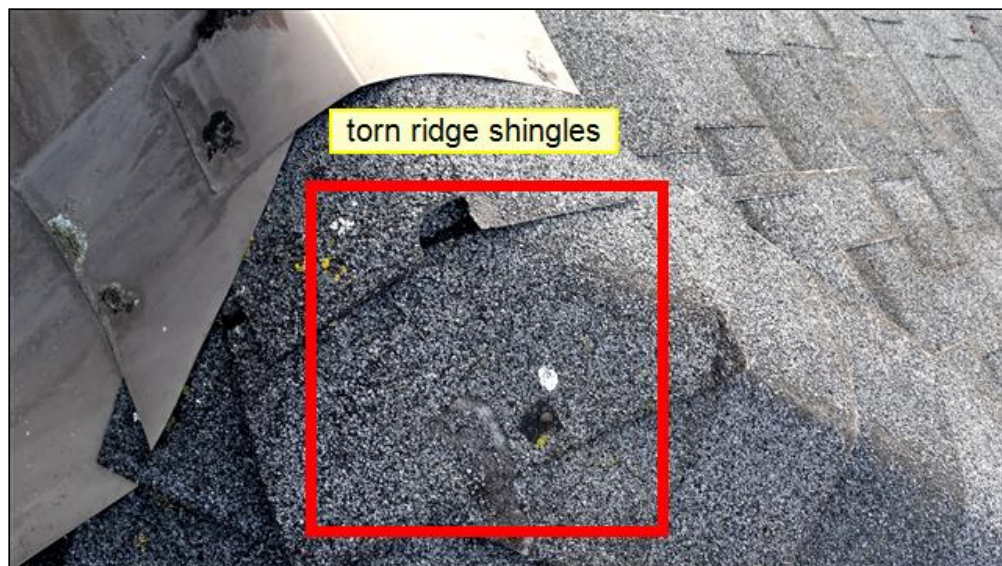
Item 1 - Item 1(Picture)

- 1
- A few shingles are torn on the roof and should be replaced to prevent water ingress. Have a qualified roofer perform the work.
