Inspection Report

Property Address:
Sample Report
Victoria British Columbia

Highland Home Inspections

Date: 2017-08-12	Time:	Report ID: 2017-352
Property: Sample Report Victoria British Columbia	Customer: Mr. Joe Somebody	Real Estate Professional:

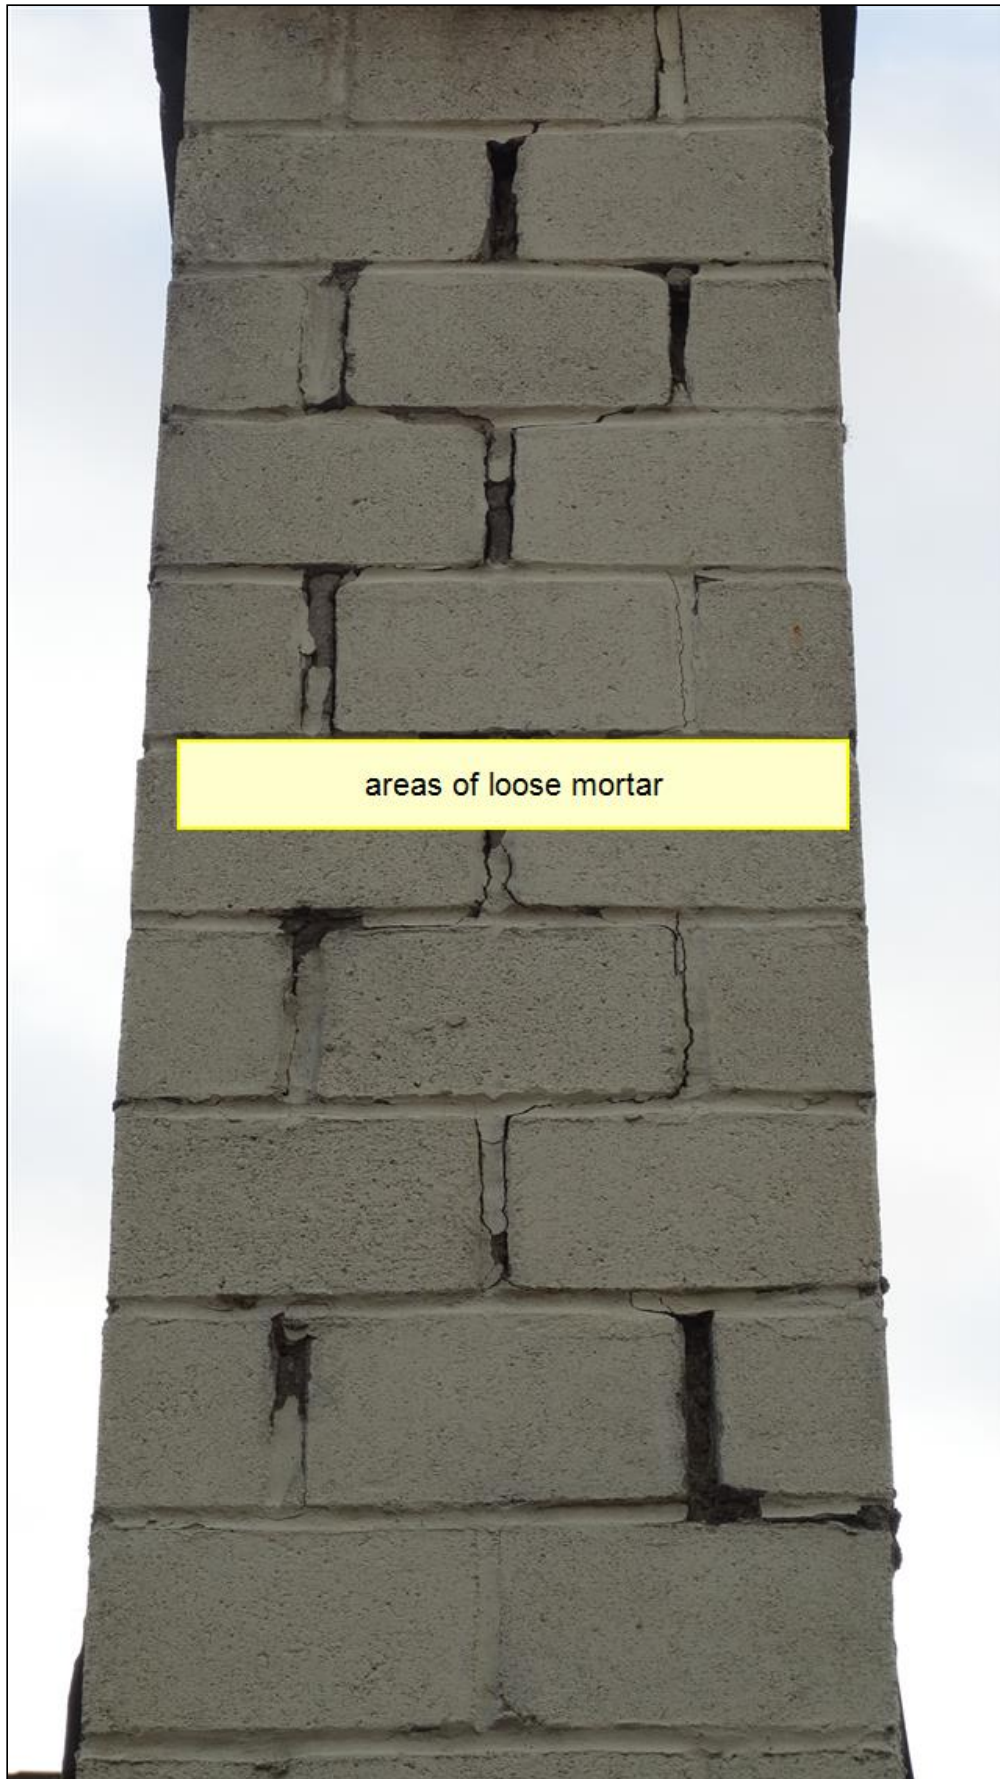
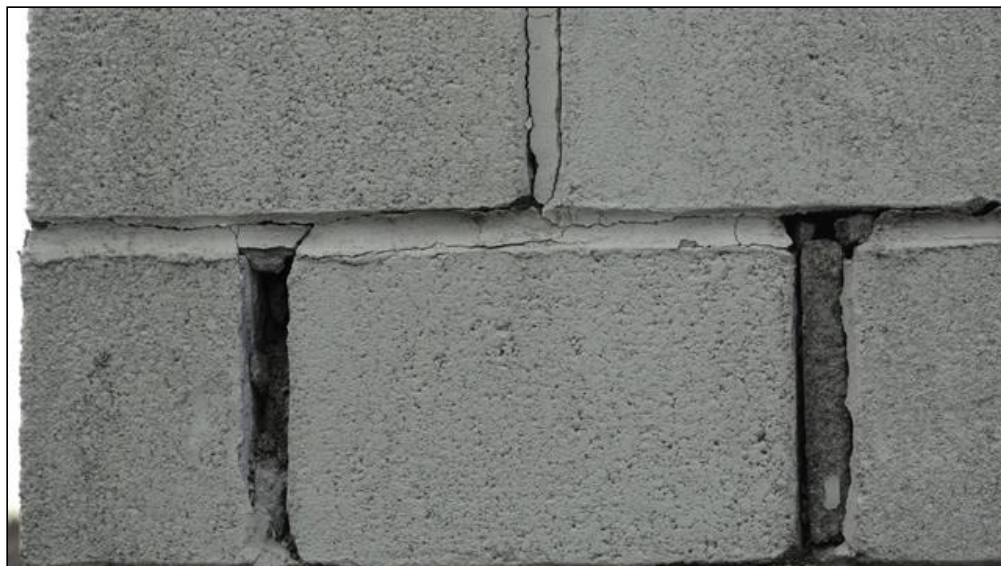
- 2** (1) The concrete block chimney has some areas of deteriorating mortar and should be re-pointed by a qualified mason to prevent further deterioration.

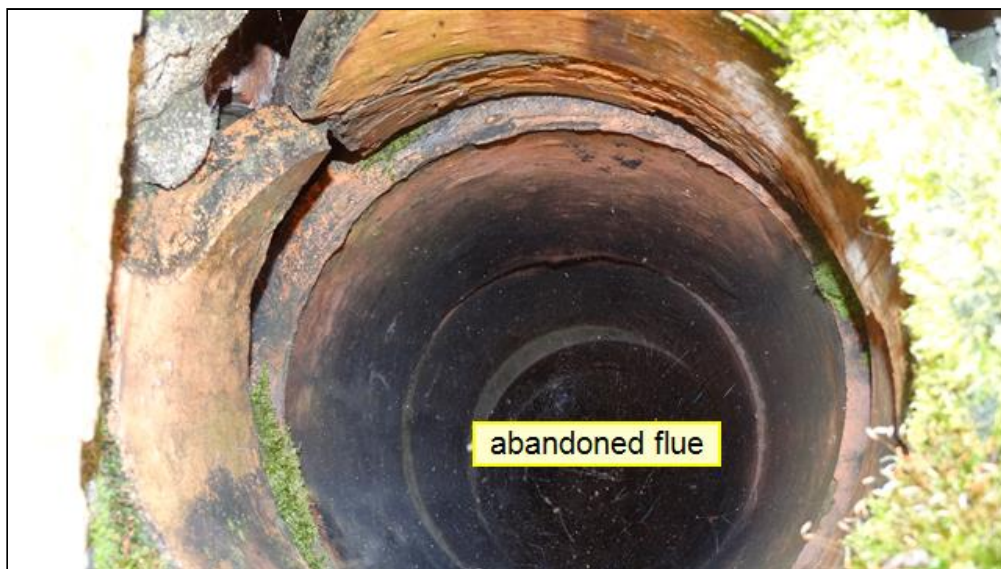
Item 3 - Item 1(Picture)

- 3 (2) One of the chimney flues on the brick chimney is not in use. Some of the liner is deteriorated. Recommend capping off this flue to prevent unwanted water and pests from entering.

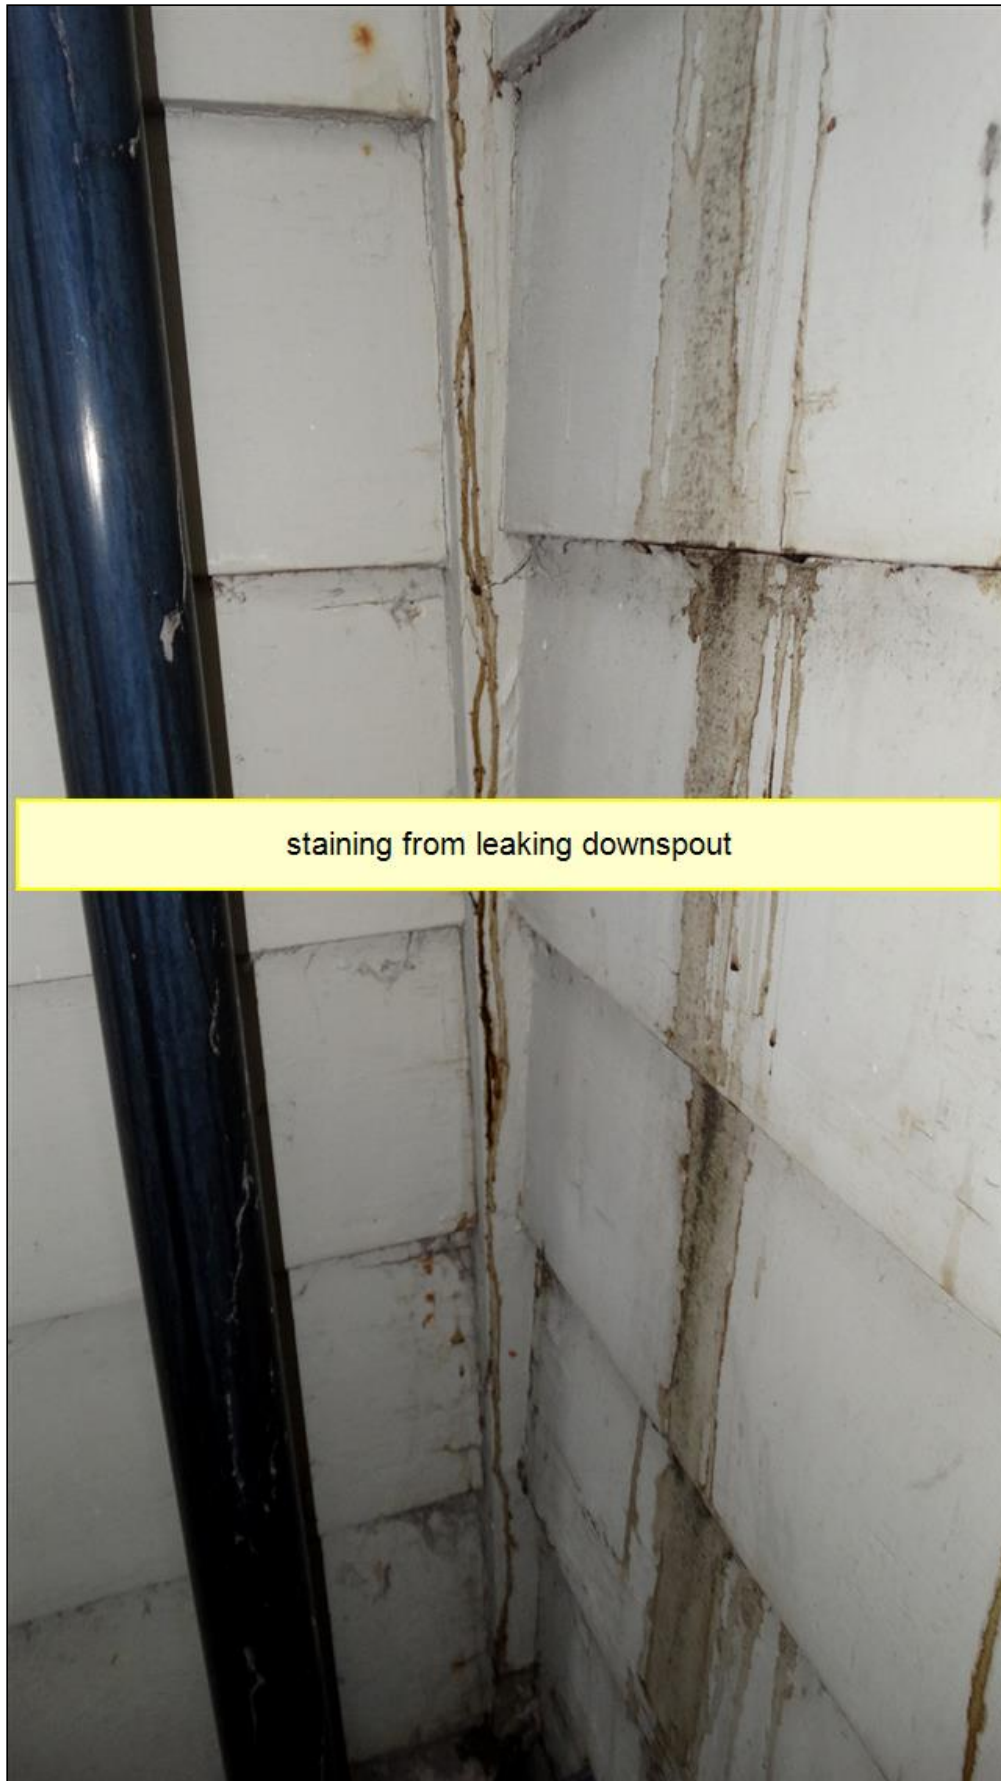
Item 4 - Item 1(Picture)

- 4 Some of the gutters are leaking and should be repaired by a qualified contactor.

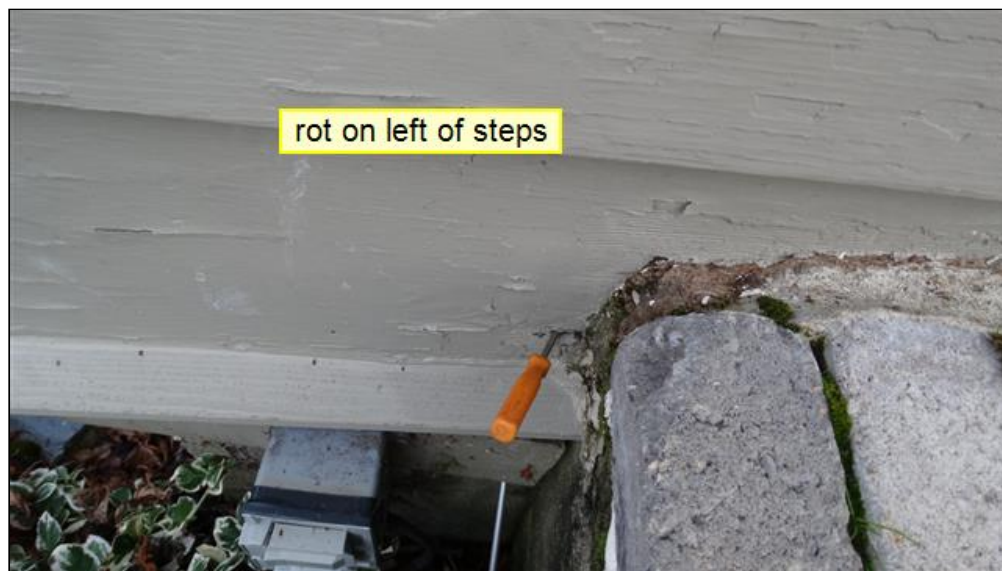
Item 5 - Item 1(Picture)

(1) The cladding on the exterior near the front steps has some rot on either side. A qualified contractor should replace the rotten wood.

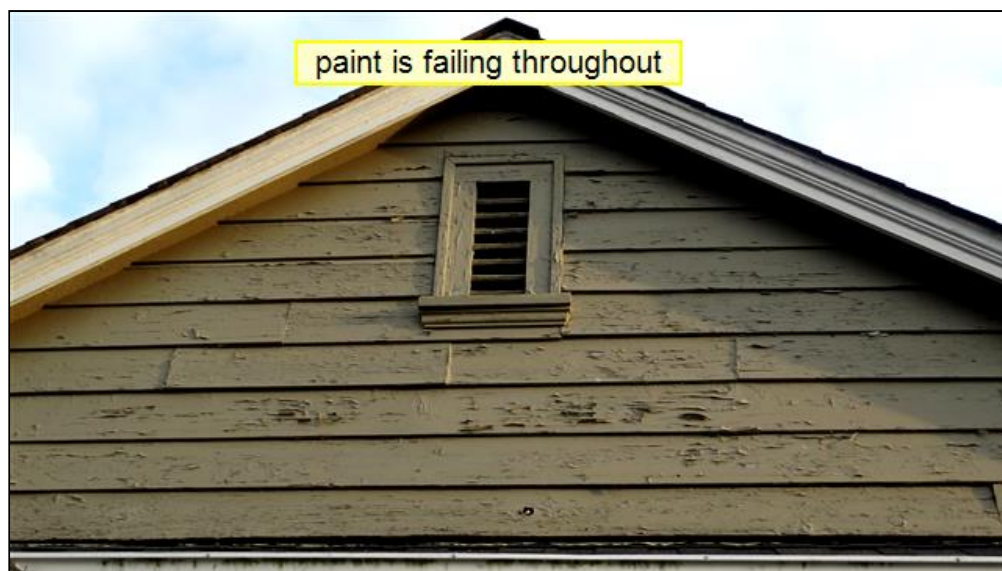
Item 6 - Item 1(Picture)

- 6 (2) The cladding has bare wood in areas and needs prep and paint by a qualified individual.

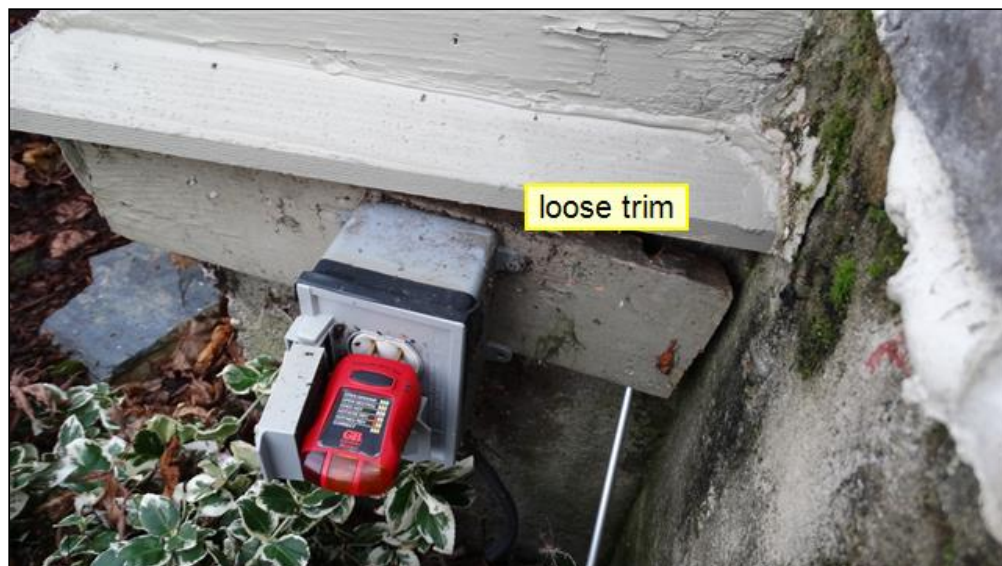
Item 7 - Item 1(Picture)

- 7 (3) The trim board holding a receptacle to the house at the front of the house is loose. Please have a qualified person secure.

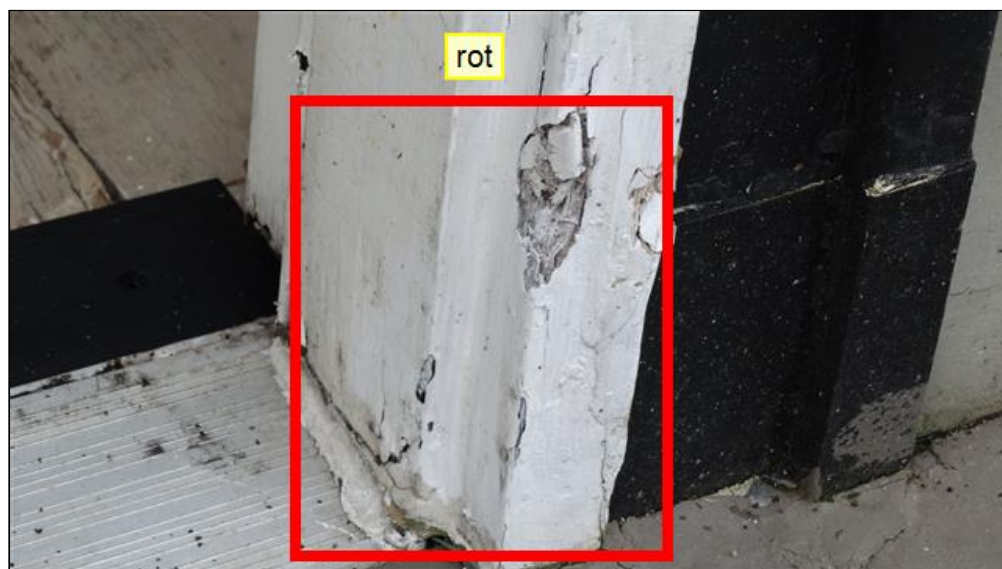
Item 8 - Item 1(Picture)

- 8 The rear entry door jamb has some rot at the bottom edge on both sides. The jamb should be replaced by a qualified contractor.

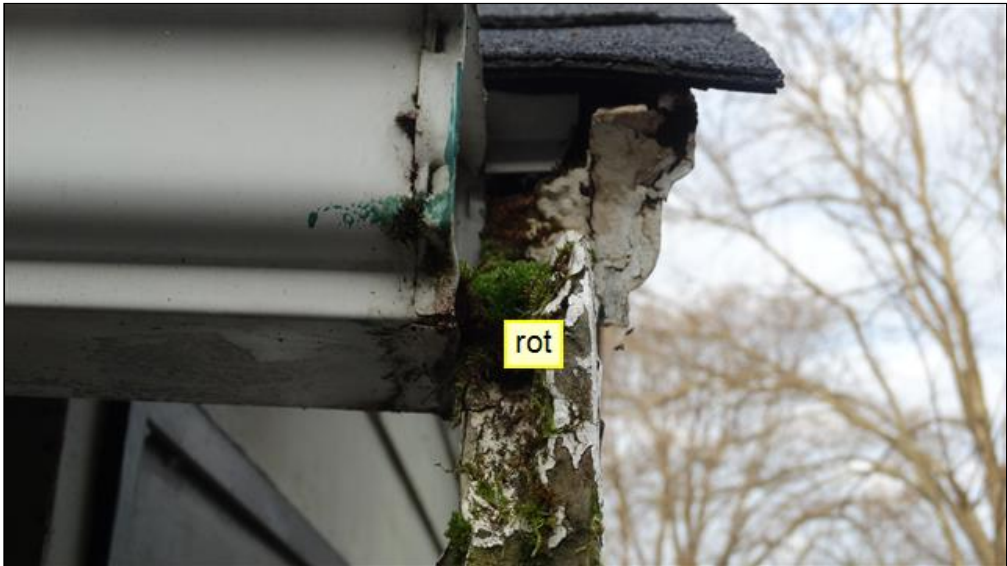
Item 9 - Item 1(Picture)

- 9
- The fascia is rotten near the bottom end at the rear of the house. Please have a qualified contractor replace all rotten exterior wood.

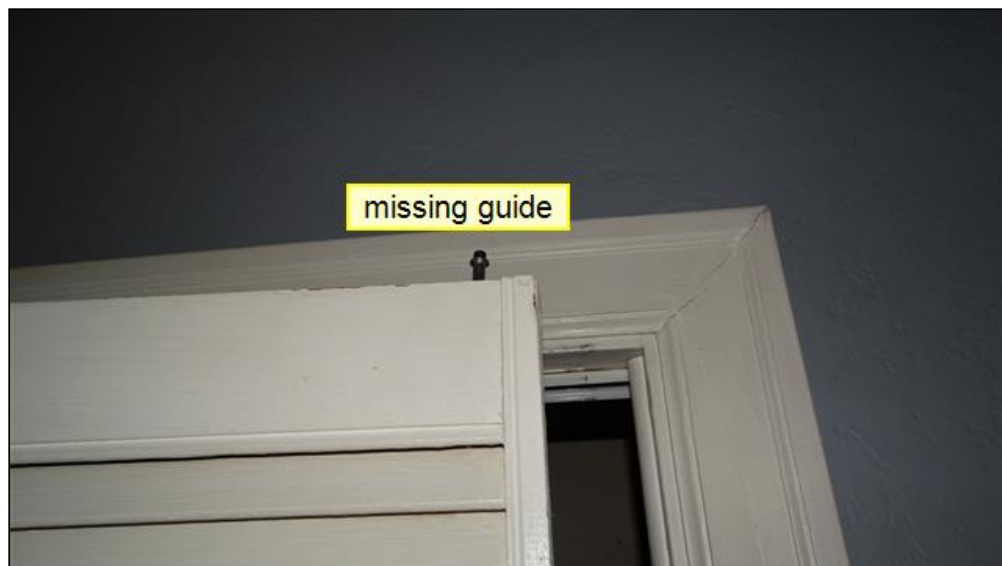
Item 10 - Item 1(Picture)

- 10
- The entry bifold door is missing its guide. Please have a qualified individual repair.

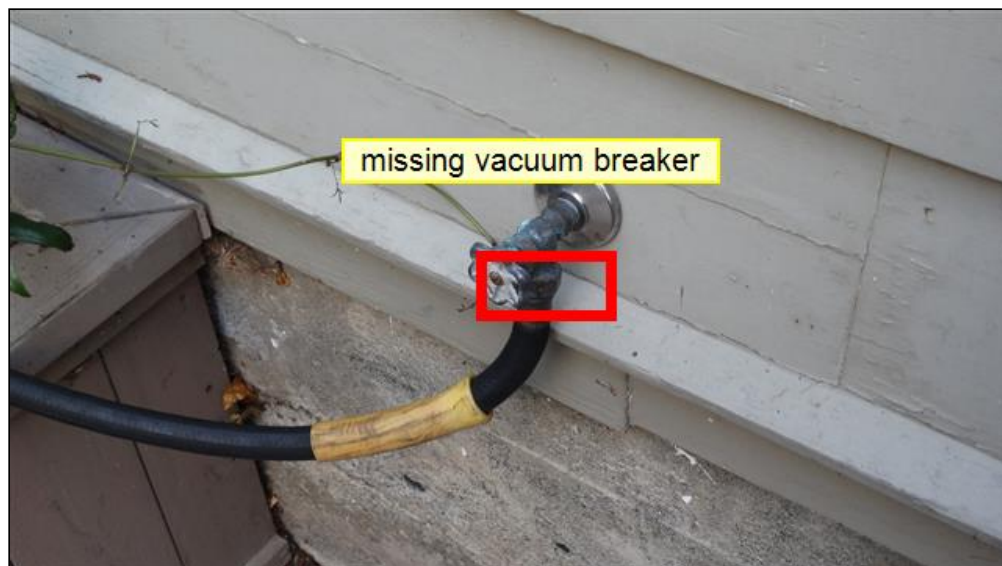
Item 14 - Item 1(Picture)

- 14
- (1) The hose bibb at the rear of the home is missing a vacuum breaker. One is required when attached to a garden hose to prevent back-siphonage and a potential cross-connection. Please have a qualified individual make the repairs.

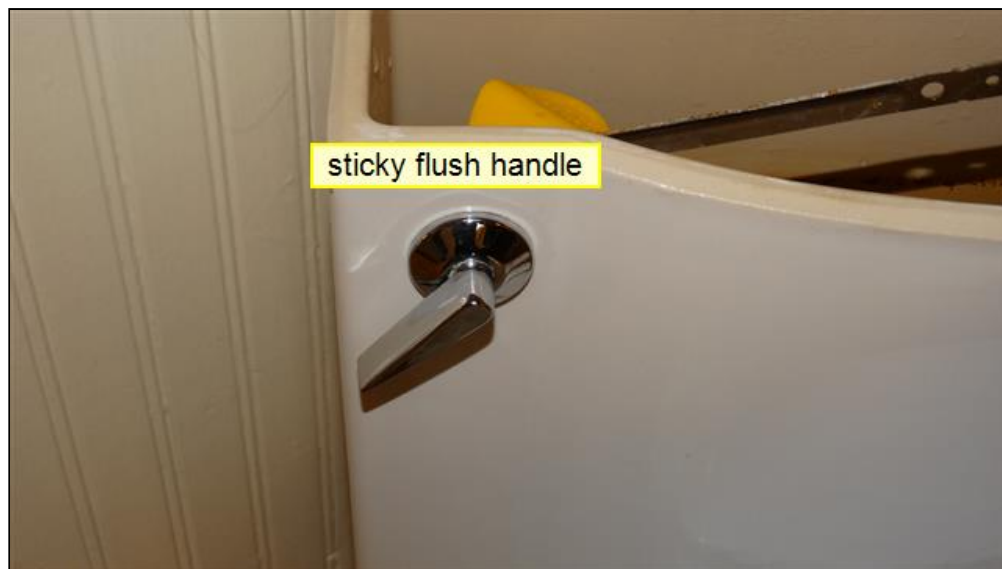
Item 15 - Item 1(Picture)

- 15** (2) The control knob for the toilet in the main bathroom sticks when operated. Please have qualified plumber repair or replace.

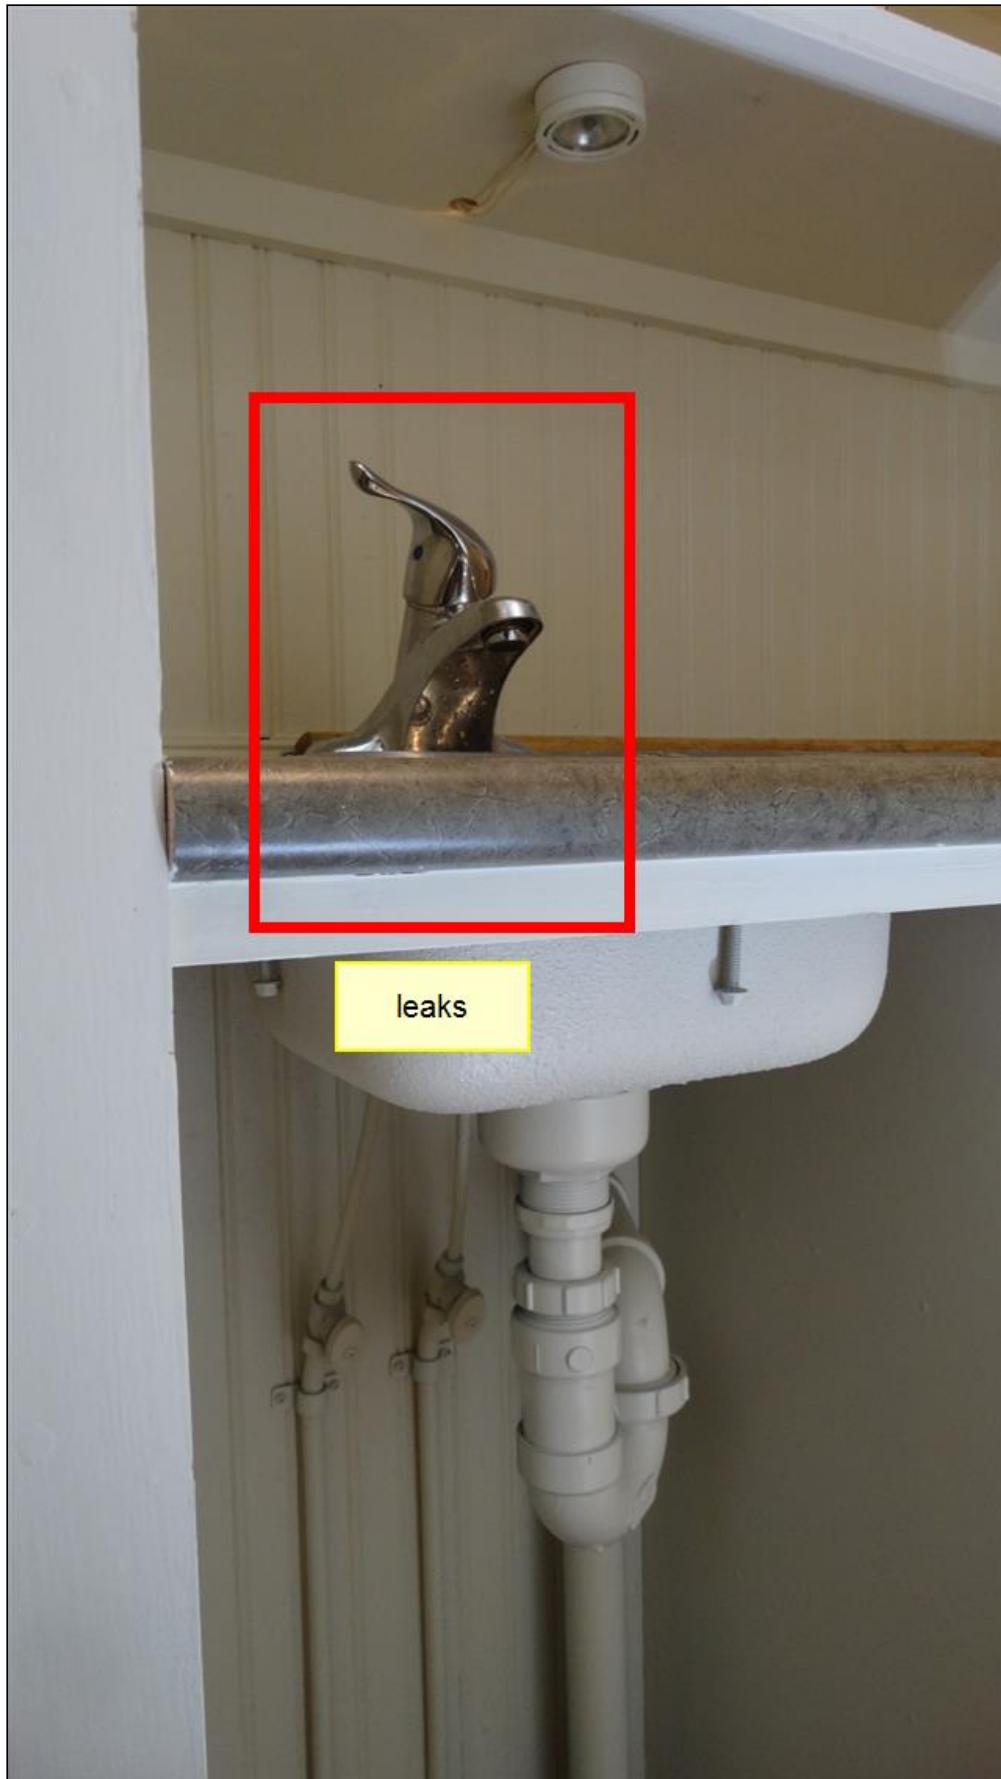
Item 16 - Item 1(Picture)

- 16** (3) The faucet for the small sink in the hallway leaks when in use. Please have a qualified plumber repair the faucet or replace.

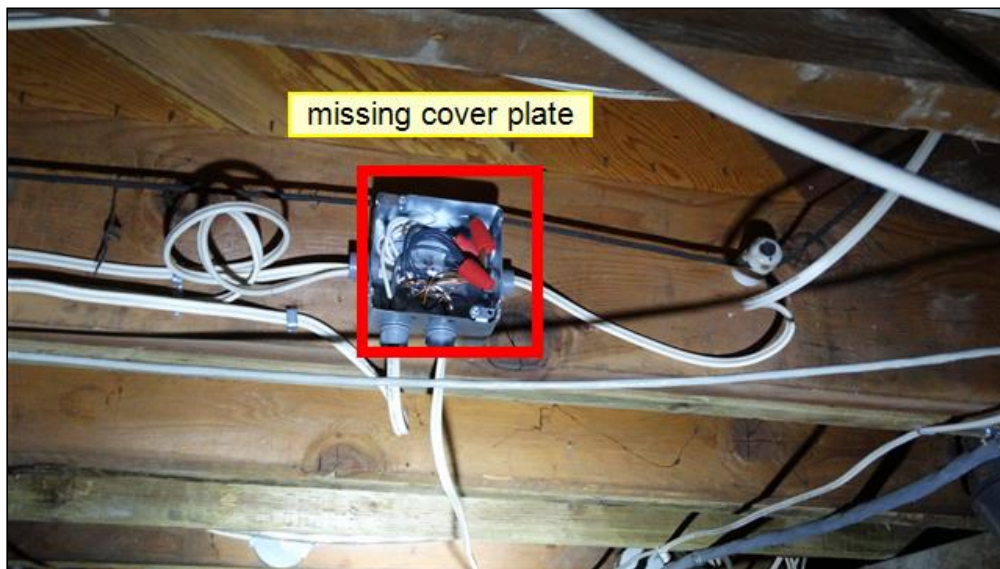
Item 17 - Item 1(Picture)

- 17 (1) Many junction boxes in the attic and crawlspace are missing their cover plates. They are a safety hazard if left without them. Please have a qualified electrician install the cover plates.

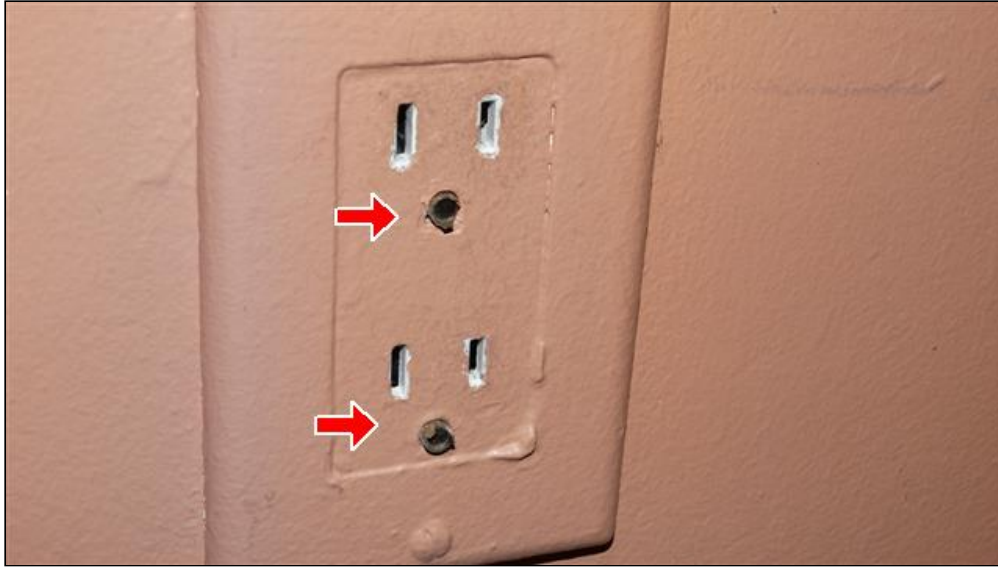
Item 18 - Item 1(Picture)

- 18 (2) The receptacle outside the master bedroom has ground prongs broken off inside of it. Please have a qualified electrician replace the receptacle.

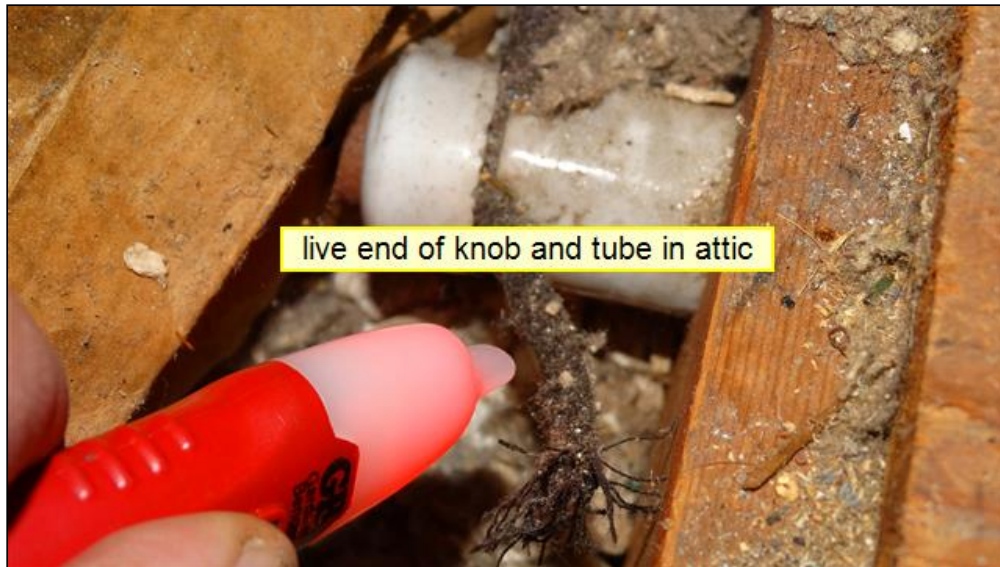
Item 19 - Item 2(Picture)

- 19 (3) This property has "knob and tube" wiring which was commonly installed prior to 1950. It is ungrounded, and considered unsafe by today's standards. Over time, the wire's insulation becomes brittle and falls apart, resulting in exposed conductors and a risk of shock and/or fire. This wiring is also easily damaged by covering it with insulation (a common practice), and incorrectly tapping new wiring into it. Some energized knob and tube wiring was found during the inspection. It is not within the scope of this inspection to determine what percentage of this property's wiring is of the knob and tube type or to determine what percentage of the knob and tube wiring is energized vs. abandoned. A qualified electrician should evaluate this wiring and make repairs or replace wiring as necessary. I recommend you verify acceptability with your insurance company and/or lender prior to closing.

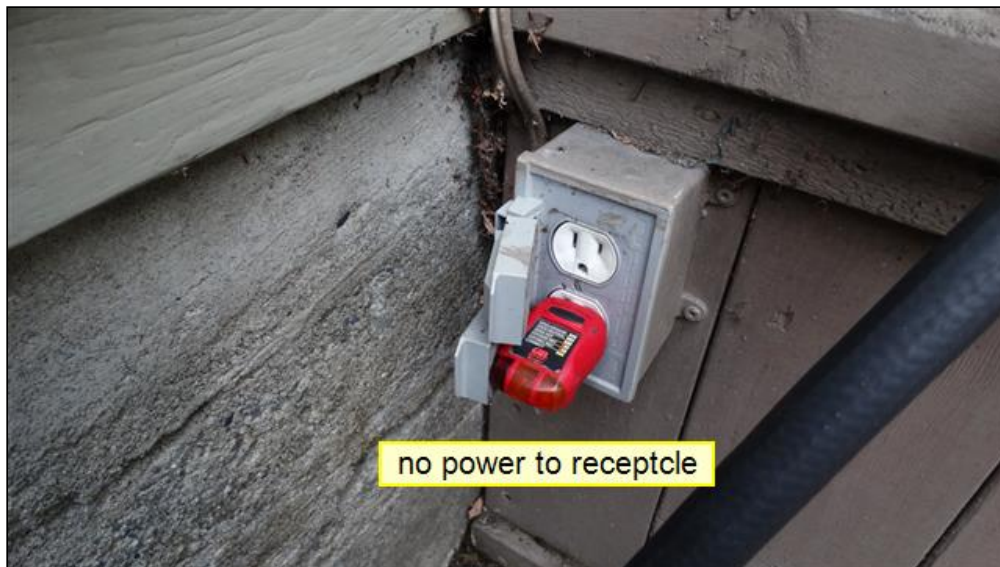
Item 20 - Item 1(Picture)

- 20 The exterior electrical receptacle at the side of the house had no power when tested. An up-stream GFCI may have been tripped. Please have a qualified electrician repair or replace.

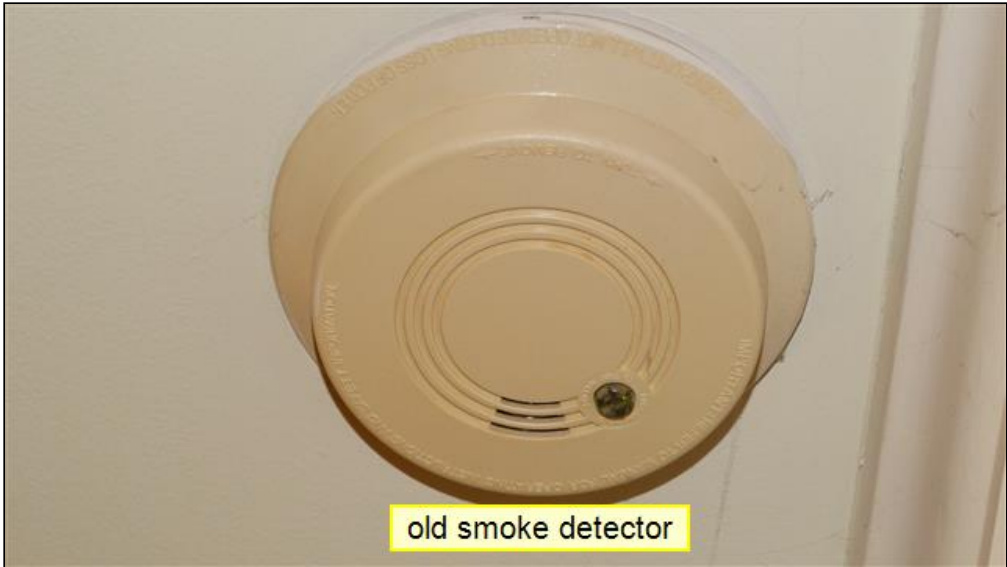
Item 21 - Item 1(Picture)

- 21 Smoke detectors over 10 years of age should be replaced by a qualified individual. Please replace this smoke detector.

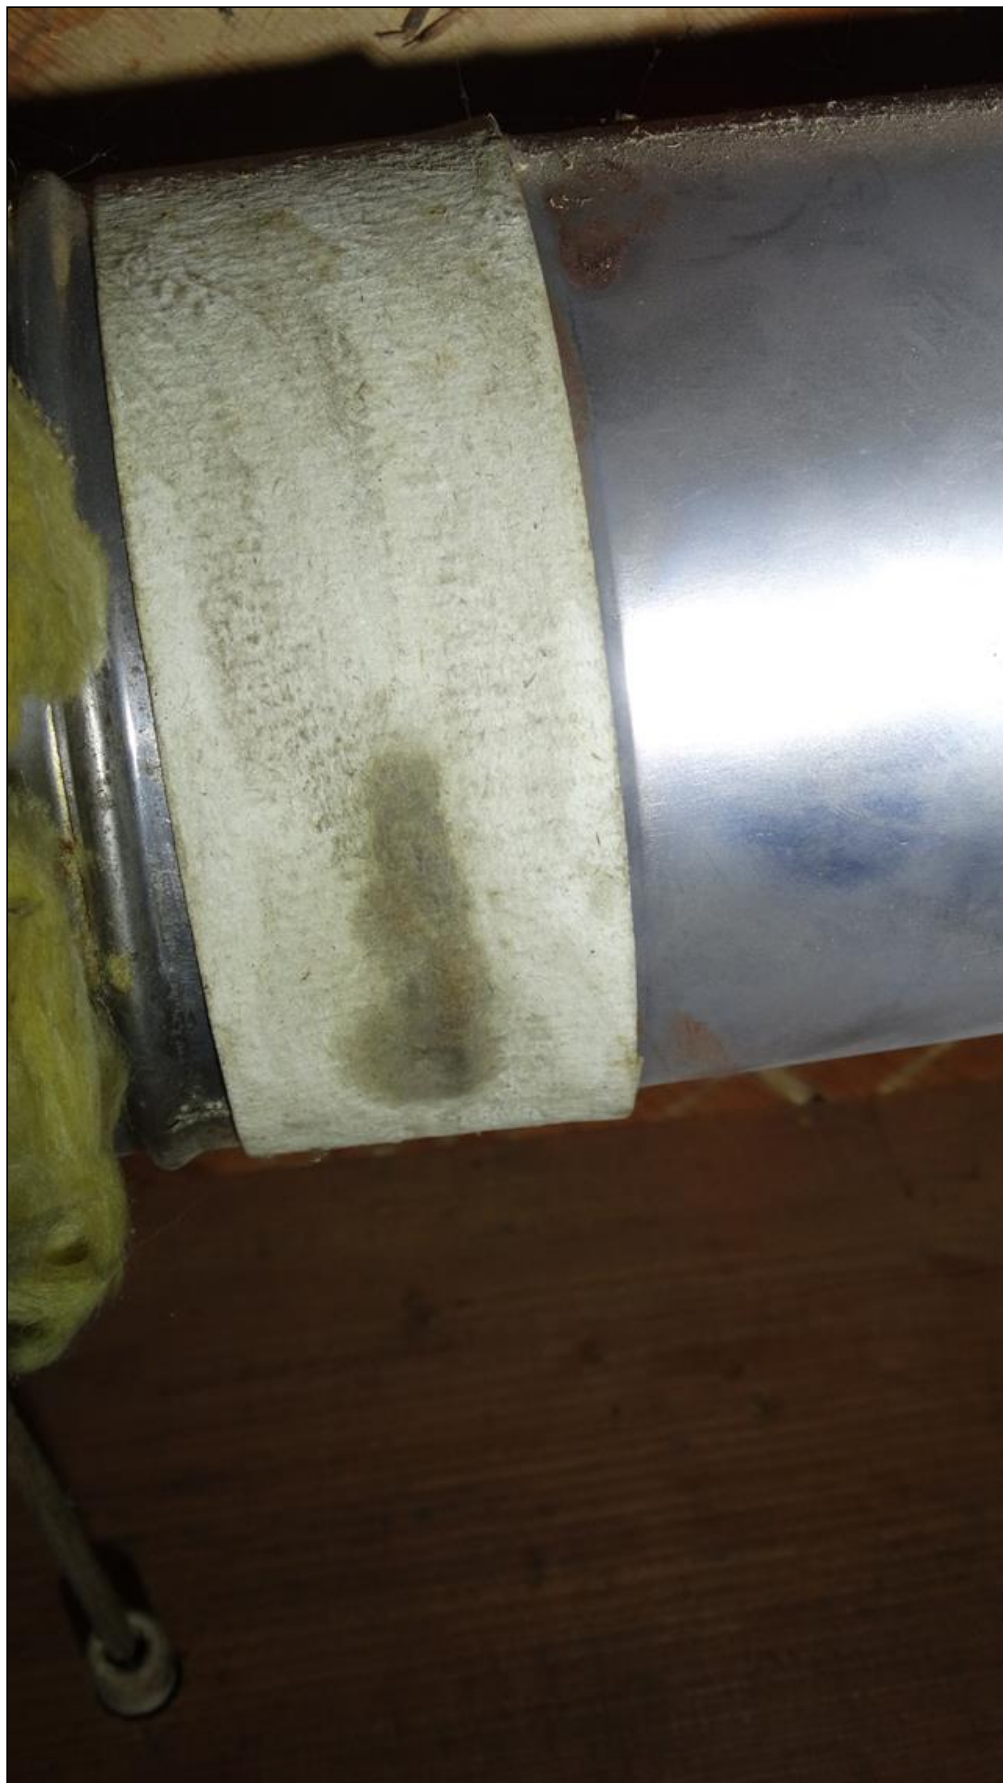
Item 23 - Item 1(Picture)

- 23
- (1) The ductwork in the crawlspace has what looks like asbestos tape on it. Recommend having a qualified individual tape over the asbestos tape with foil faced tape.

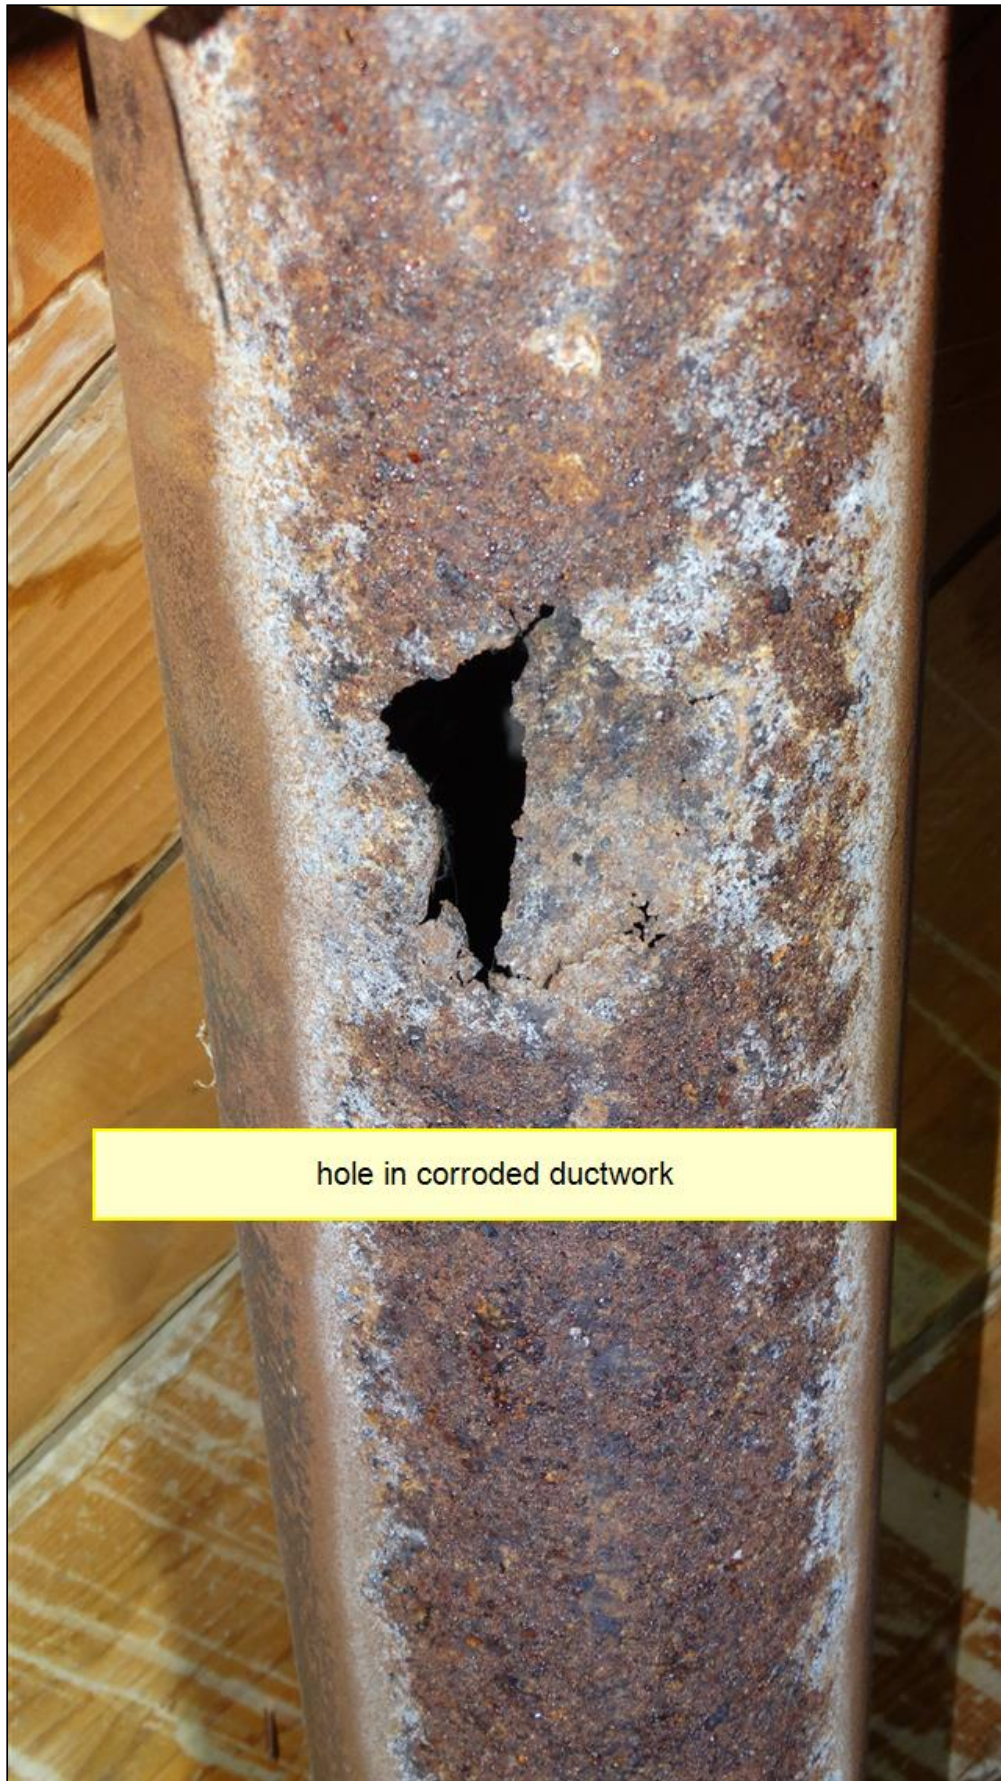
Item 24 - Item 1(Picture)

- 24
- (2) Some of the ductwork in the crawlspace is very rusty and in need of replacement. Please have a qualified HVAC specialist replace the corroded ductwork.

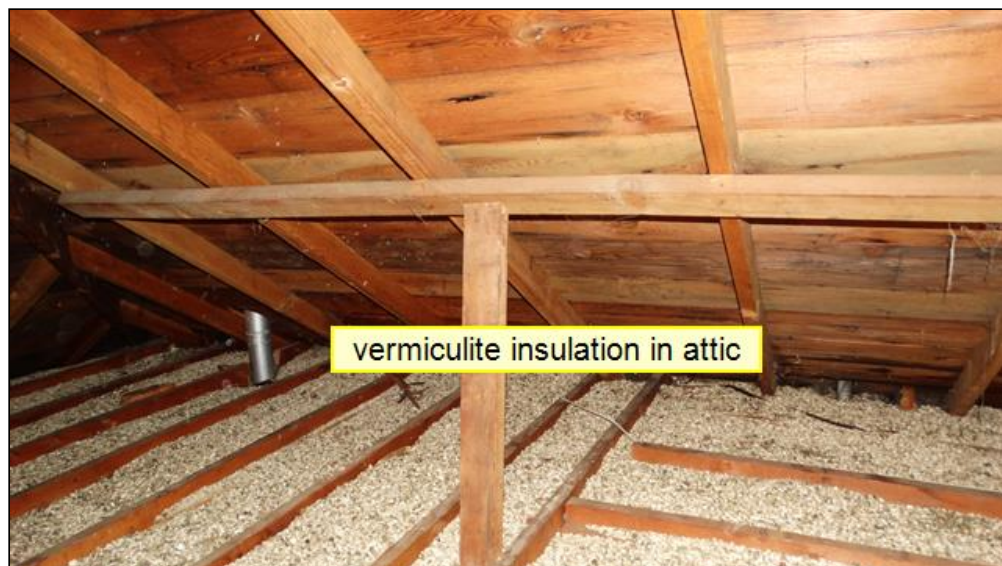
Item 26 - Item 1(Picture)

- 26 (1) It appears that Vermiculite insulation was used in the attic. Some Vermiculite insulation is known to contain asbestos. Its strongly recommend that Vermiculite insulation is left undisturbed. It is also recommended that you do not store boxes or other items in your attic, do not allow children to play in an attic, and do not attempt to remove the insulation yourself. Hire a professional contractor if you plan to remodel or conduct renovations that would disturb the Vermiculite in your attic or walls to make sure the material is safely handled and/or removed.

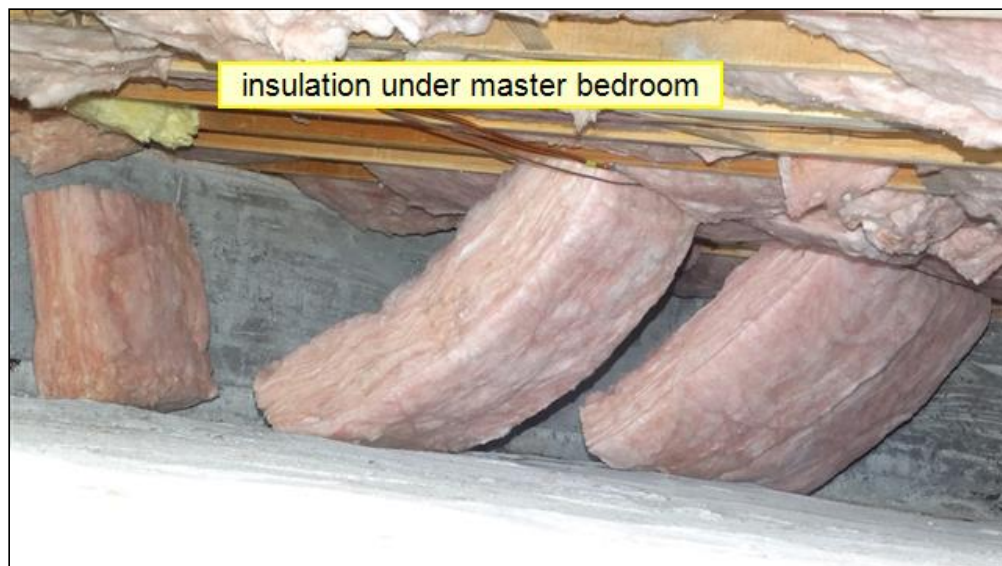
Item 28 - Item 1(Picture)

(1) Some insulation has fallen down under the master bedroom. Please replace for comfort.

- 28 (1)** Some insulation has fallen down under the master bedroom. Please replace for comfort.

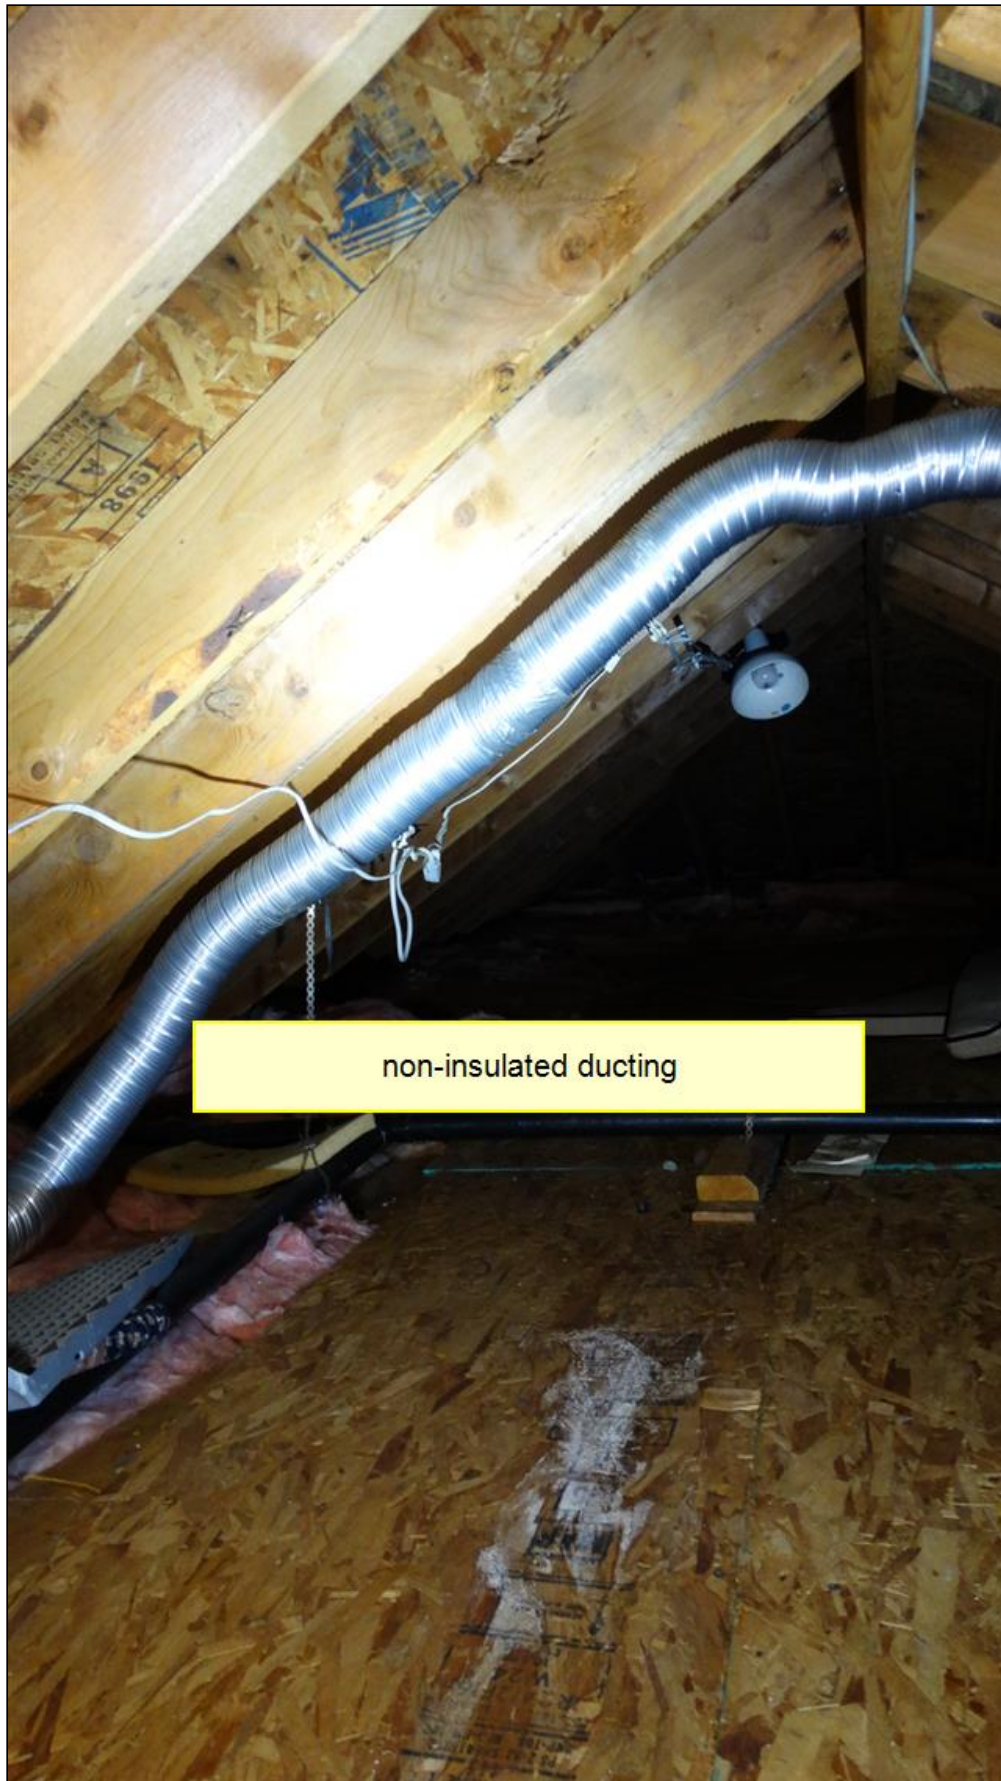
Item 30 - Item 1(Picture)

The exhaust fans use non-insulated ducting in a non conditioned space (attic).. Ducting that is not insulated in a non-conditioned area can lead to condensation within the ductwork. Please have a qualified contractor repair.

- 30** The exhaust fans use non-insulated ducting in a non conditioned space (attic).. Ducting that is not insulated in a non-conditioned area can lead to condensation within the ductwork. Please have a qualified contractor repair.

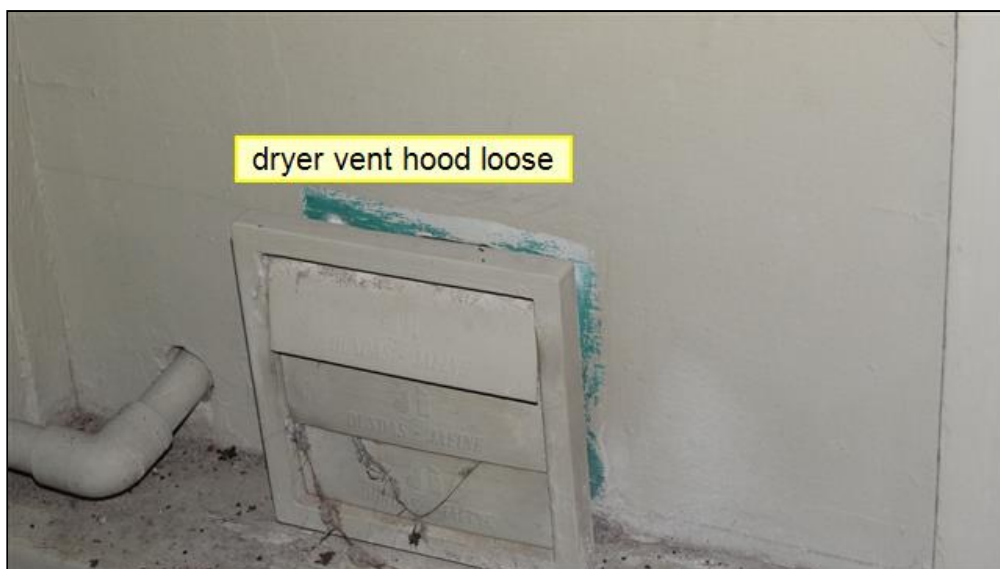
Item 30 - Item 3(Picture)

The dryer vent hood is loose from the wall. Please have a qualified person secure.

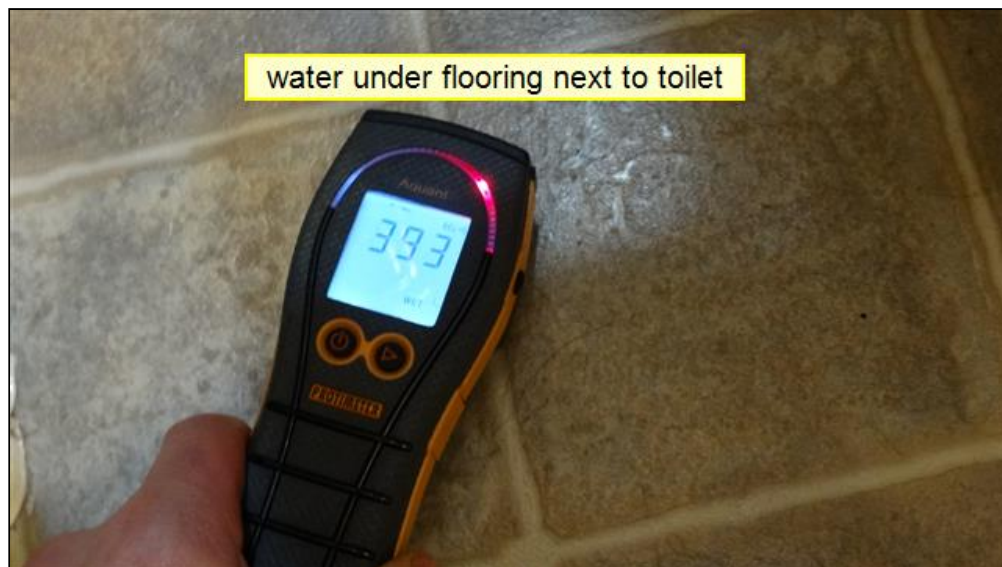
Item 32 - Item 1(Picture)

The toilet is loose at the floor in the bathroom. Repairs may involve re-setting the toilet on a new wax seal. I recommend a qualified licensed plumber make the repairs. The thermal imaging camera and moisture meter confirmed water under the flooring in the bathroom from the leaking toilet.

- 32** The toilet is loose at the floor in the bathroom. Repairs may involve re-setting the toilet on a new wax seal. I recommend a qualified licensed plumber make the repairs. The thermal imaging camera and moisture meter confirmed water under the flooring in the bathroom from the leaking toilet.
